QUESTA TAILINGS FACILITY – REVISED CLOSURE PLAN

Molycorp, Inc. (Molycorp) owns and operates tailings impoundments located adjacent to the town of Questa, New Mexico. These impoundments contain the tailings from the Questa molybdenum mine, which is located 3.5 miles east of Questa. It is anticipated that these tailings facilities will be operated for at least another 20 years. However provision must be made for the eventual reclamation and closure of these tailings impoundments.

Under the terms of the approval granted by the Groundwater Protection and Remediation Bureau of the New Mexico Environmental Department (NMED) for Molycorps Discharge Plan (DP-933), Molycorp was required to prepare a Revised Closure Plan (RCP) for the Questa tailings impoundments. The schedule for submitting documents that support a revised closure plan for the tailings impoundments were to be as follows:

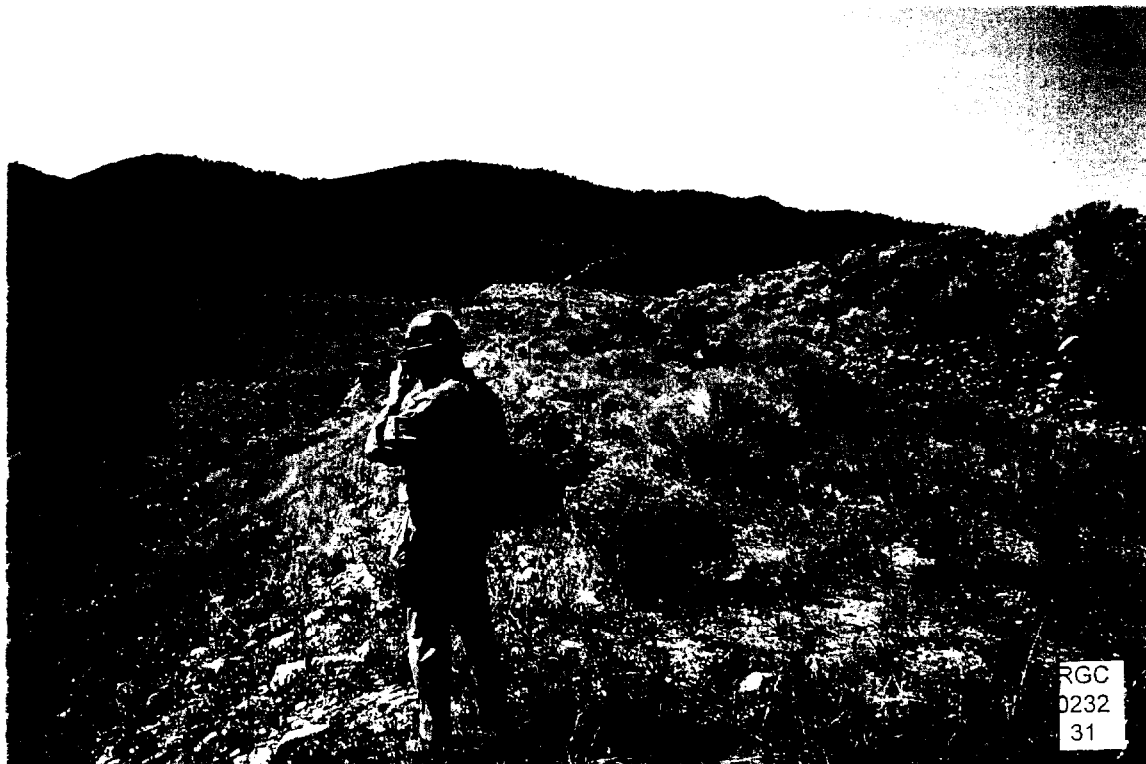
Photo 4: Looking west along Dam 1 embankment showing vegetation development and minimal erosion (photo taken September, 1996).

The gravel alluvium has a high percentage of gravel and is resistant to sheet erosion, even for steep slopes. This conclusion is well demonstrated by the negligible erosion that is observed on the interim cover (Photo 14) as well as the dam faces (Photos 4 to 6) and the sidewalls of the diversion ditch excavations (particularly in the deep cut near the discharge end of the east

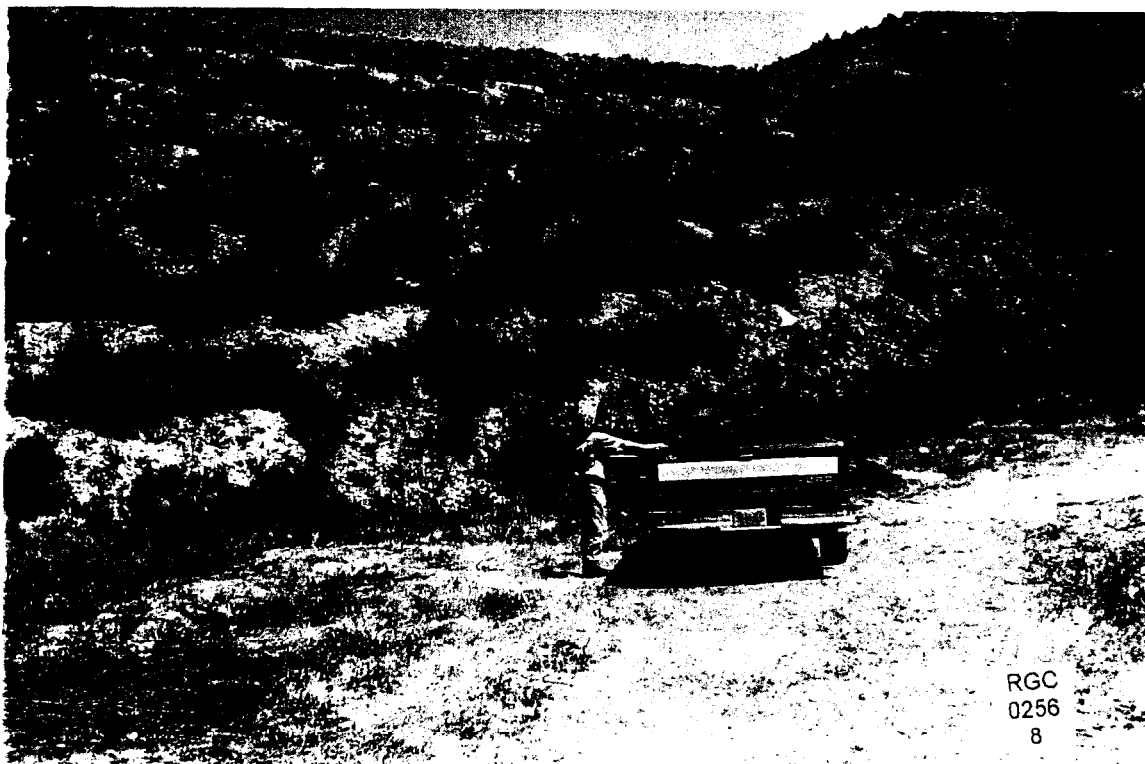
Photo 5: Toe buttress near east abutment of Dam 1 showing well-developed brush vegetation (photo taken August, 1997).

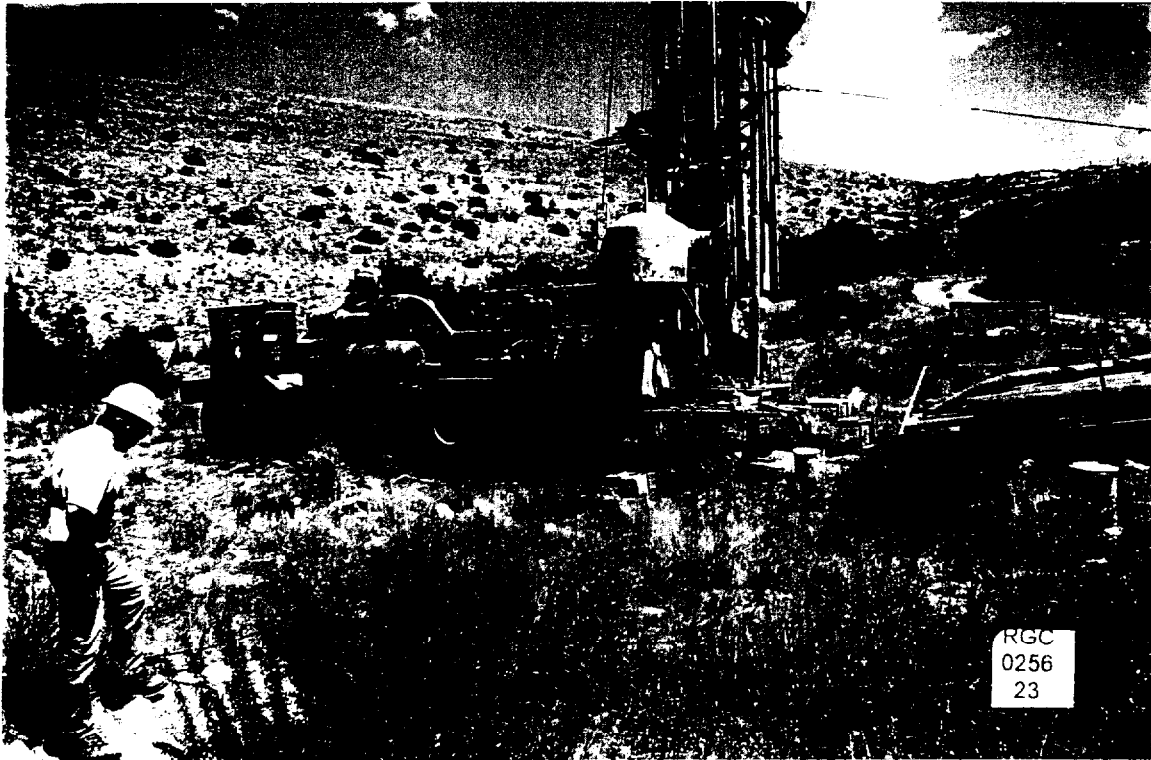
Photo 6: Drilling of monitoring well MW-13 at toe of Dam 4 looking northeast (photo taken August, 1997).

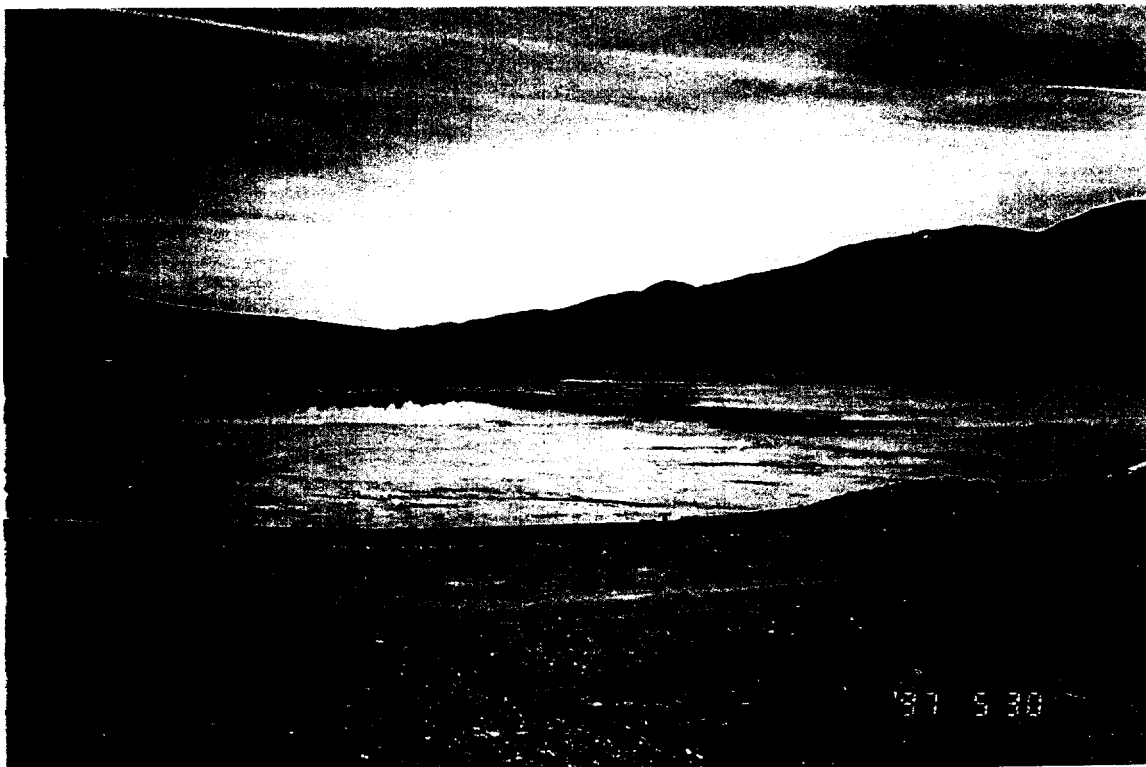
Photo 8: Tailings Discharge behind Dam 5A showing spigotted beaches and pond in background (photo taken May, 1997).

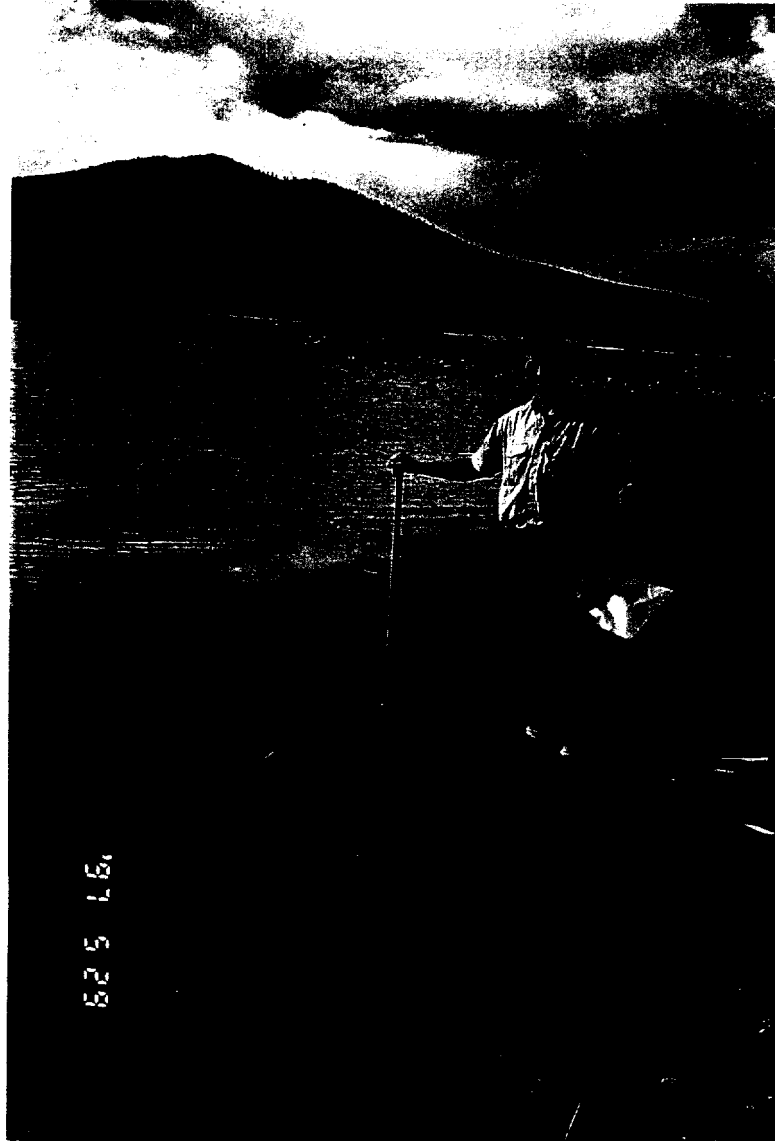
Photo 10: Intermediate tailings on beach adjacent to pond (sampling location 97-T-2 in section 35 impoundment) indicating shear strength and permitting access (photo taken May, 1997).

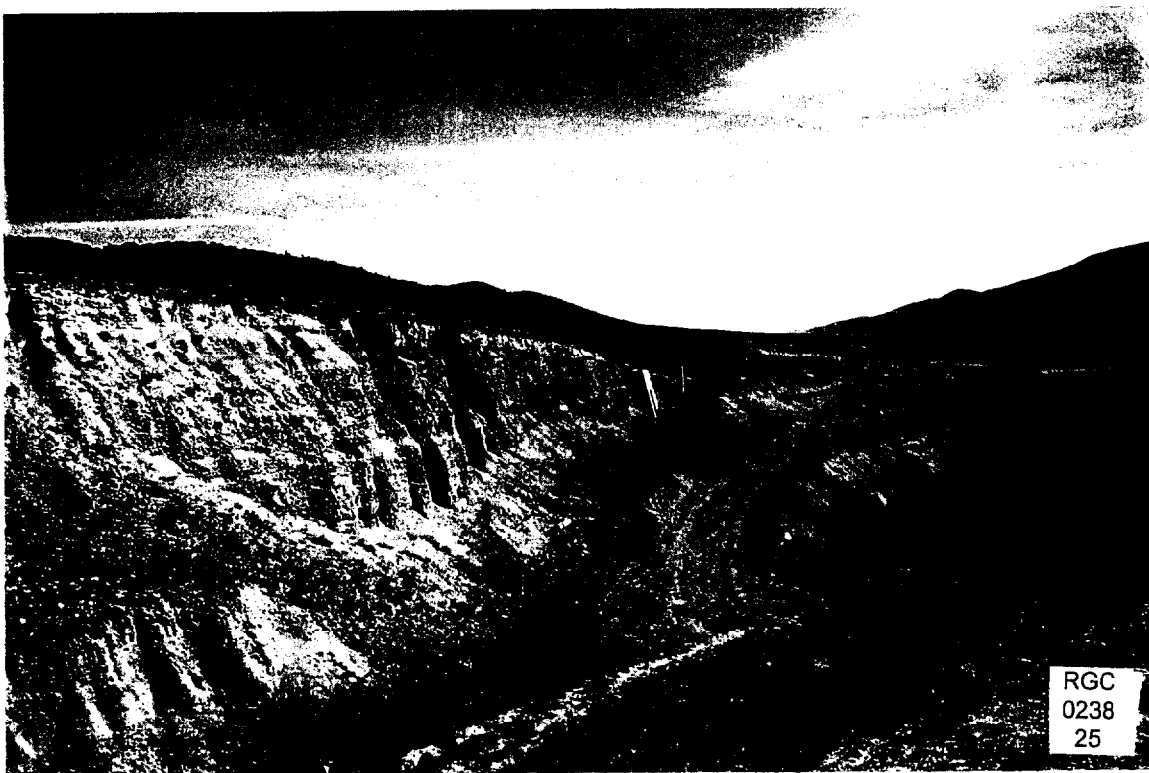
Photo 13: Looking north towards decant channel of Dam 5A exposing alluvial sediments used as cover material. At least three horizontally extensive (>200m) layers of fine sediment (clay/silt) can be seen in the alluvial sediment sequence (photo taken May, 1997).

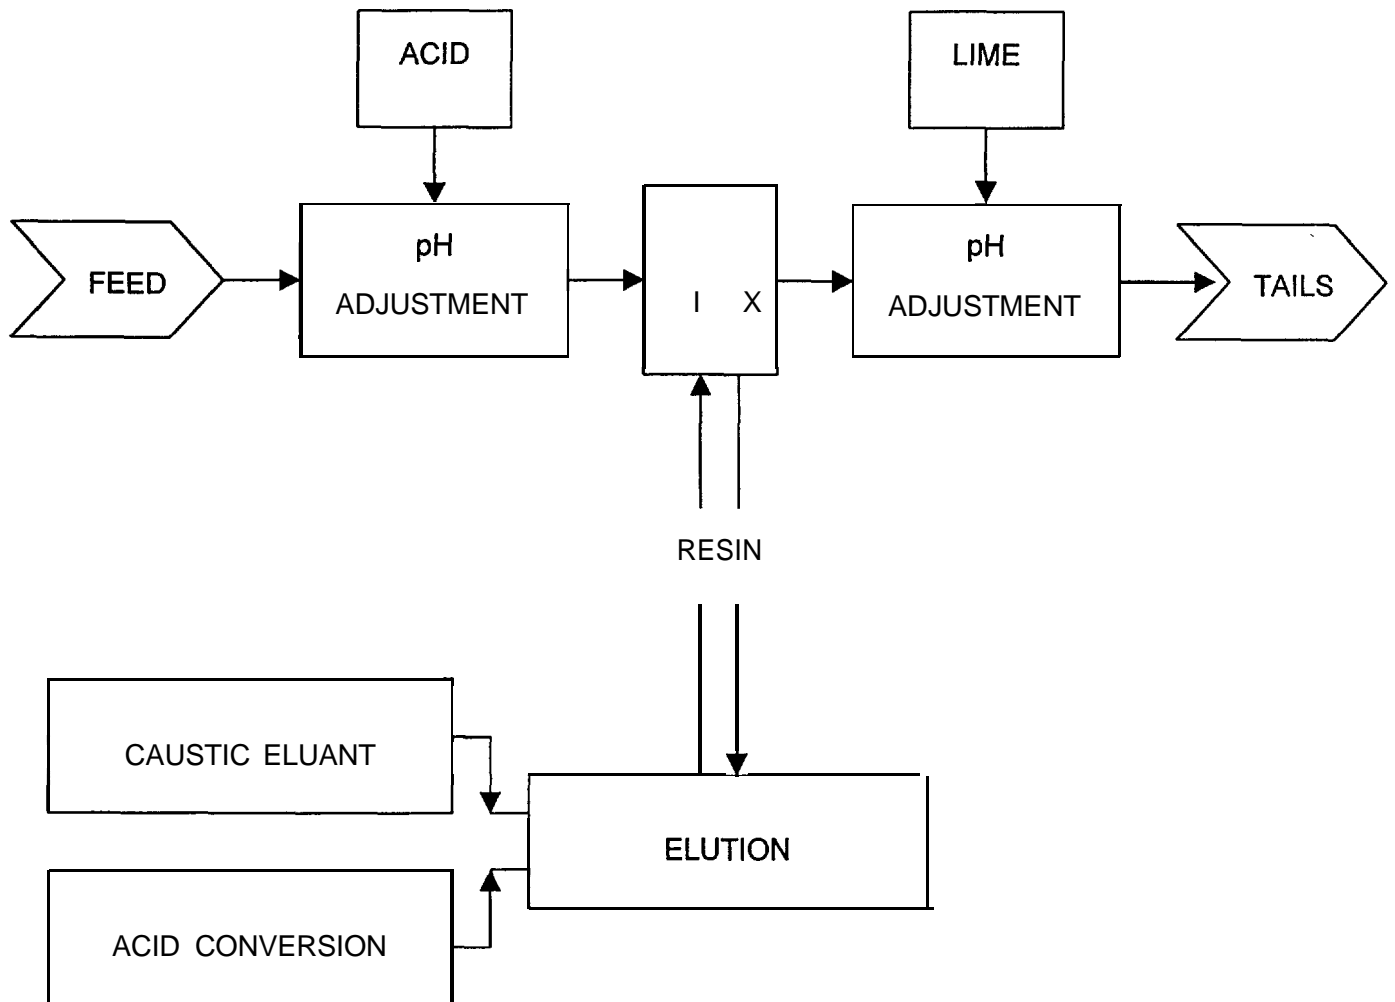
Figure 3-12.

Flowchart of Ion Exchange (IX) Plant.

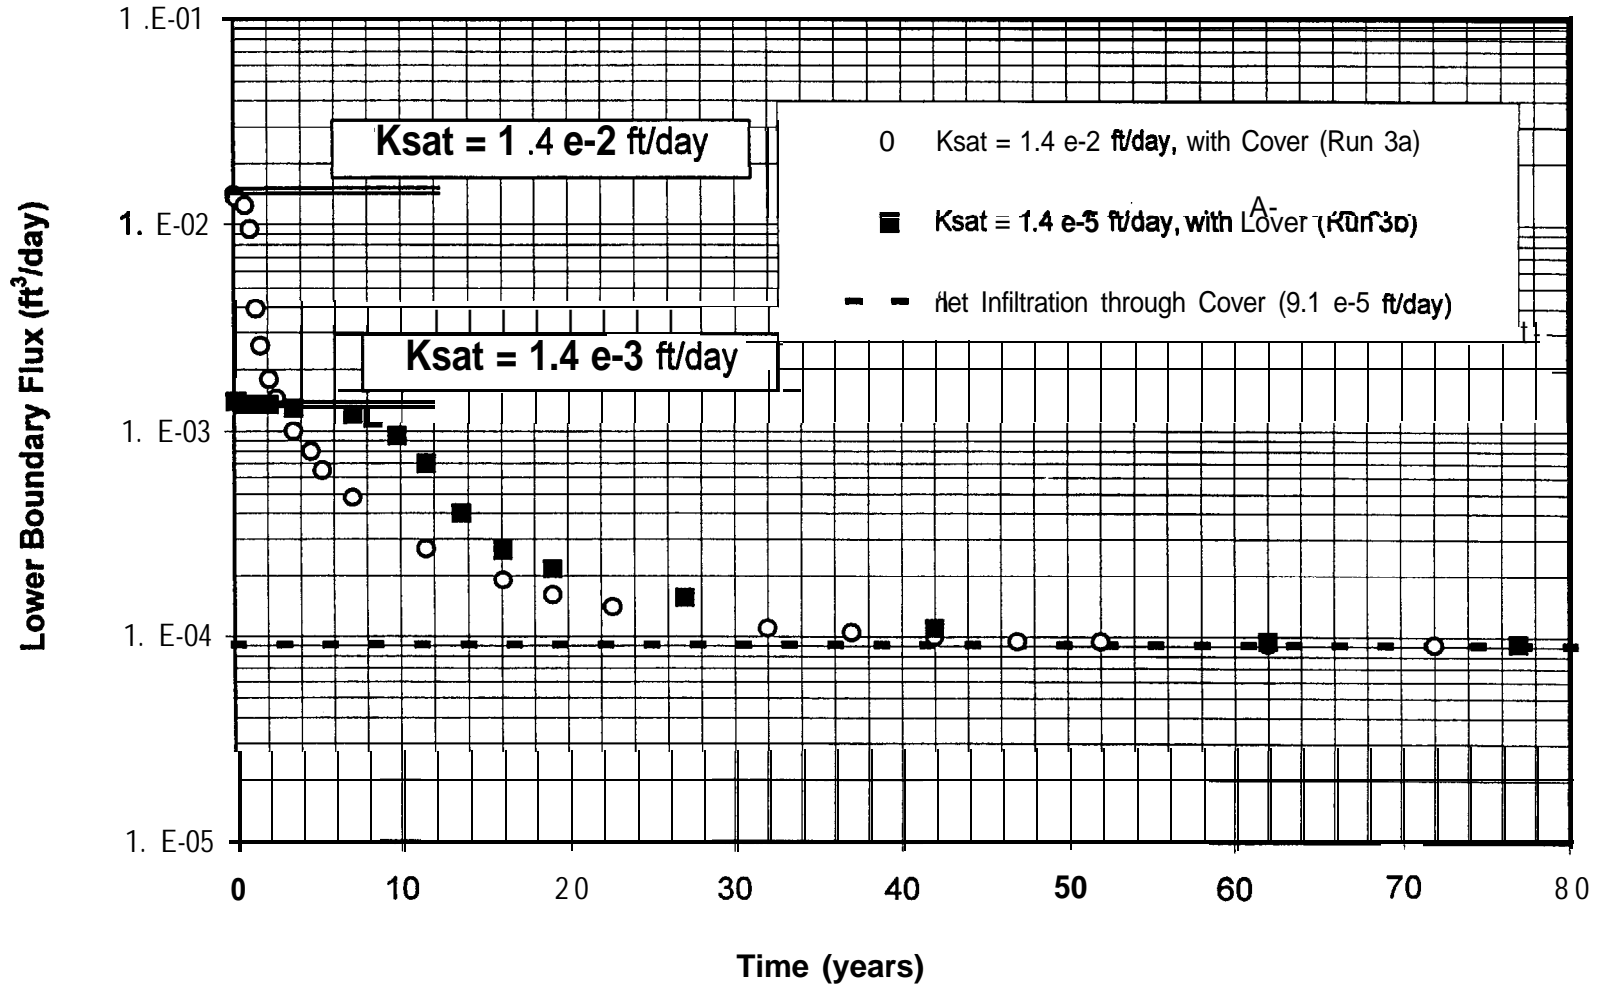
Seepage Losses for Fine Tailings

Figure 4-10b.
 Simulated Seepage Losses from the Fine Tailings of Section 35 over Time.

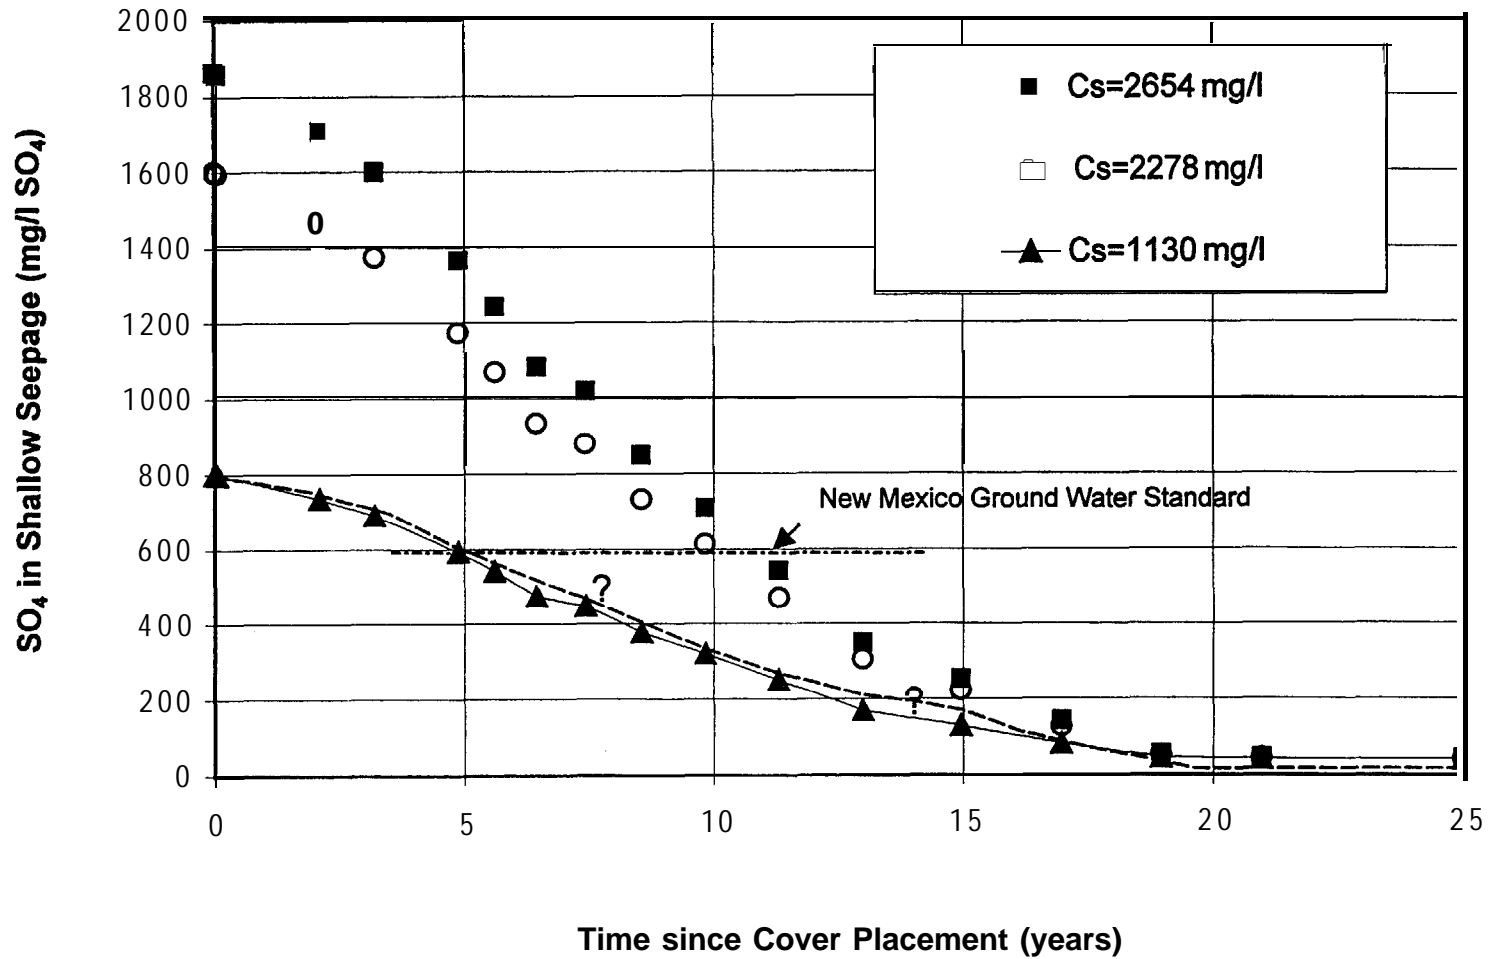
Figure 4-14a.
 Simulated [SO₄] in Shallow Seepage versus Time.

The predicted trends of water quality in shallow and deep seepage over time are shown in Figures 4-14a/b/c and 4-15a/b/c, respectively. The estimated times to reach acceptable groundwater quality standards in shallow and deep seepage are summarized in Table 4.7. The model calculations suggest that sulfate concentrations in shallow seepage will improve significantly within 5-10 years after pond drainage and cover placement (Figure 4-14a). Clearly, the sulfate predictions for scenario 2 ($C_{PW} = 2278$ mg/l) and scenario 3 ($C_{PW} = 2654$ mg/l) are unrealistically high for early times for the reasons mentioned above (note that observed sulfate concentration in shallow seepage are presently only at ~800 mg/l). In our opinion the slow dewatering of the tailings (with predominantly process water) will result in only a very small rise in sulfate concentrations for the first 15 years or so after cover placement as indicated by the dashed line in Figure 4-14a. This conclusion is also consistent with the actual observations of seepage water quality during the extended "shut-down" period that occurred in the mid-1990's.
