Copper Flat Mine Discharge Permit DP-1840 Application

Steven T. Finch, Jr., CPG, PG
Principal Hydrogeologist-Geochemist
John Shomaker & Associates, Inc.
WATER-RESOURCE AND ENVIRONMENTAL CONSULTANTS

September 2018

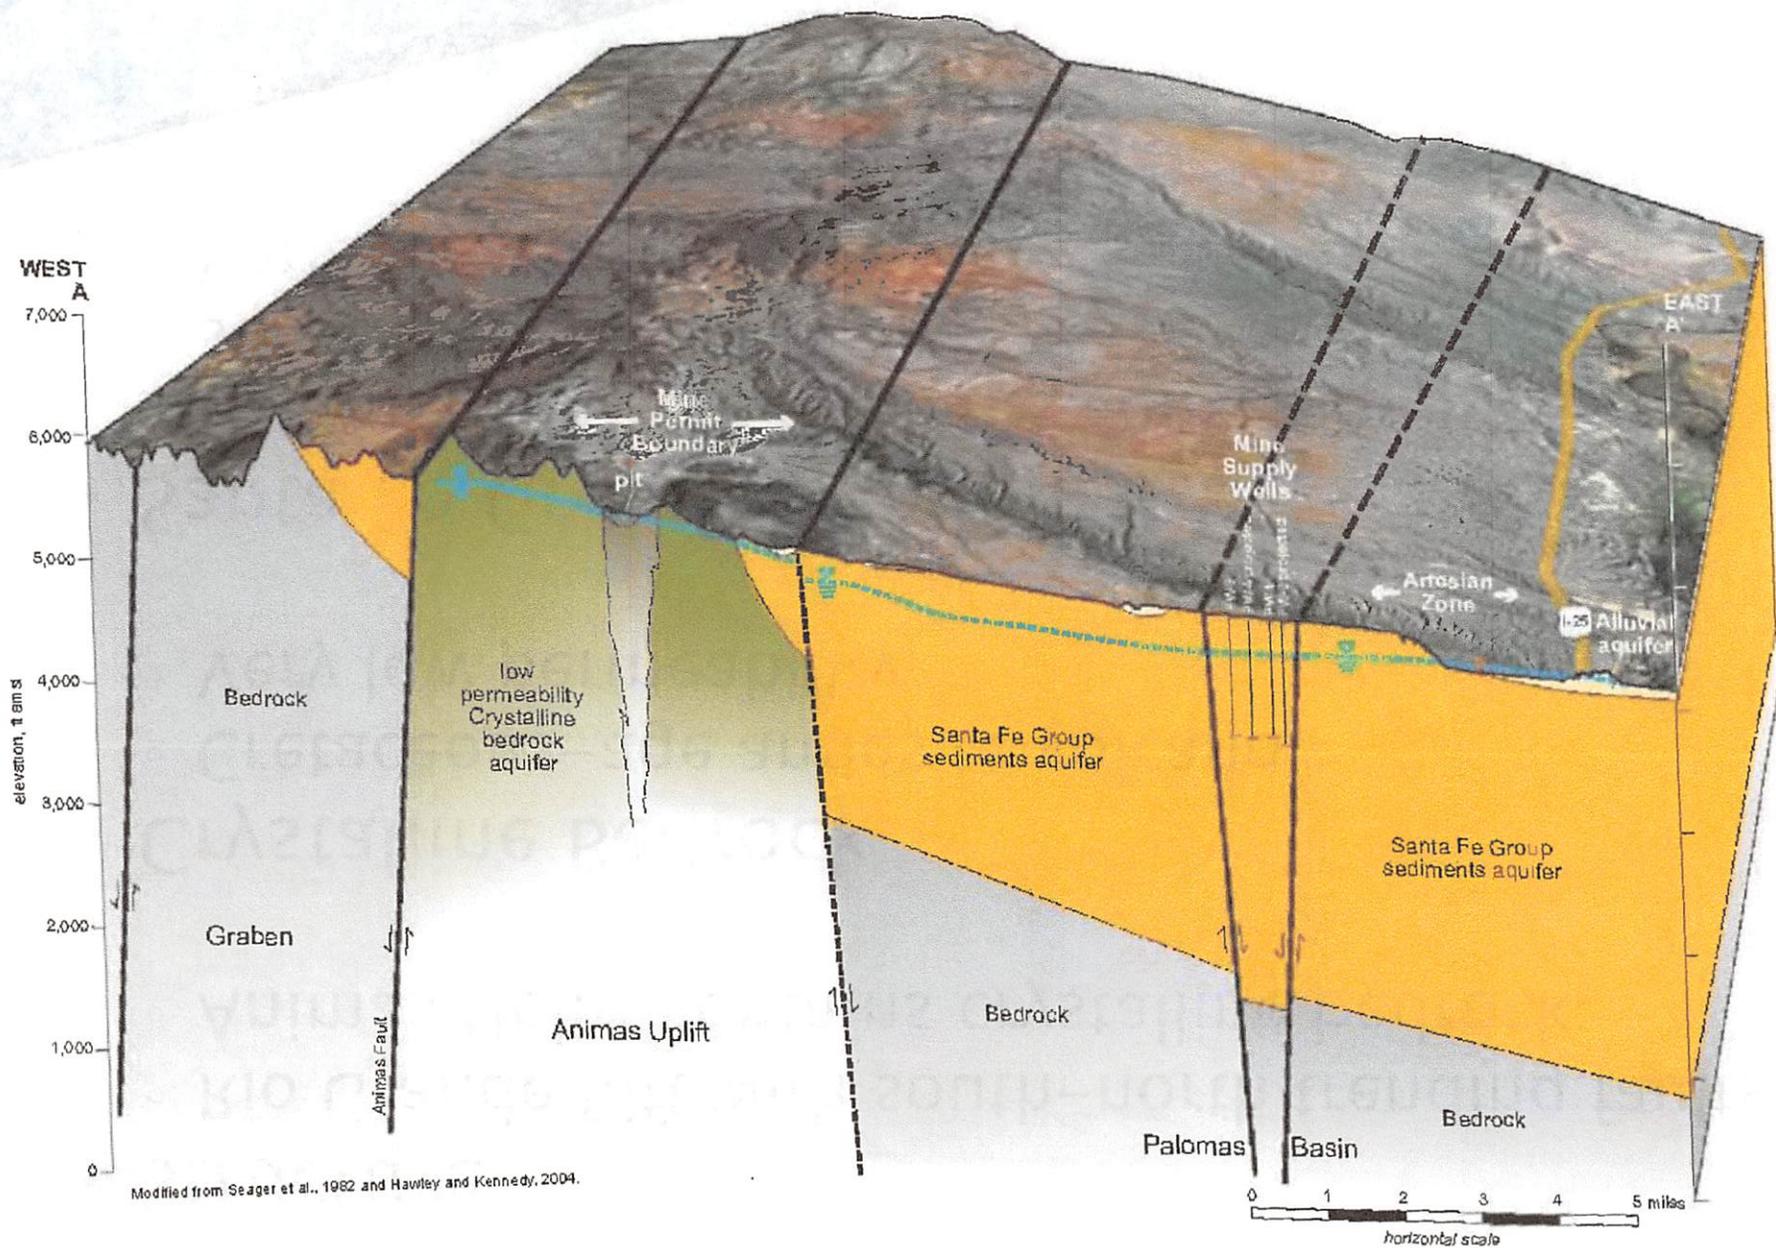
Regional Geologic Setting 20.6.7.11.P(2) NMAC

- ▶ **Structure**
 - Rio Grande Rift with south–north trending faults
 - Animas Uplift contains crystalline bedrock

- ▶ **Crystalline Bedrock**
 - Cretaceous–age andesite volcano
 - Very low permeability

- ▶ **Santa Fe Group Sediments**
 - Unconsolidated sediments consisting of clay, silt, sand, and gravel
 - Variable permeability

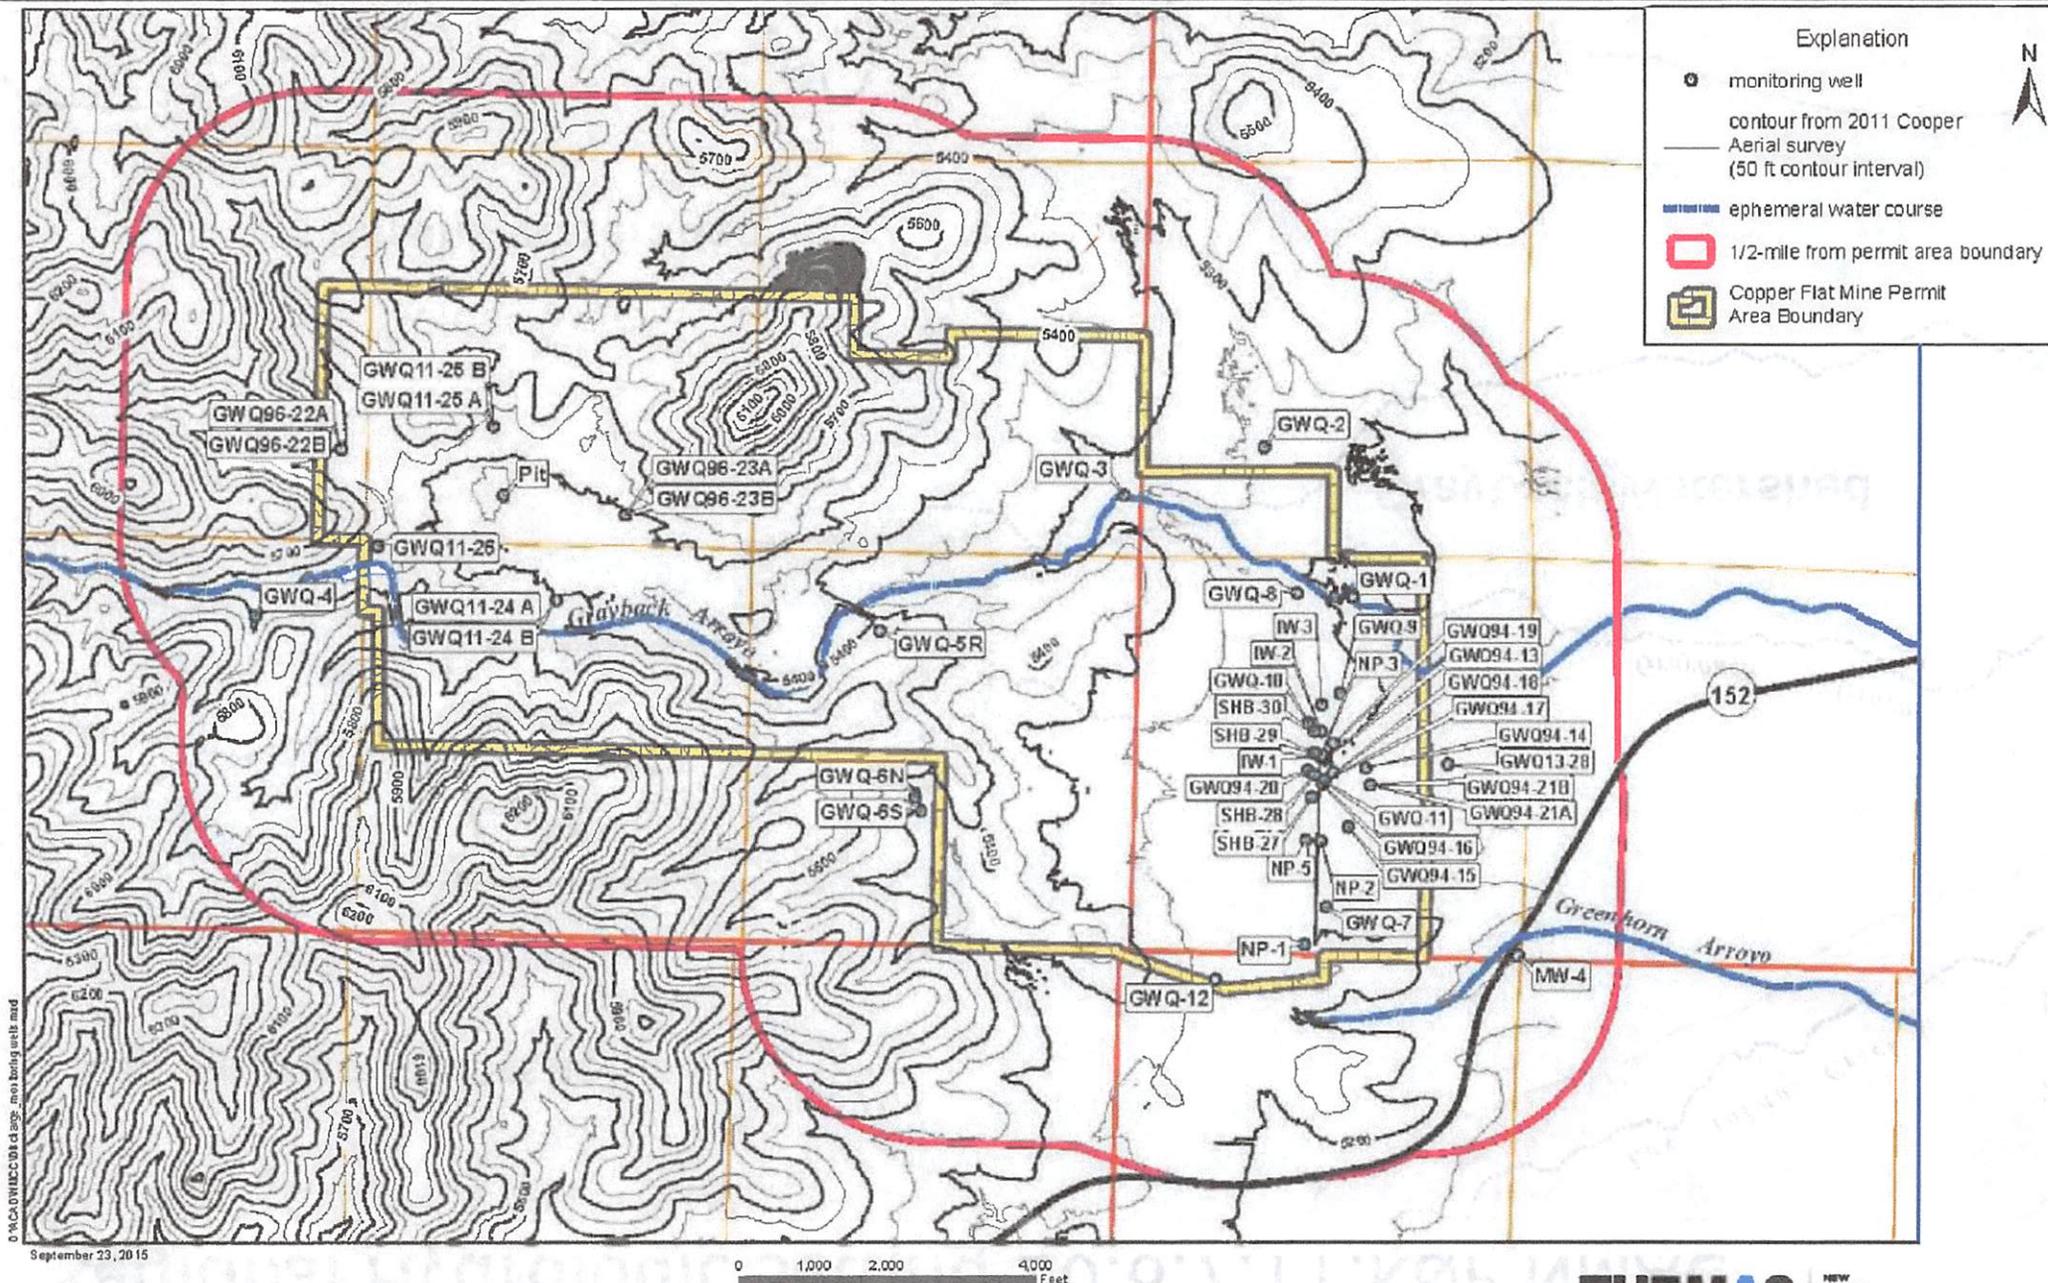
Figure 11K-8. Surface water within 1/2-mile from Copper Flat Mine Permit Area Boundary.

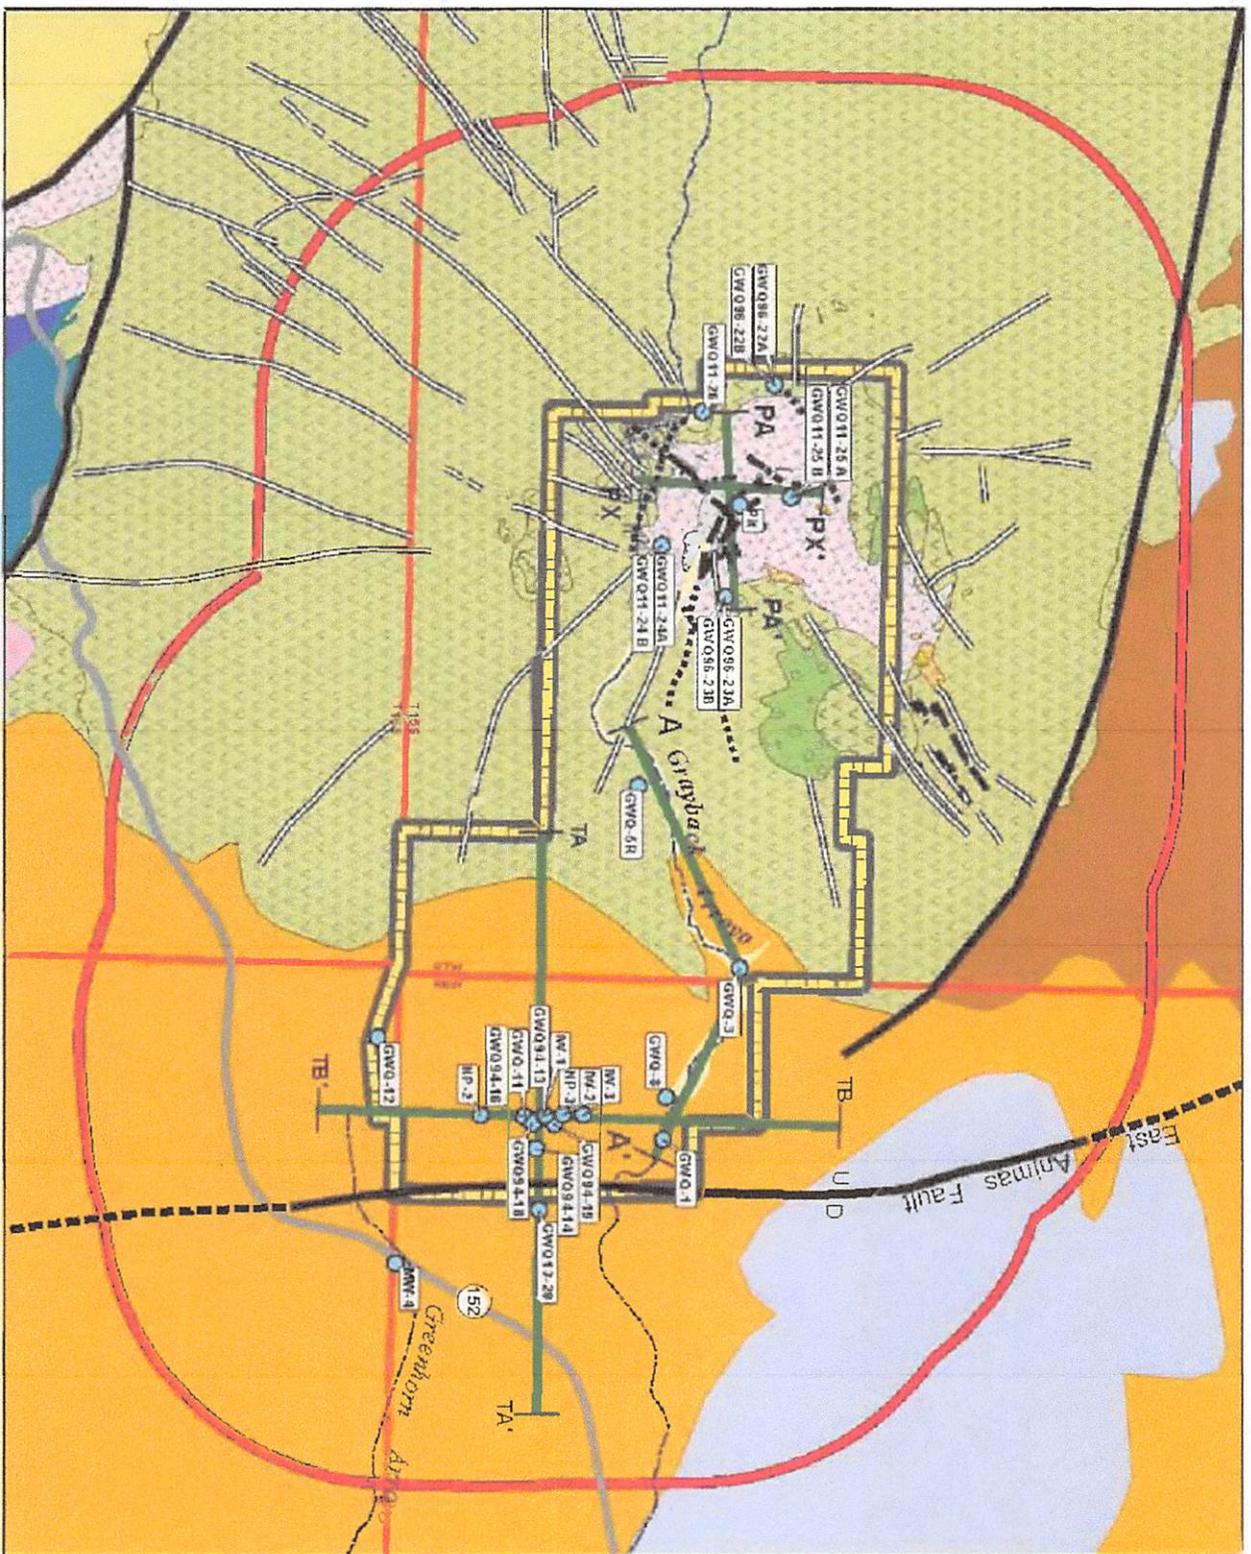
Figure 11K-2a. Geologic map within 1-mile of the Copper Flat Mine Area permit boundary, Sierra County, New Mexico.

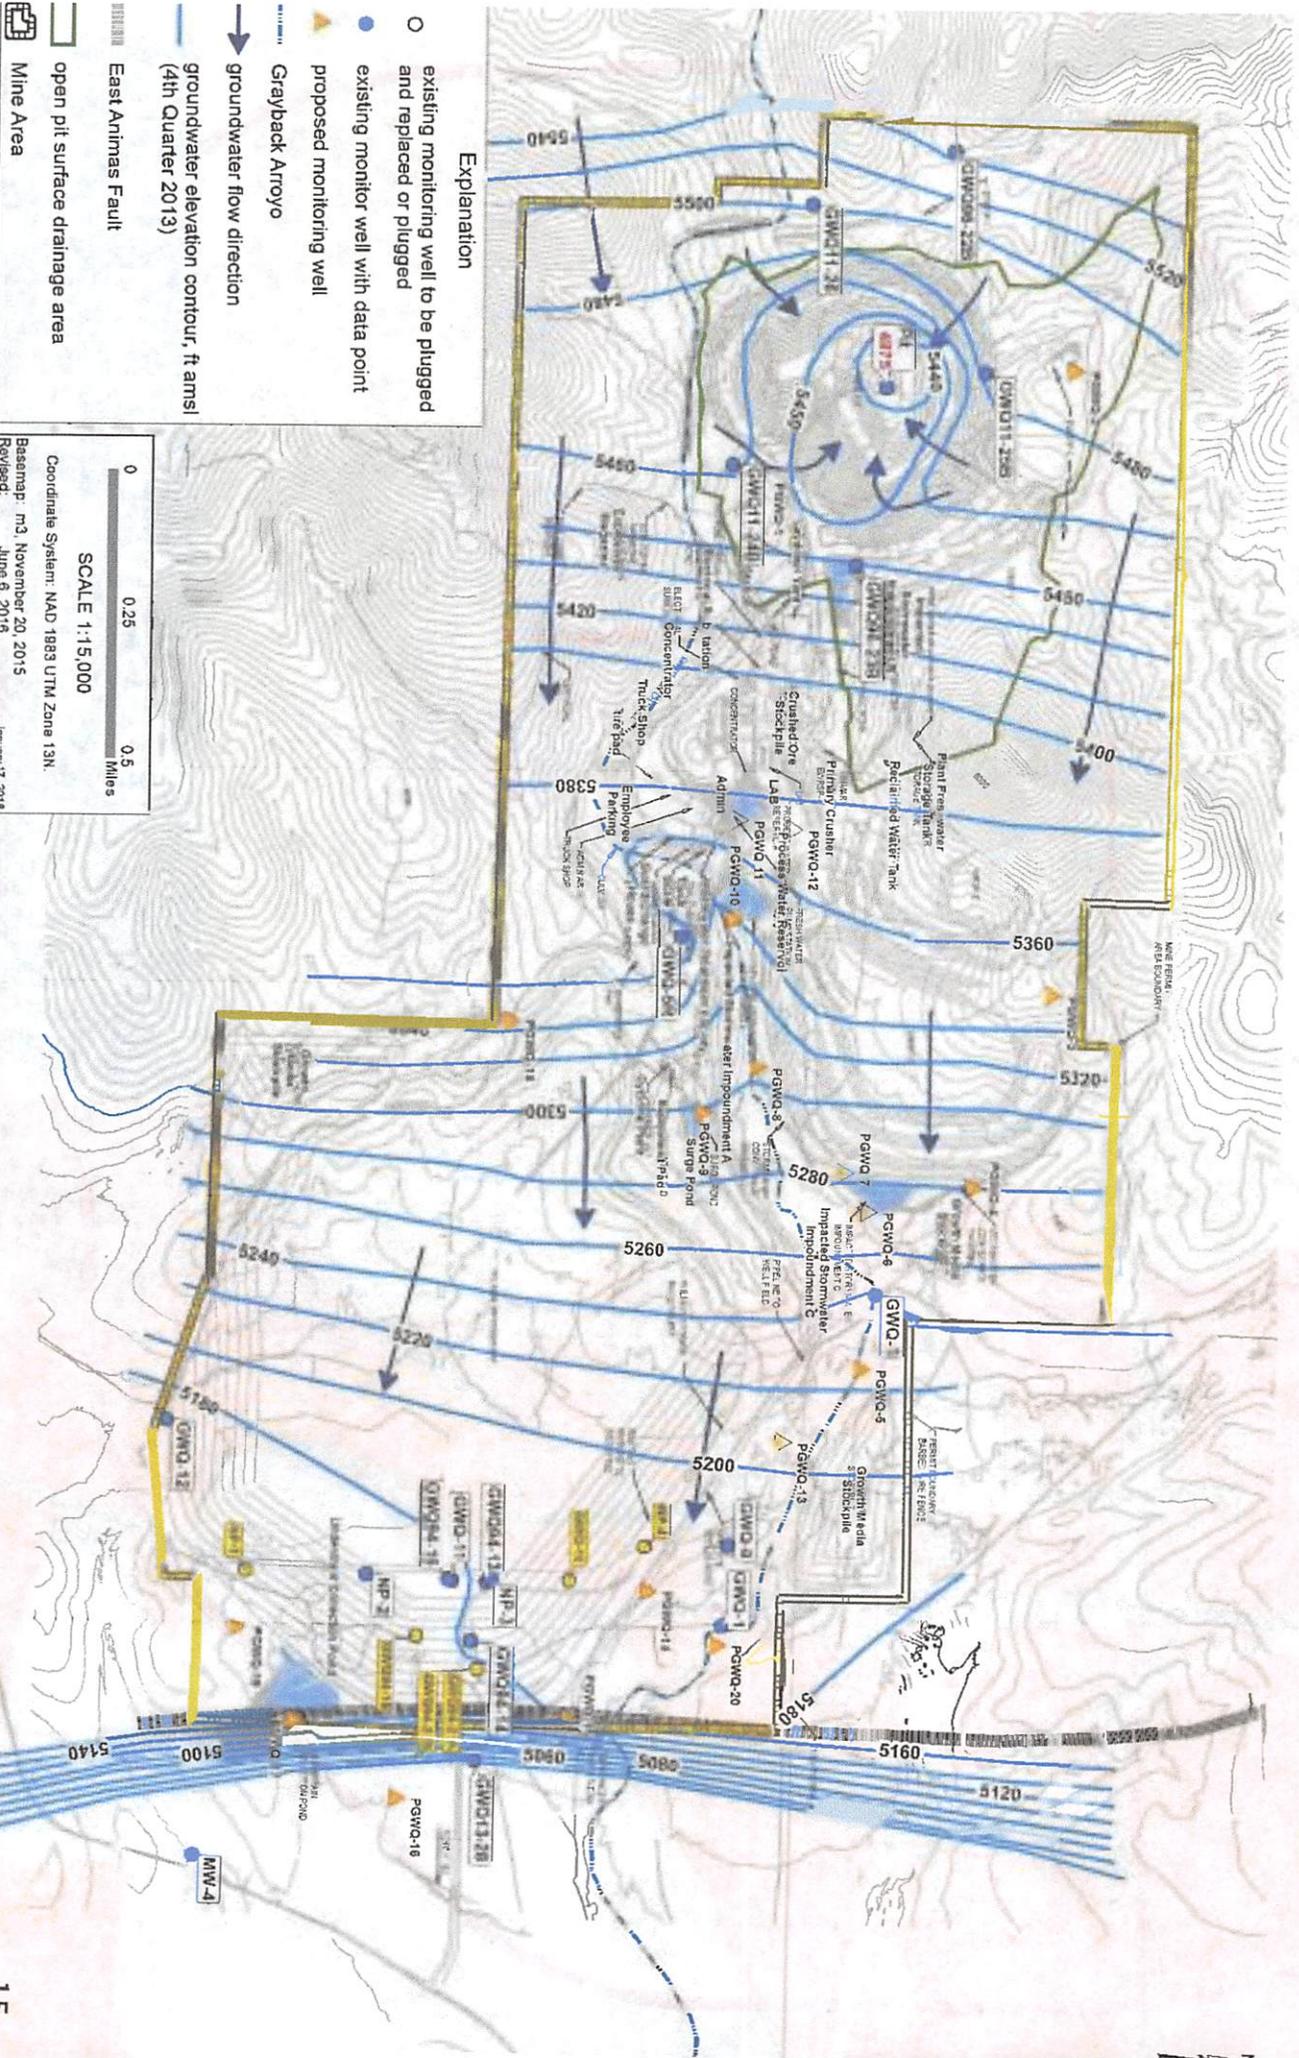
Groundwater Elevation Contours 20.6.7.11.P(1) NMAC

- existing monitoring well to be plugged and replaced or plugged
- existing monitoring well with data point
- ▲ proposed monitoring well
- Grayback Arrow
- groundwater flow direction
- groundwater elevation contour, ft amsl (4th Quarter 2013)
- East Animas Fault
- open pit surface drainage area
- Mine Area

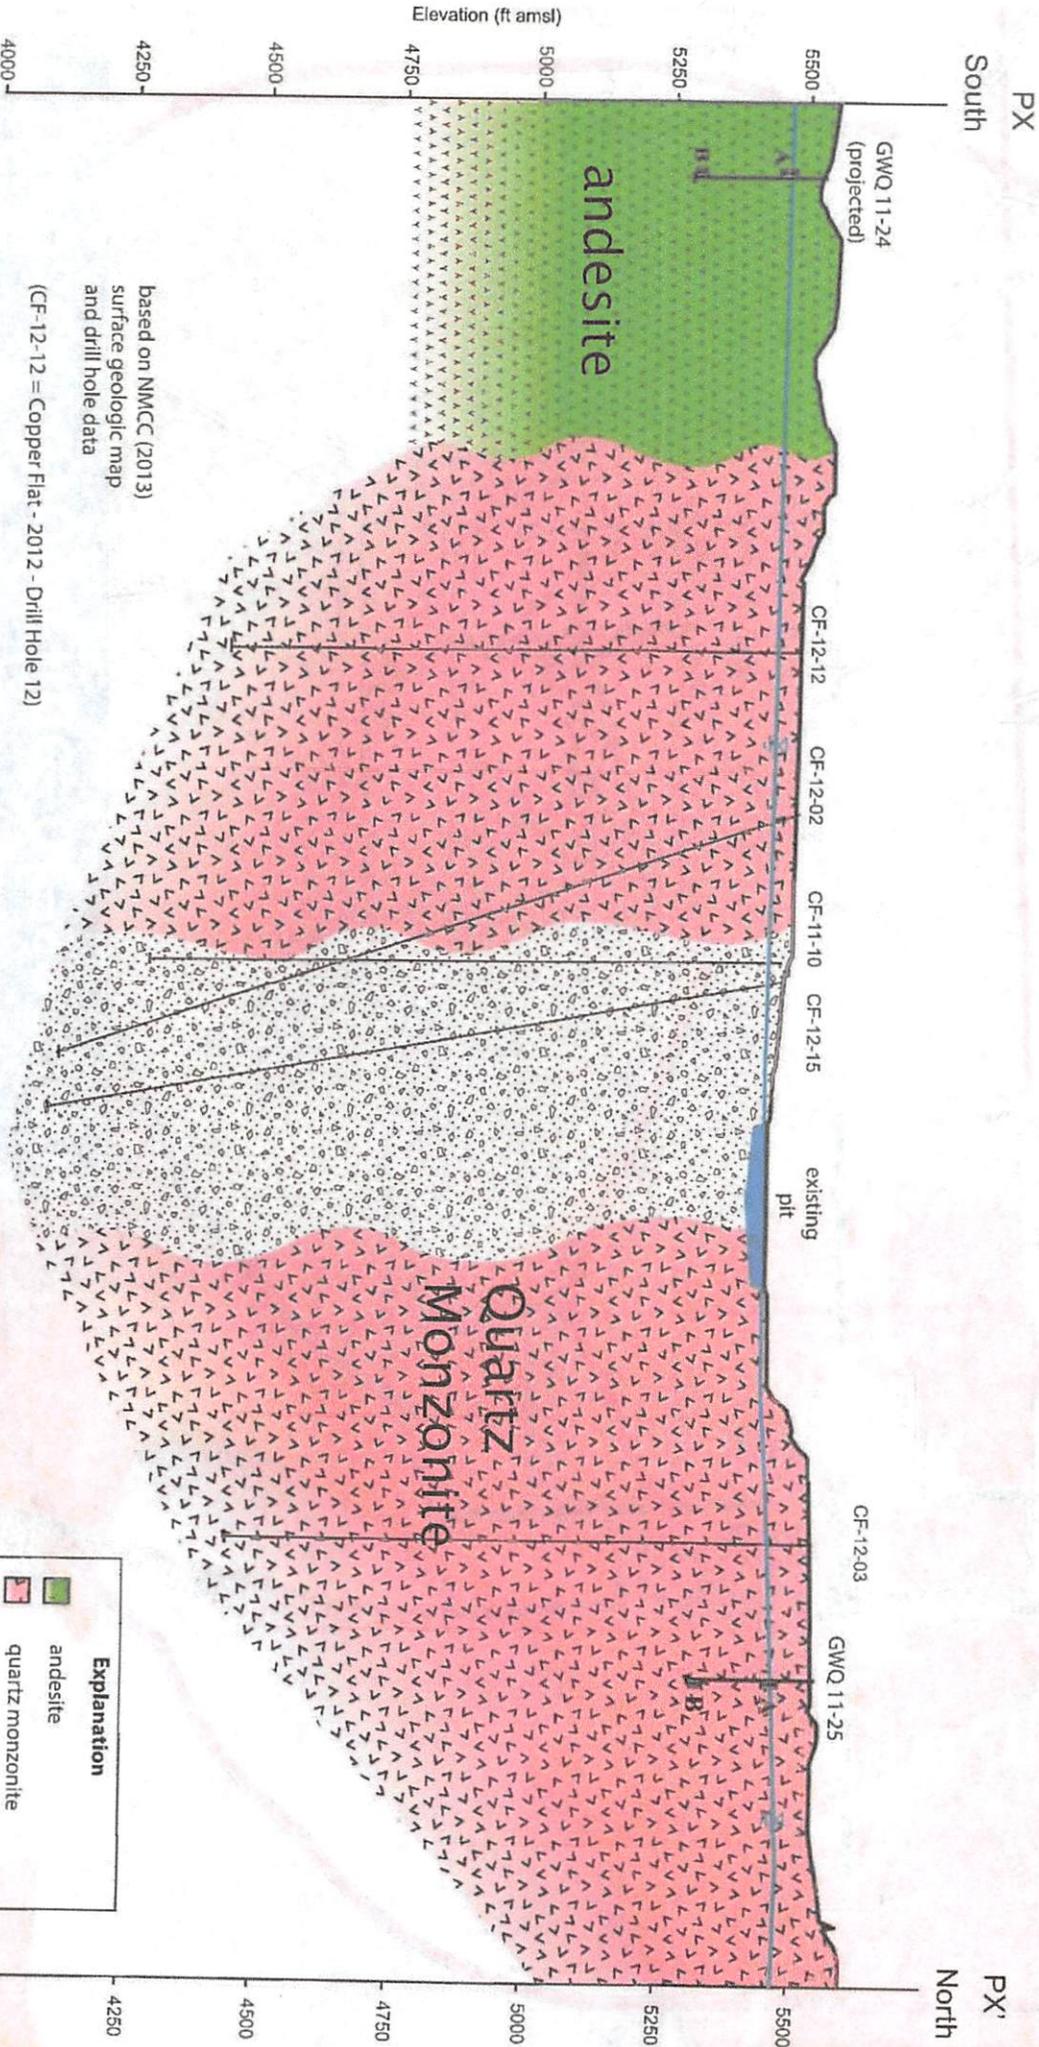
Copper Flat Open Pit Hydrogeologic Cross-Section

Figure 11K-5. Hydrogeologic cross-section PX-PX: Copper Flat Mine, Sierra County, New Mexico.

Explanation	
	andesite
	quartz monzonite
	quartz monzonite breccia

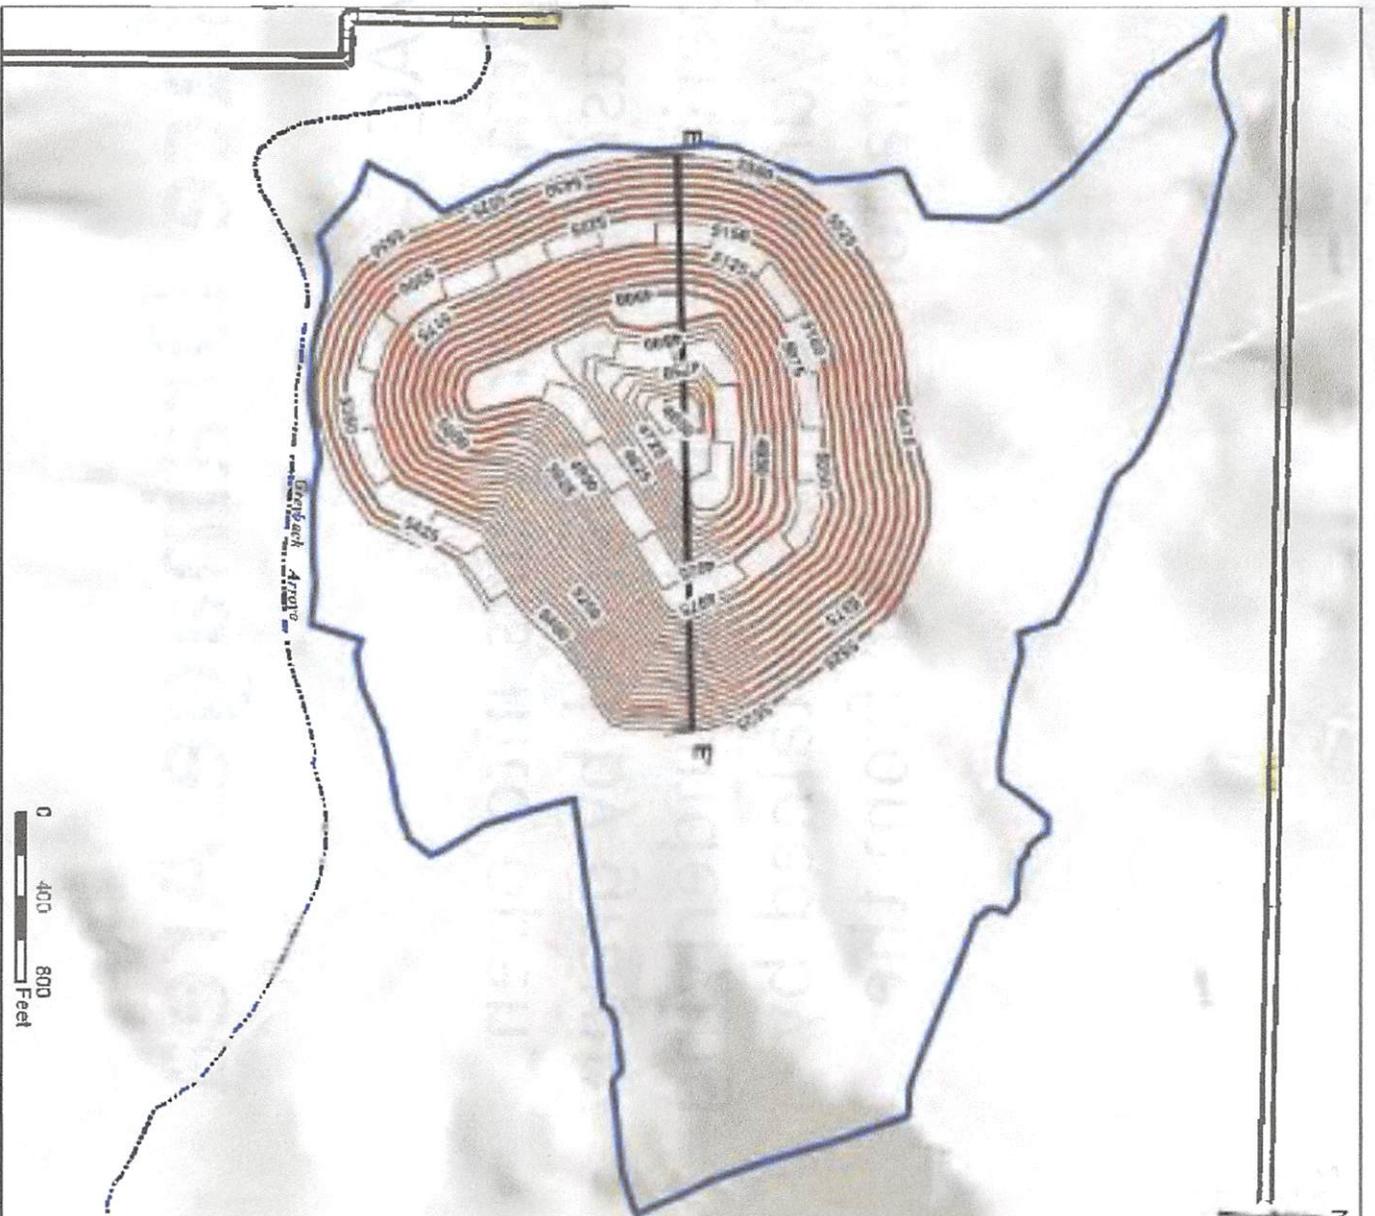
Copper Flat Open Pit Surface Drainage Area

- ▶ Area in which storm water drains into open pit and cannot feasibly be diverted by gravity outside the pit perimeter, and the underlying groundwater is hydrologically contained by pumping or evaporation of water from the open pit.

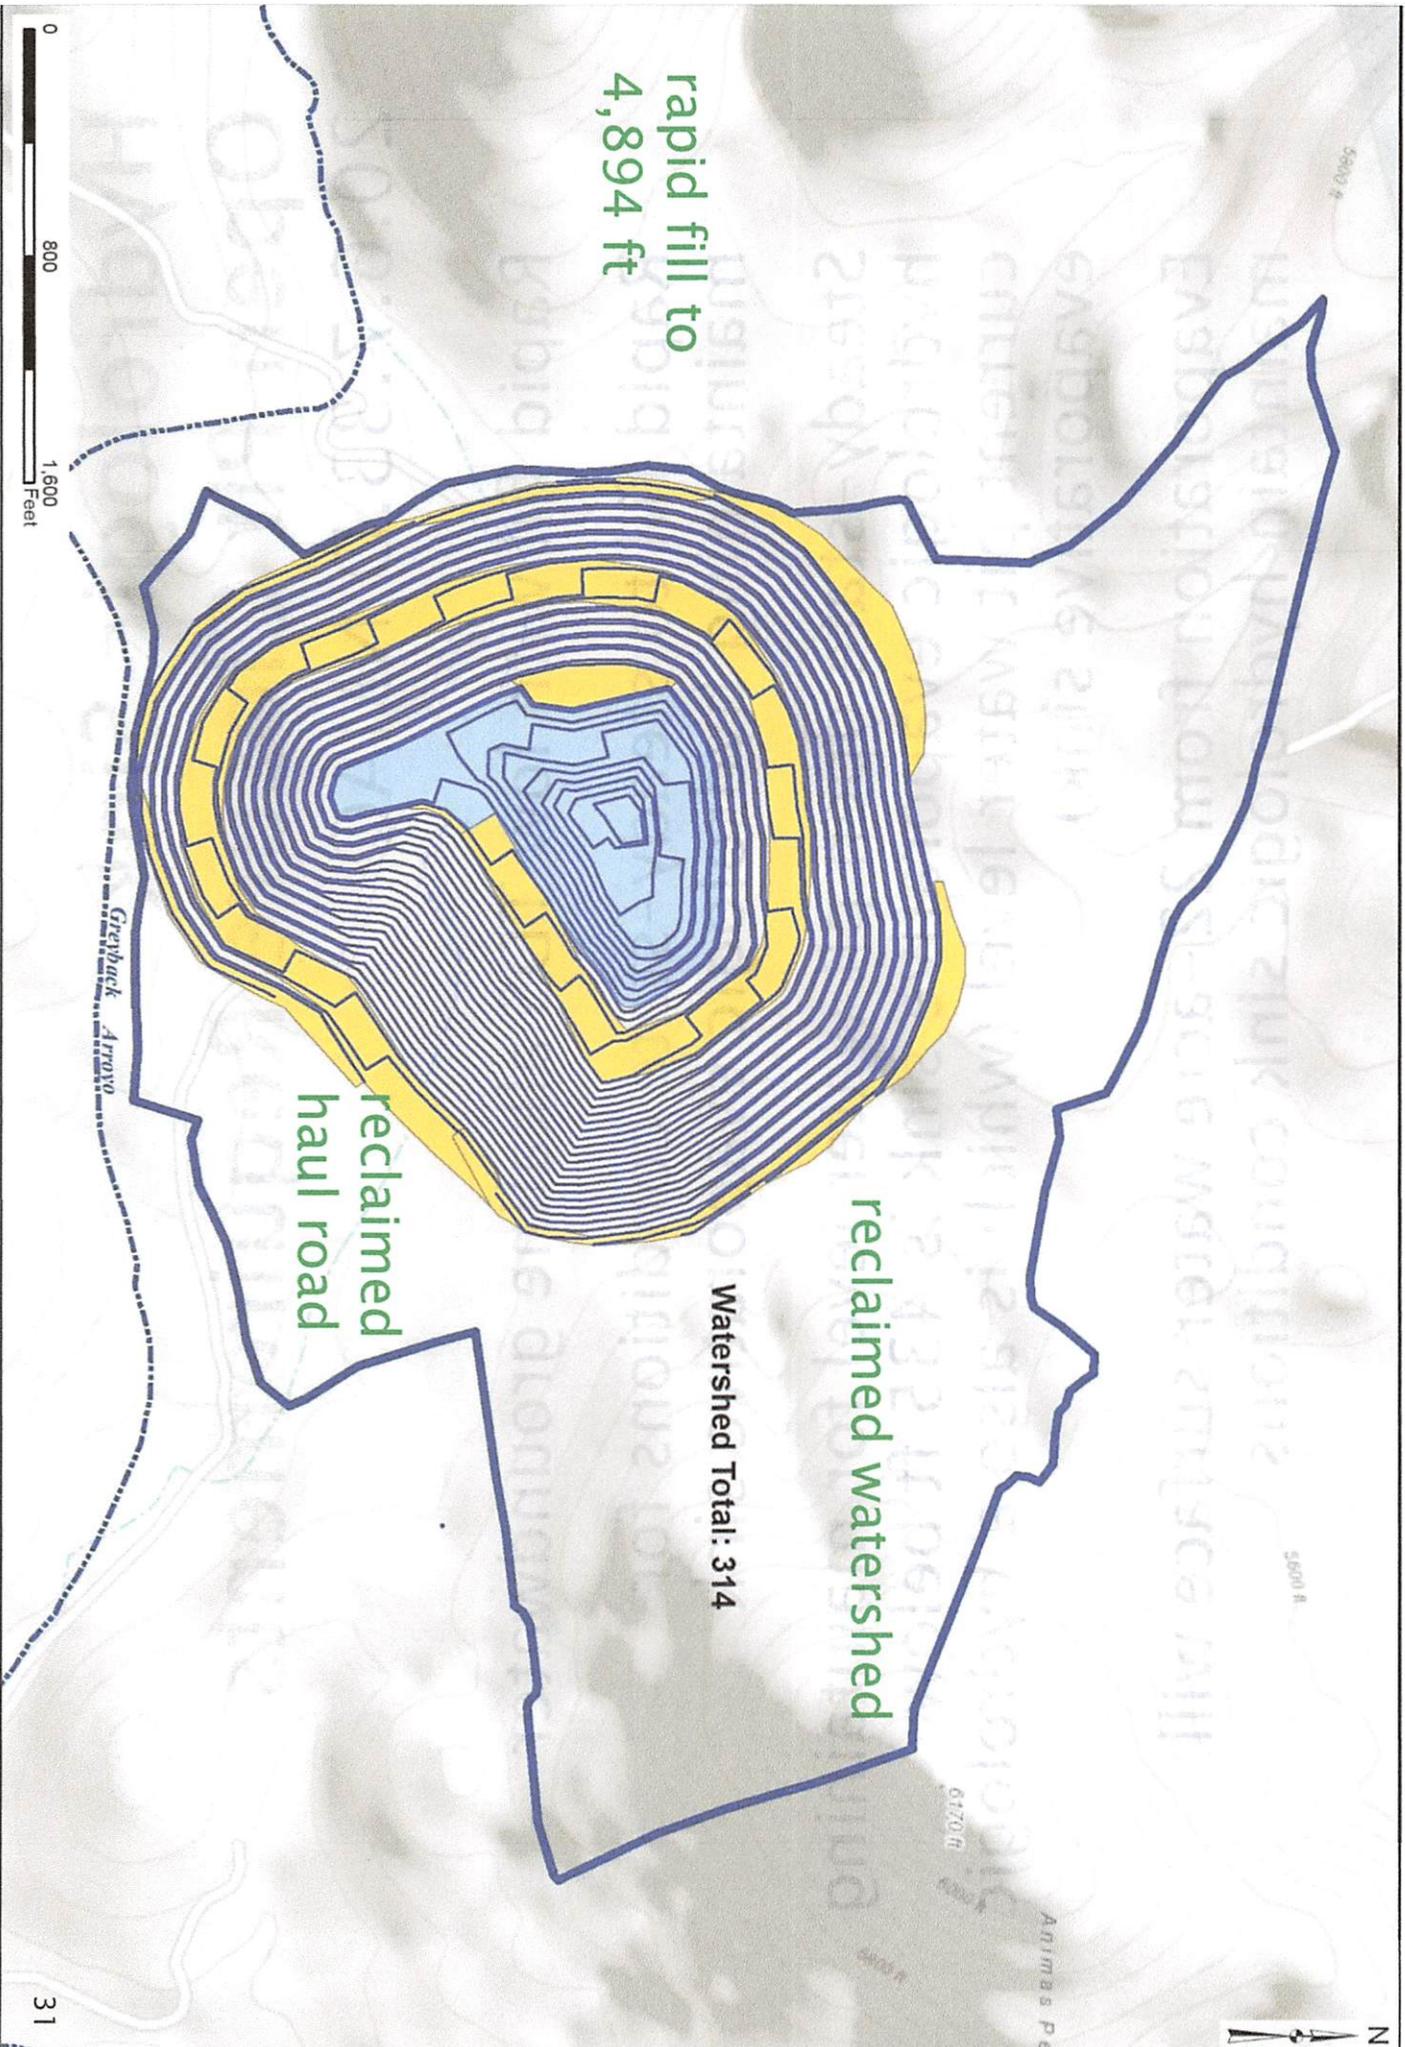
Open Pit Rapid Fill Reclamation

rapid fill to
4,894 ft

reclaimed
haul road

reclaimed watershed

Watershed Total: 314

- Rapid fill with low TDS alkaline groundwater
- Rapid fill to steady-state conditions for maintaining hydrologic evaporative sink
- Steady-state open pit water level for maintaining hydrologic evaporative sink is 435 ft below current pit water level (which is also a hydrologic evaporative sink)
- Evaporation from 22-acre water surface will maintain hydrologic sink conditions

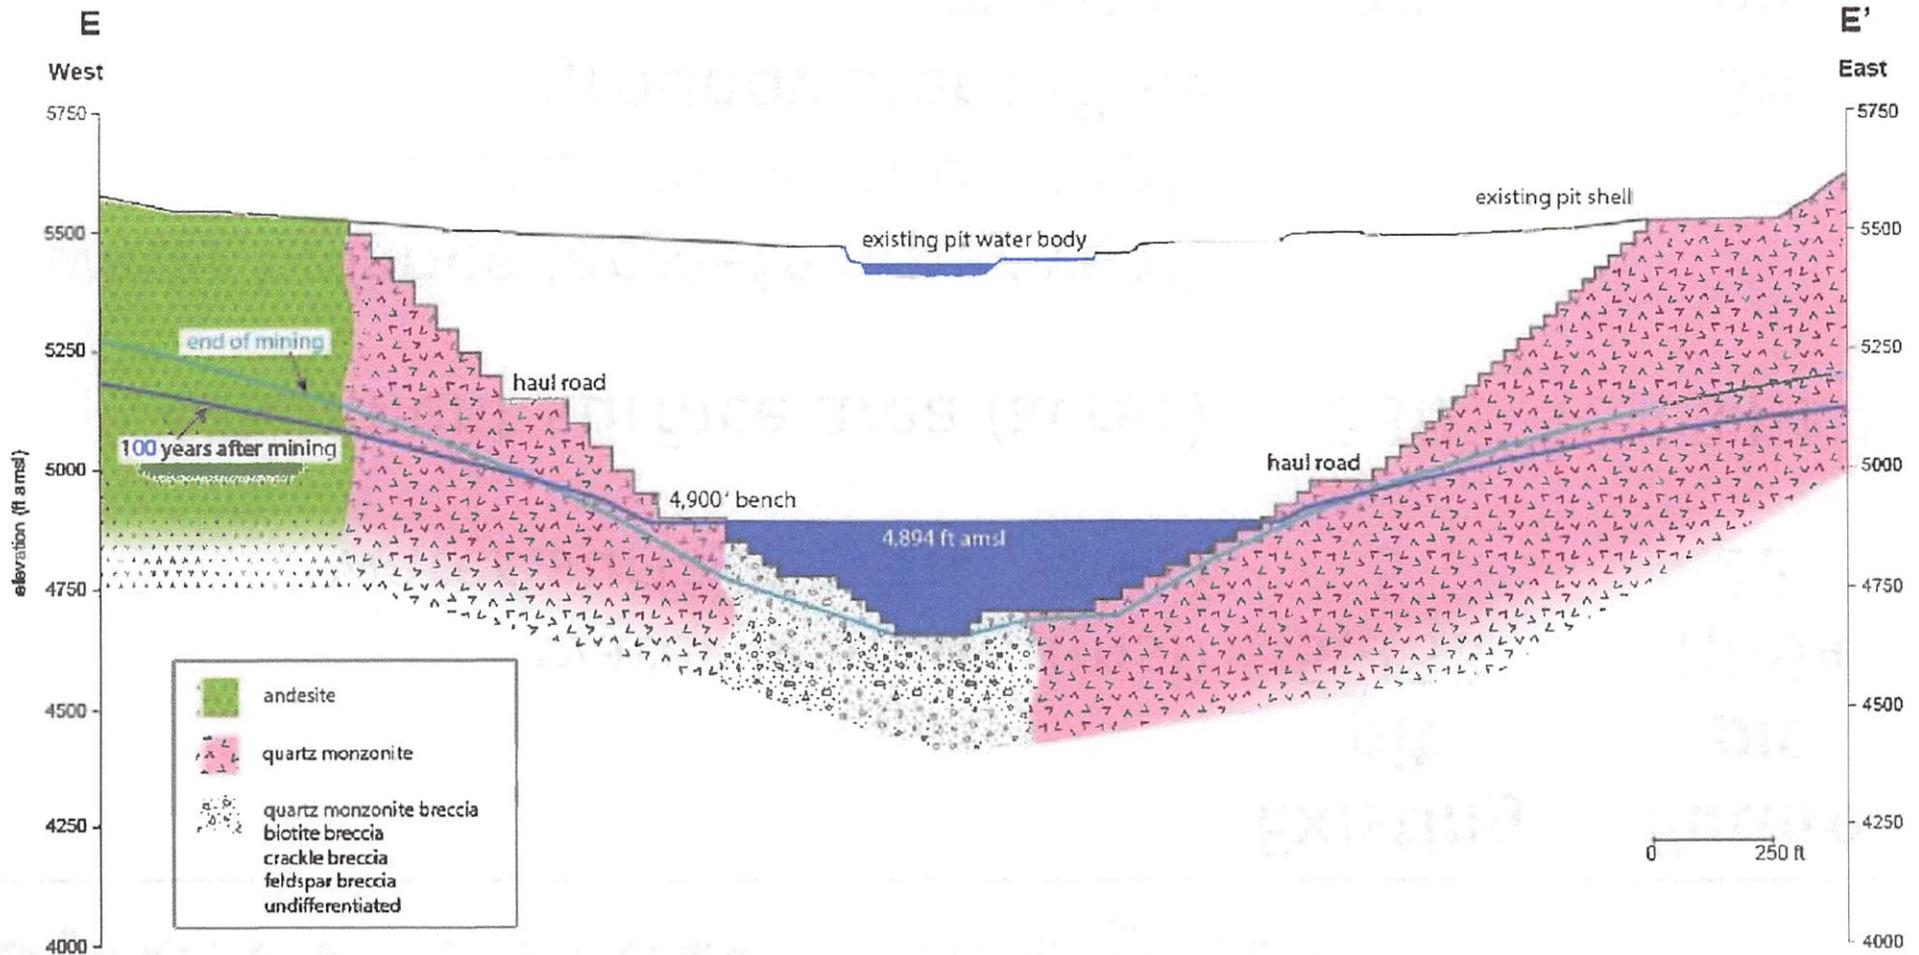
Open Pit Dewatering and Rapid Fill Reclamation

Existing pit	Future pit
water level (ft amsl)	5,433	4,894
water surface area (acres)	5	22
catchment surface area (acres)	230	314
<u>water balance (acre-feet per year)</u>		
precipitation and runoff	18	57
groundwater inflow	7	36
Total In	25	93
Evaporation Out	25	93

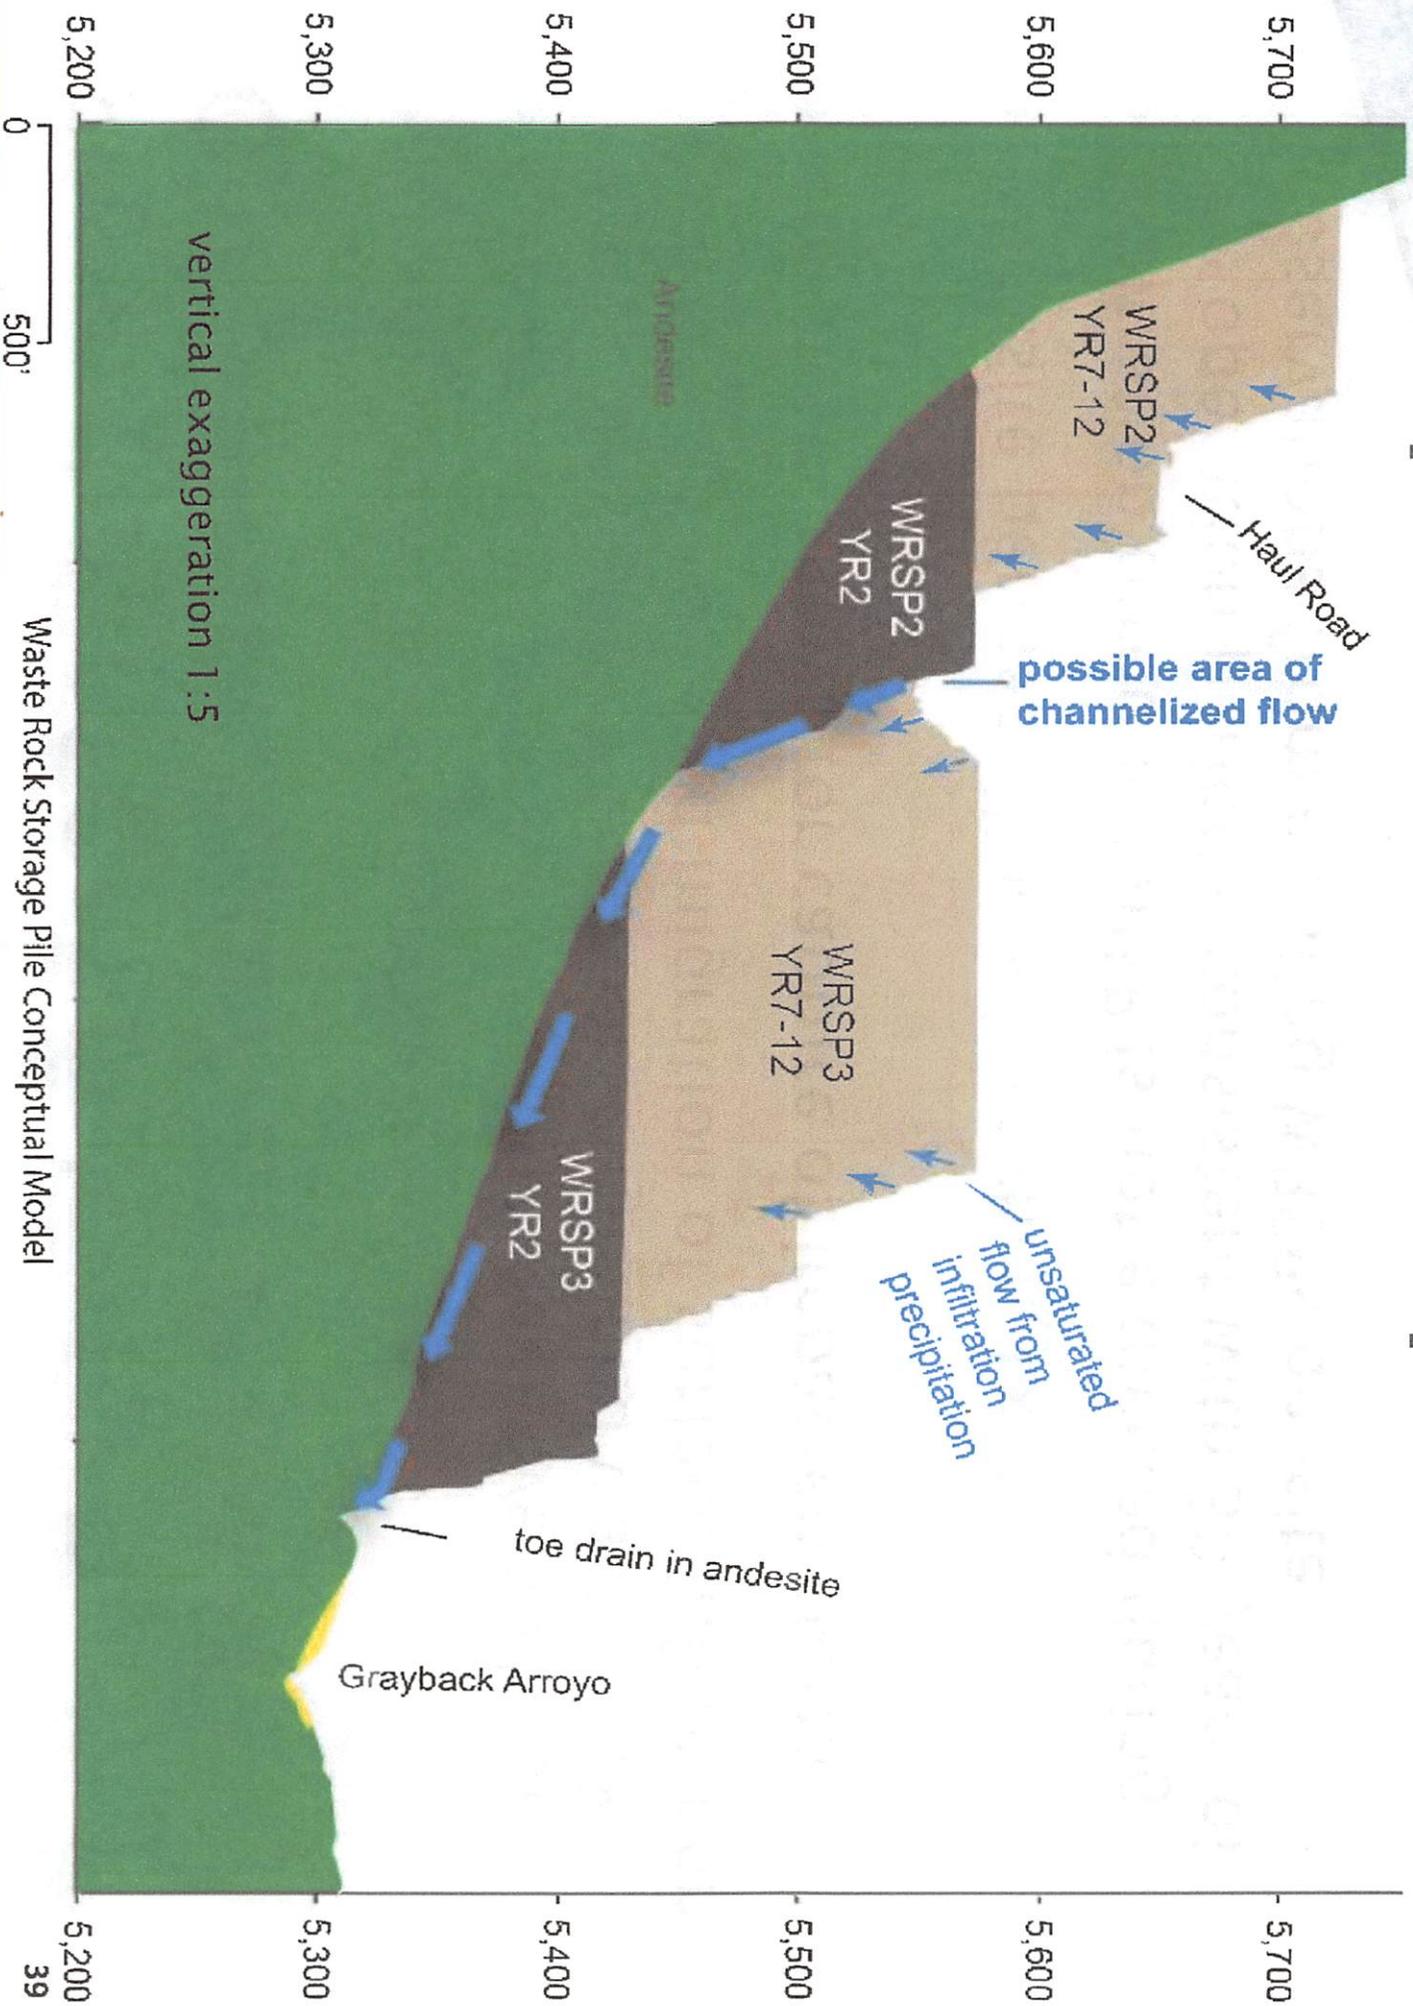
WRSP Operational Conceptual Model

- ▶ Storm water diverted away from WRSP
- ▶ Low moisture content and high negative soil pore-water pressure of the coarse-grained waste rock prevents downward migration of surface infiltration
- ▶ Toe drain allows for capture of impacted storm water
- ▶ Andesite permeability is less than 1×10^{-6} cm/s
- ▶ Infiltration through WRSP is not expected during the operation period – consistent with 30 years of observations from existing WRSPs on-site

- ▶ Storm water diverted away from WRSP
- ▶ Installation of 36-in.-thick store-and-release cover system
- ▶ Vadose zone modeling indicates discharge to groundwater will be nil when considering:
 - Limited time between operations and reclamation for development of conditions for net infiltration
 - Store and release cover system
 - Low permeability of andesite
