Copper Flat Mine Discharge Permit DP-1840 Application

Steven T. Finch, Jr., CPG, PG
Principal Hydrogeologist-Geochemist
John Shomaker & Associates, Inc.
WATER-RESOURCE AND ENVIRONMENTAL CONSULTANTS

September 2018

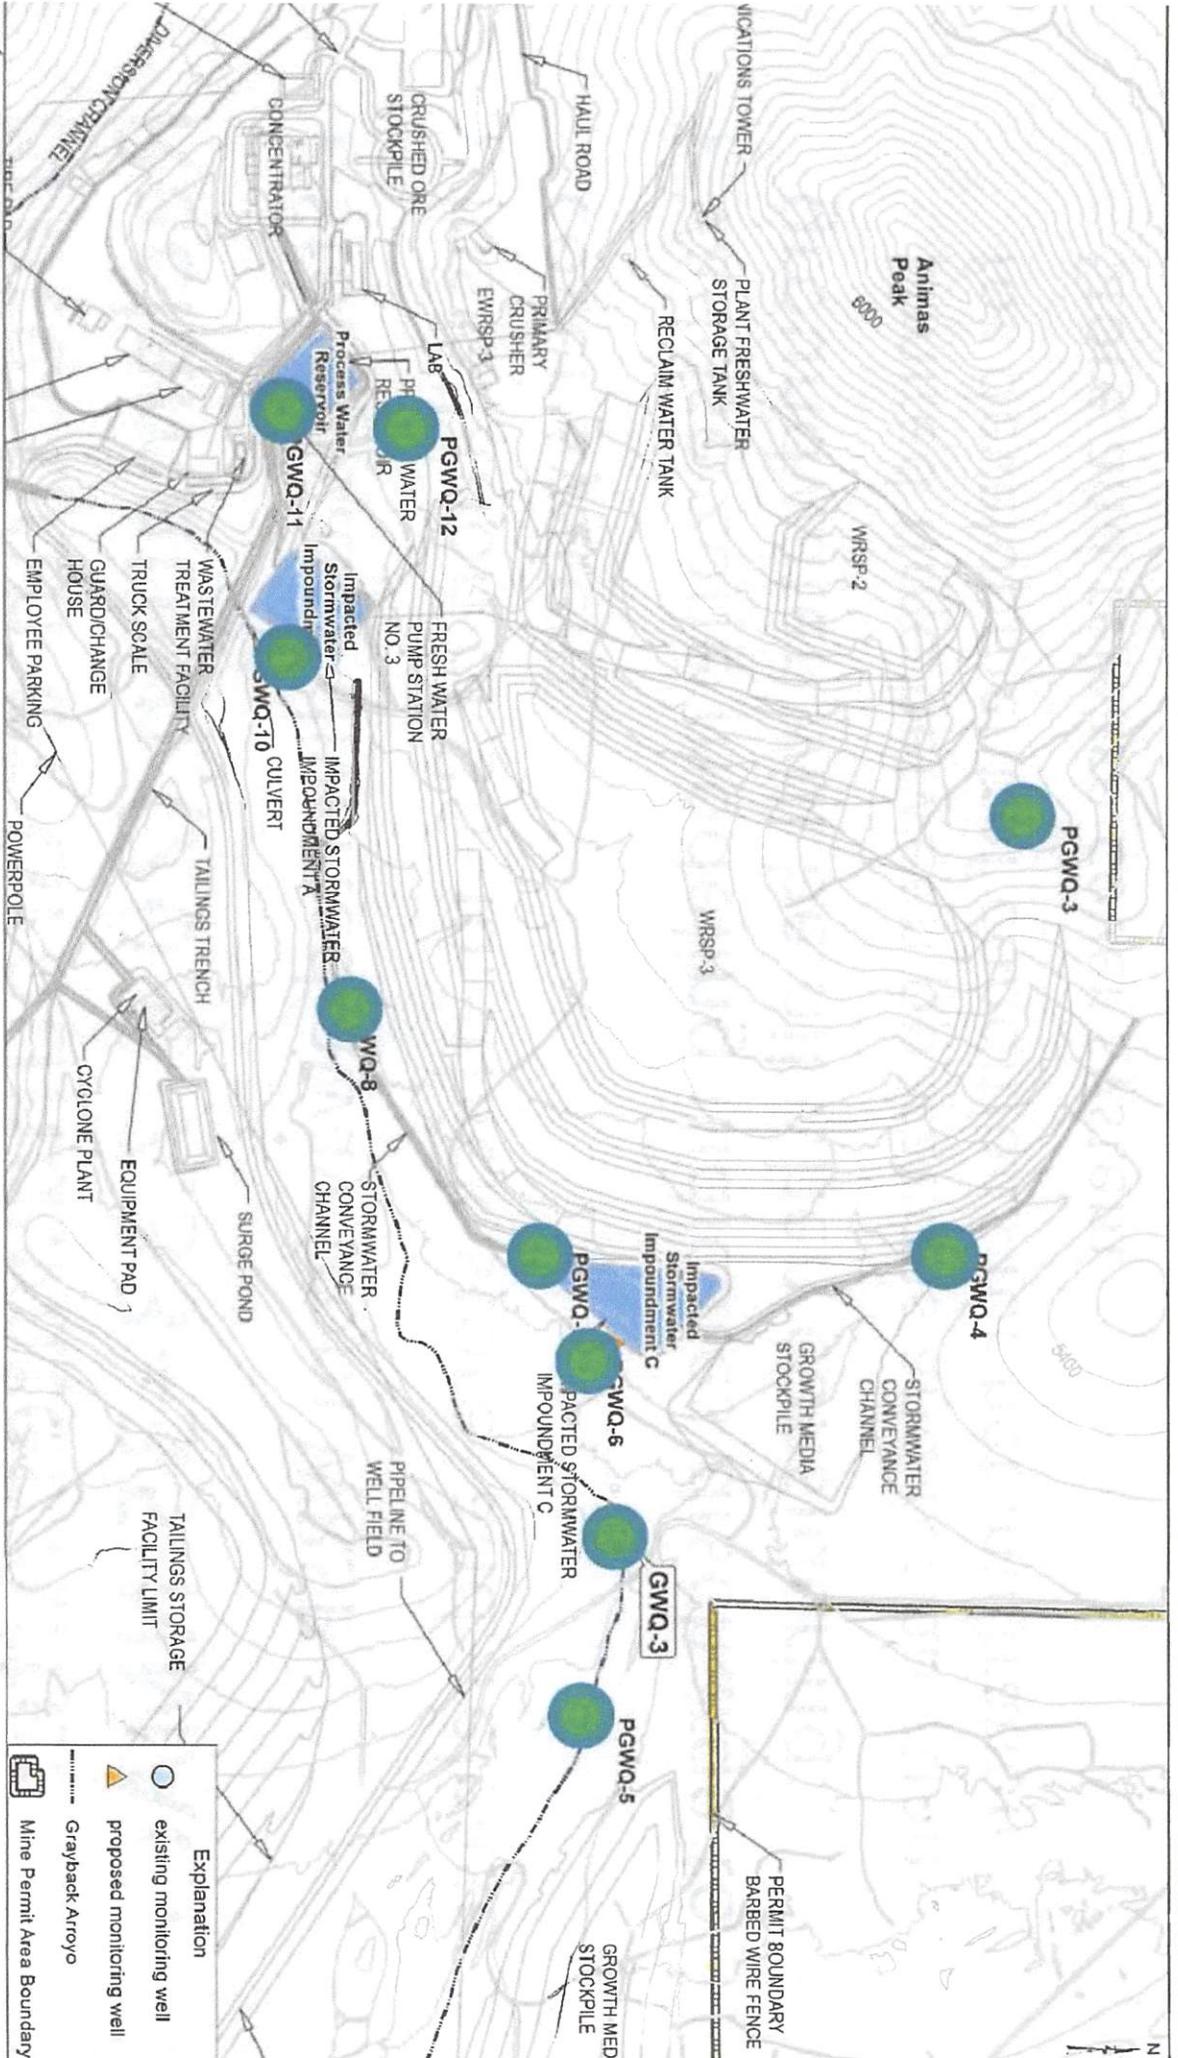
WRSP 2&3 Groundwater Monitoring

- existing monitoring well
- proposed monitoring well
- Grayback Arroyo
- Mine Permit Area Boundary

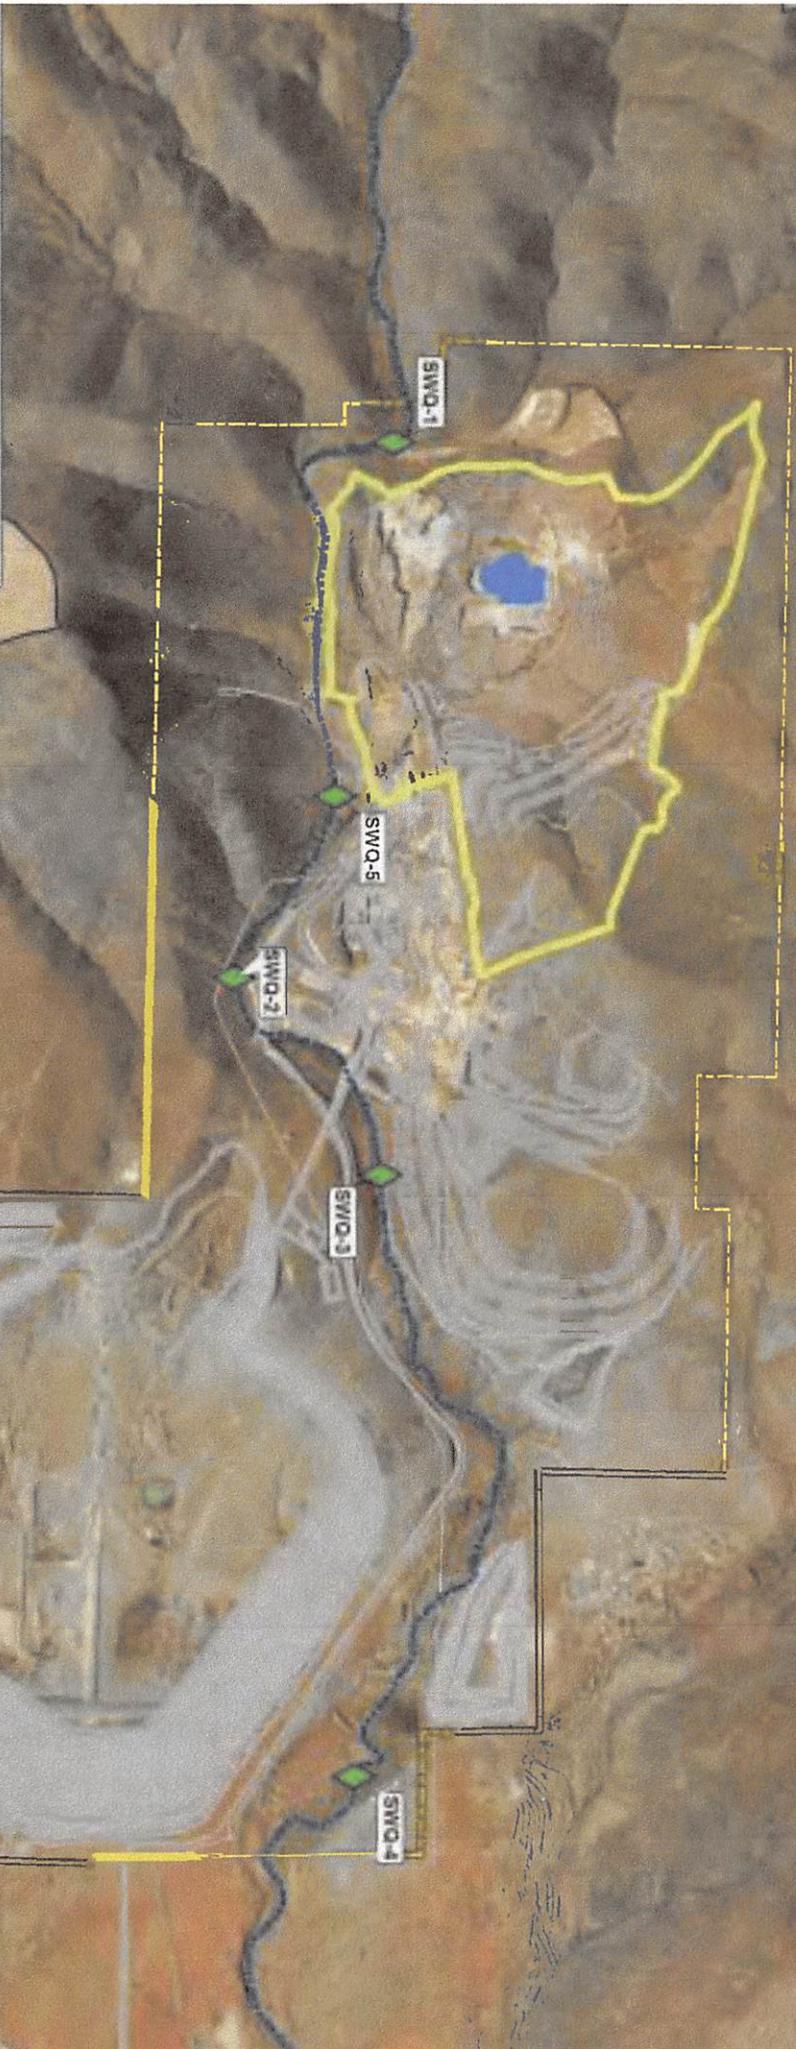
WRSP 2&3 Surface-Water Monitoring

◆ surface-water sampling location

open pit surface drainage area
