**RE: FASE 2 PROPUESTA DEL PLAN DE MODIFICACIÓN DE REDUCCIÓN Y DAD-06,
MONITOREO DE LA REHABILITACIÓN DE POZO PARA DOÑA ANA DAIRIES,
CONDADO DE DOÑA ANA, NUEVO MÉXICO, REVISIÓN 02**

DOÑA ANA DAIRIES MESQUITE, NUEVO MÉXICO

Título **SISTEMA DE EXTRACCIÓN PROPUESTO EN
DEL ORO DAIRY, PORCIÓN SUR,
ACUÍFERO ELEVADO**

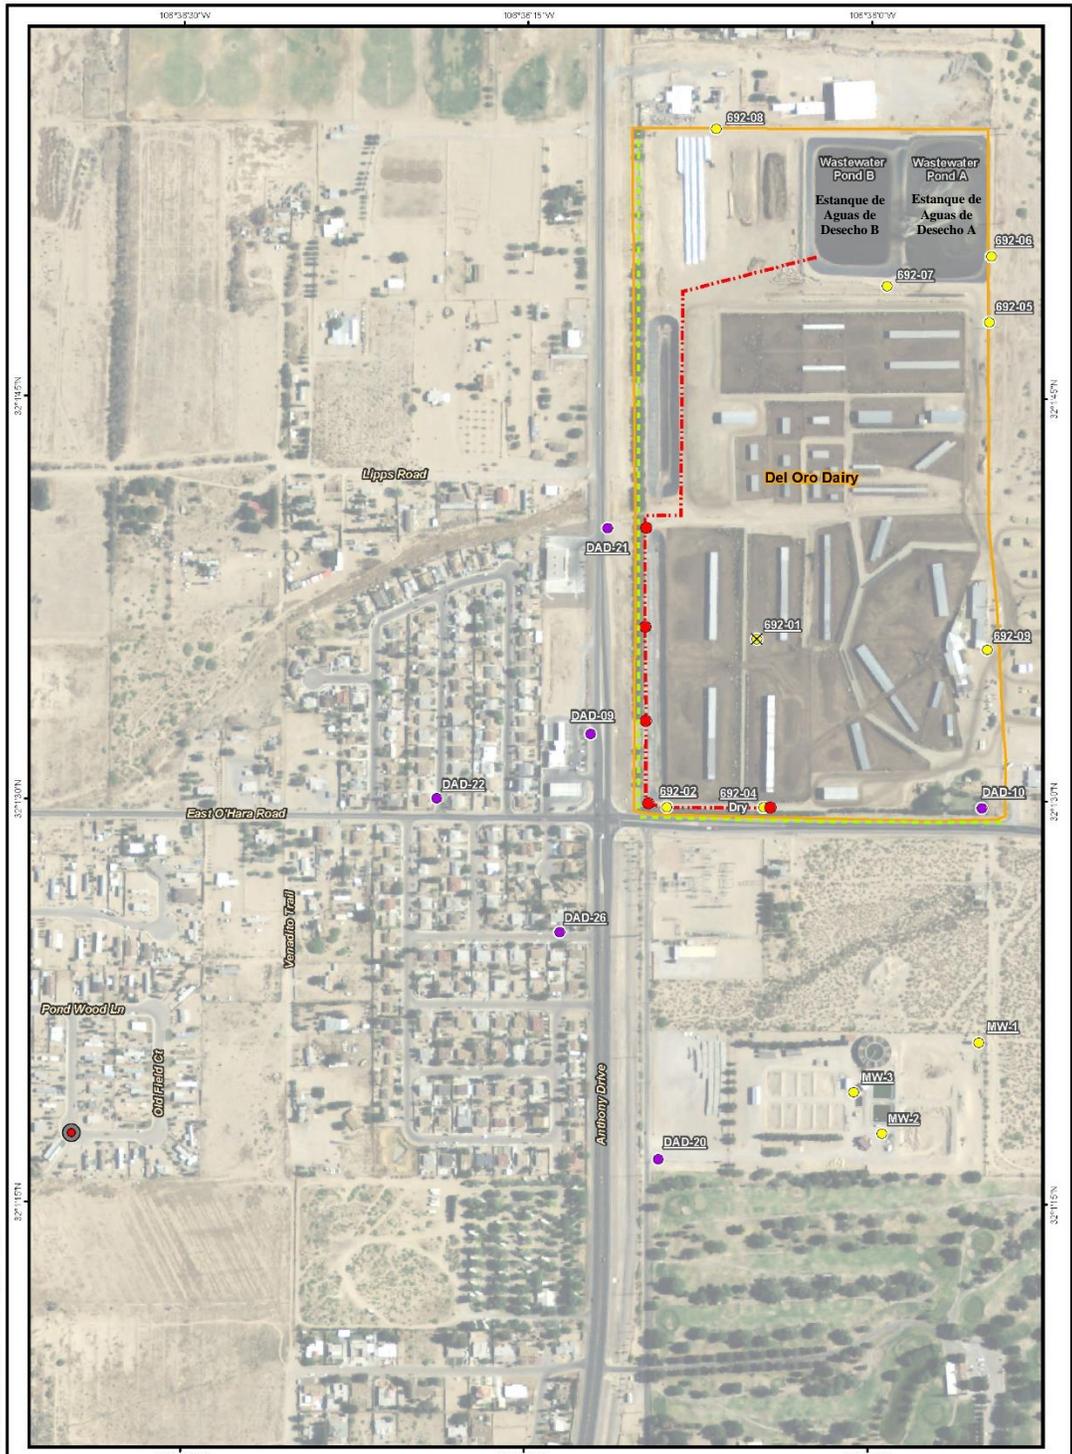
PROJECT No: 1464103.0006	Info: arnold@ea.com
DESIGN: EA	SCALE: AS SHOWN	REV: 0
DRAWN: EM		
CHECK: []		
REVIEW: []	FIGURA 1

- Pozo de Monitoreo del Plan de Reducción Propuesto
- Nuevo pozo de extracción
- Pozo de Monitoreo del Plan de Reducción
- Pozo de Monitoreo del Plan de Descarga
- ⊗ Pozo de Monitoreo del Plan de Descarga
- Línea de Transmisión
- Línea eléctrica aérea
- Propiedad de Dairies

EA propone instalar un sistema de bombeo a lo largo de las frontera occidental y sur de *Del Oro Dairy* (Figura 1). El sistema de bombeo incluirá cinco nuevos pozos dentro del acuífero elevado. Estos pozos serán equipados con bombas sumergibles. Es difícil determinar el efecto de captura de estos pozos, sin embargo, la inestabilidad de la pluma parece haber surgido del taponamiento del pozo de Plan de Descarga 692-01 en diciembre de 2015 y también de la cesación del bombeo en ese pozo. NMED observó que este pozo estaba siendo bombeado durante una visita de campo realizada en octubre/noviembre de 2012 (Adjunto 1). Por lo tanto, la línea propuesta de cinco pozos debe ser suficiente. Una evaluación de desempeño durante el bombeo permitirá verificar la teoría. Según sea necesario, se pueden agregar más pozos al sistema.

La figure 2 proporciona el diagrama de flujo del proceso (PFD) del sistema. El agua bombeada será descargada a un estanque de agua de desecho (Estanque B) como se muestra en la Figura 1. Este estanque tiene la capacidad de almacenar y evaporar el agua bombeada como se muestra en el cálculo en el adjunto (Adjunto No. 2). Los estanques de *Del Oro Dairy* son inspeccionados y si es necesario, reparados anualmente para garantizar la integridad del recubrimiento interno (Adjunto No. 4). Una muestra del ingreso de agua de desecho del estanque será agregada al régimen de monitoreo trimestral bajo el S2AP existente. Las muestras serán analizadas en busca de contaminantes del sitio identificados en S2AP incluyendo nitratos, sólidos totales disueltos, cloruros y nitrógeno total Kjeldahl (TKN).

Con el fin de delinear la pluma de nitrógeno en el acuífero elevado sur, se propone un nuevo pozo de monitoreo al sureste de los pozos DAD-22 y DAD-26 (Figura 1).

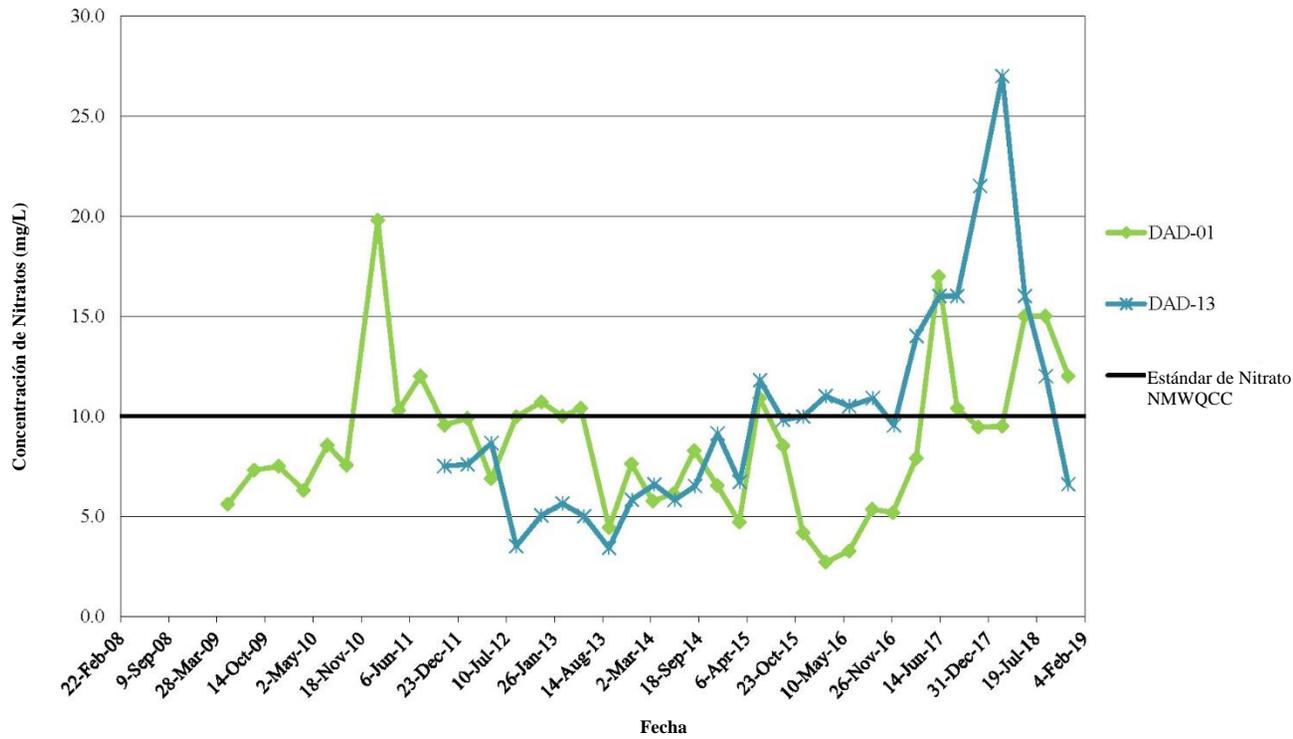
FIGURA 5
TENDENCIA DE CONCENTRACIÓN DE NITRATOS
POZOS DE MONITOREO DEL PLAN DE DESCARGA PARA LA DELINEACIÓN DE LA FRONTERA ORIENTAL DE DOÑA ANA DAIRIES,
CONDADO DE DOÑA ANA, NUEVO MÉXICO

Exceptuando el pozo DAD-13, las concentraciones de nitrato en estos pozos permanecen por debajo del estándar del Control de Calidad de Agua de Nuevo México y no muestran un aumento en las concentraciones de nitrato (Figura 4 y Figura 5). Aunque las concentraciones de nitrato en el pozo DAD-13 han constantemente aumentado entre noviembre de 2016 y febrero de 2018, las concentraciones de nitrato detectadas entre mayo y noviembre de 2018 fueron significativamente menores y muestra un cambio de tendencia (Figura 4). Se propondrá a futuro un sitio para un pozo de monitoreo si las concentraciones de nitrato del pozo DAD-13 no continúa cayendo.
