**AMENDMENT TO THE
STAGE I ABATEMENT PLAN PROPOSAL
FOR THE COPPER FLAT MINE**

JOHN SHOMAKER & ASSOCIATES, INC.
Water-Resource and Environmental Consultants
2611 Broadbent Parkway NE
Albuquerque, New Mexico 87107
505-345-3407
www.shomaker.com

New Mexico Copper Corporation
2425 San Pedro Dr. NE, Suite 100
Albuquerque, New Mexico 87110

October 14, 2011

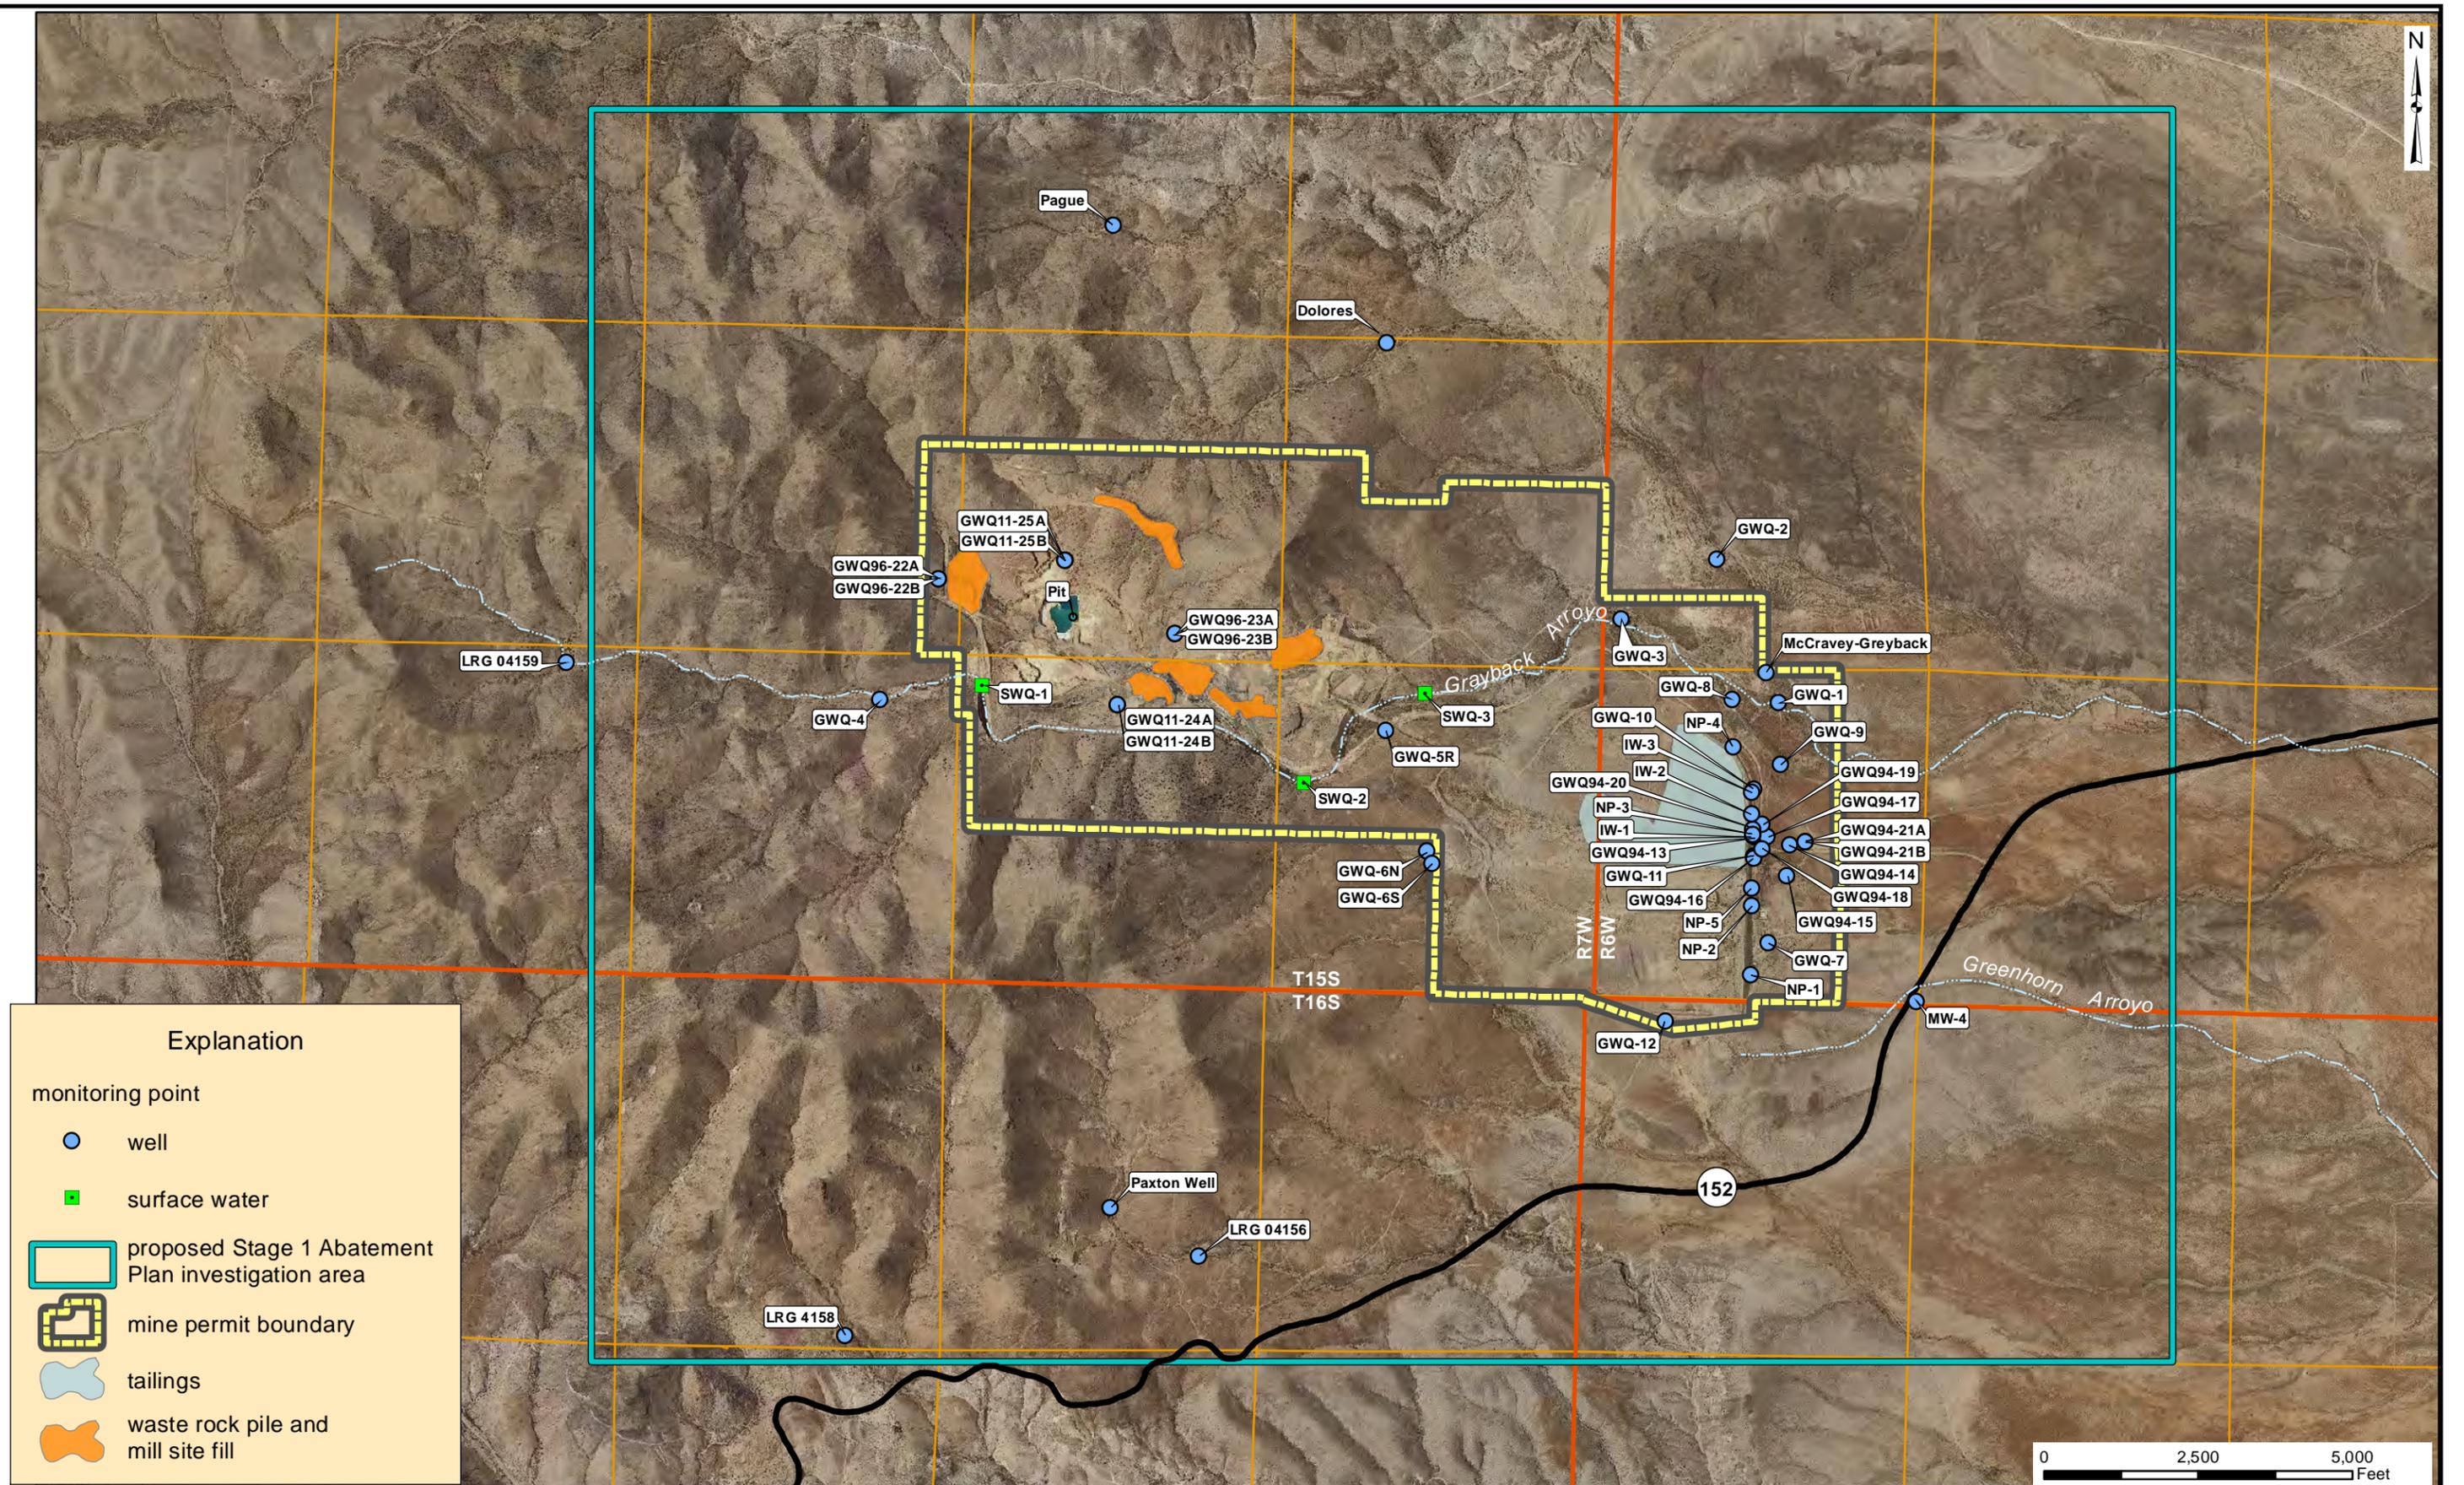
Figure 2. Map of proposed Stage 1 Abatement Plan area of investigation, Copper Flat Mine facilities, and monitoring point locations, Copper Flat Mine, Sierra County, New Mexico.

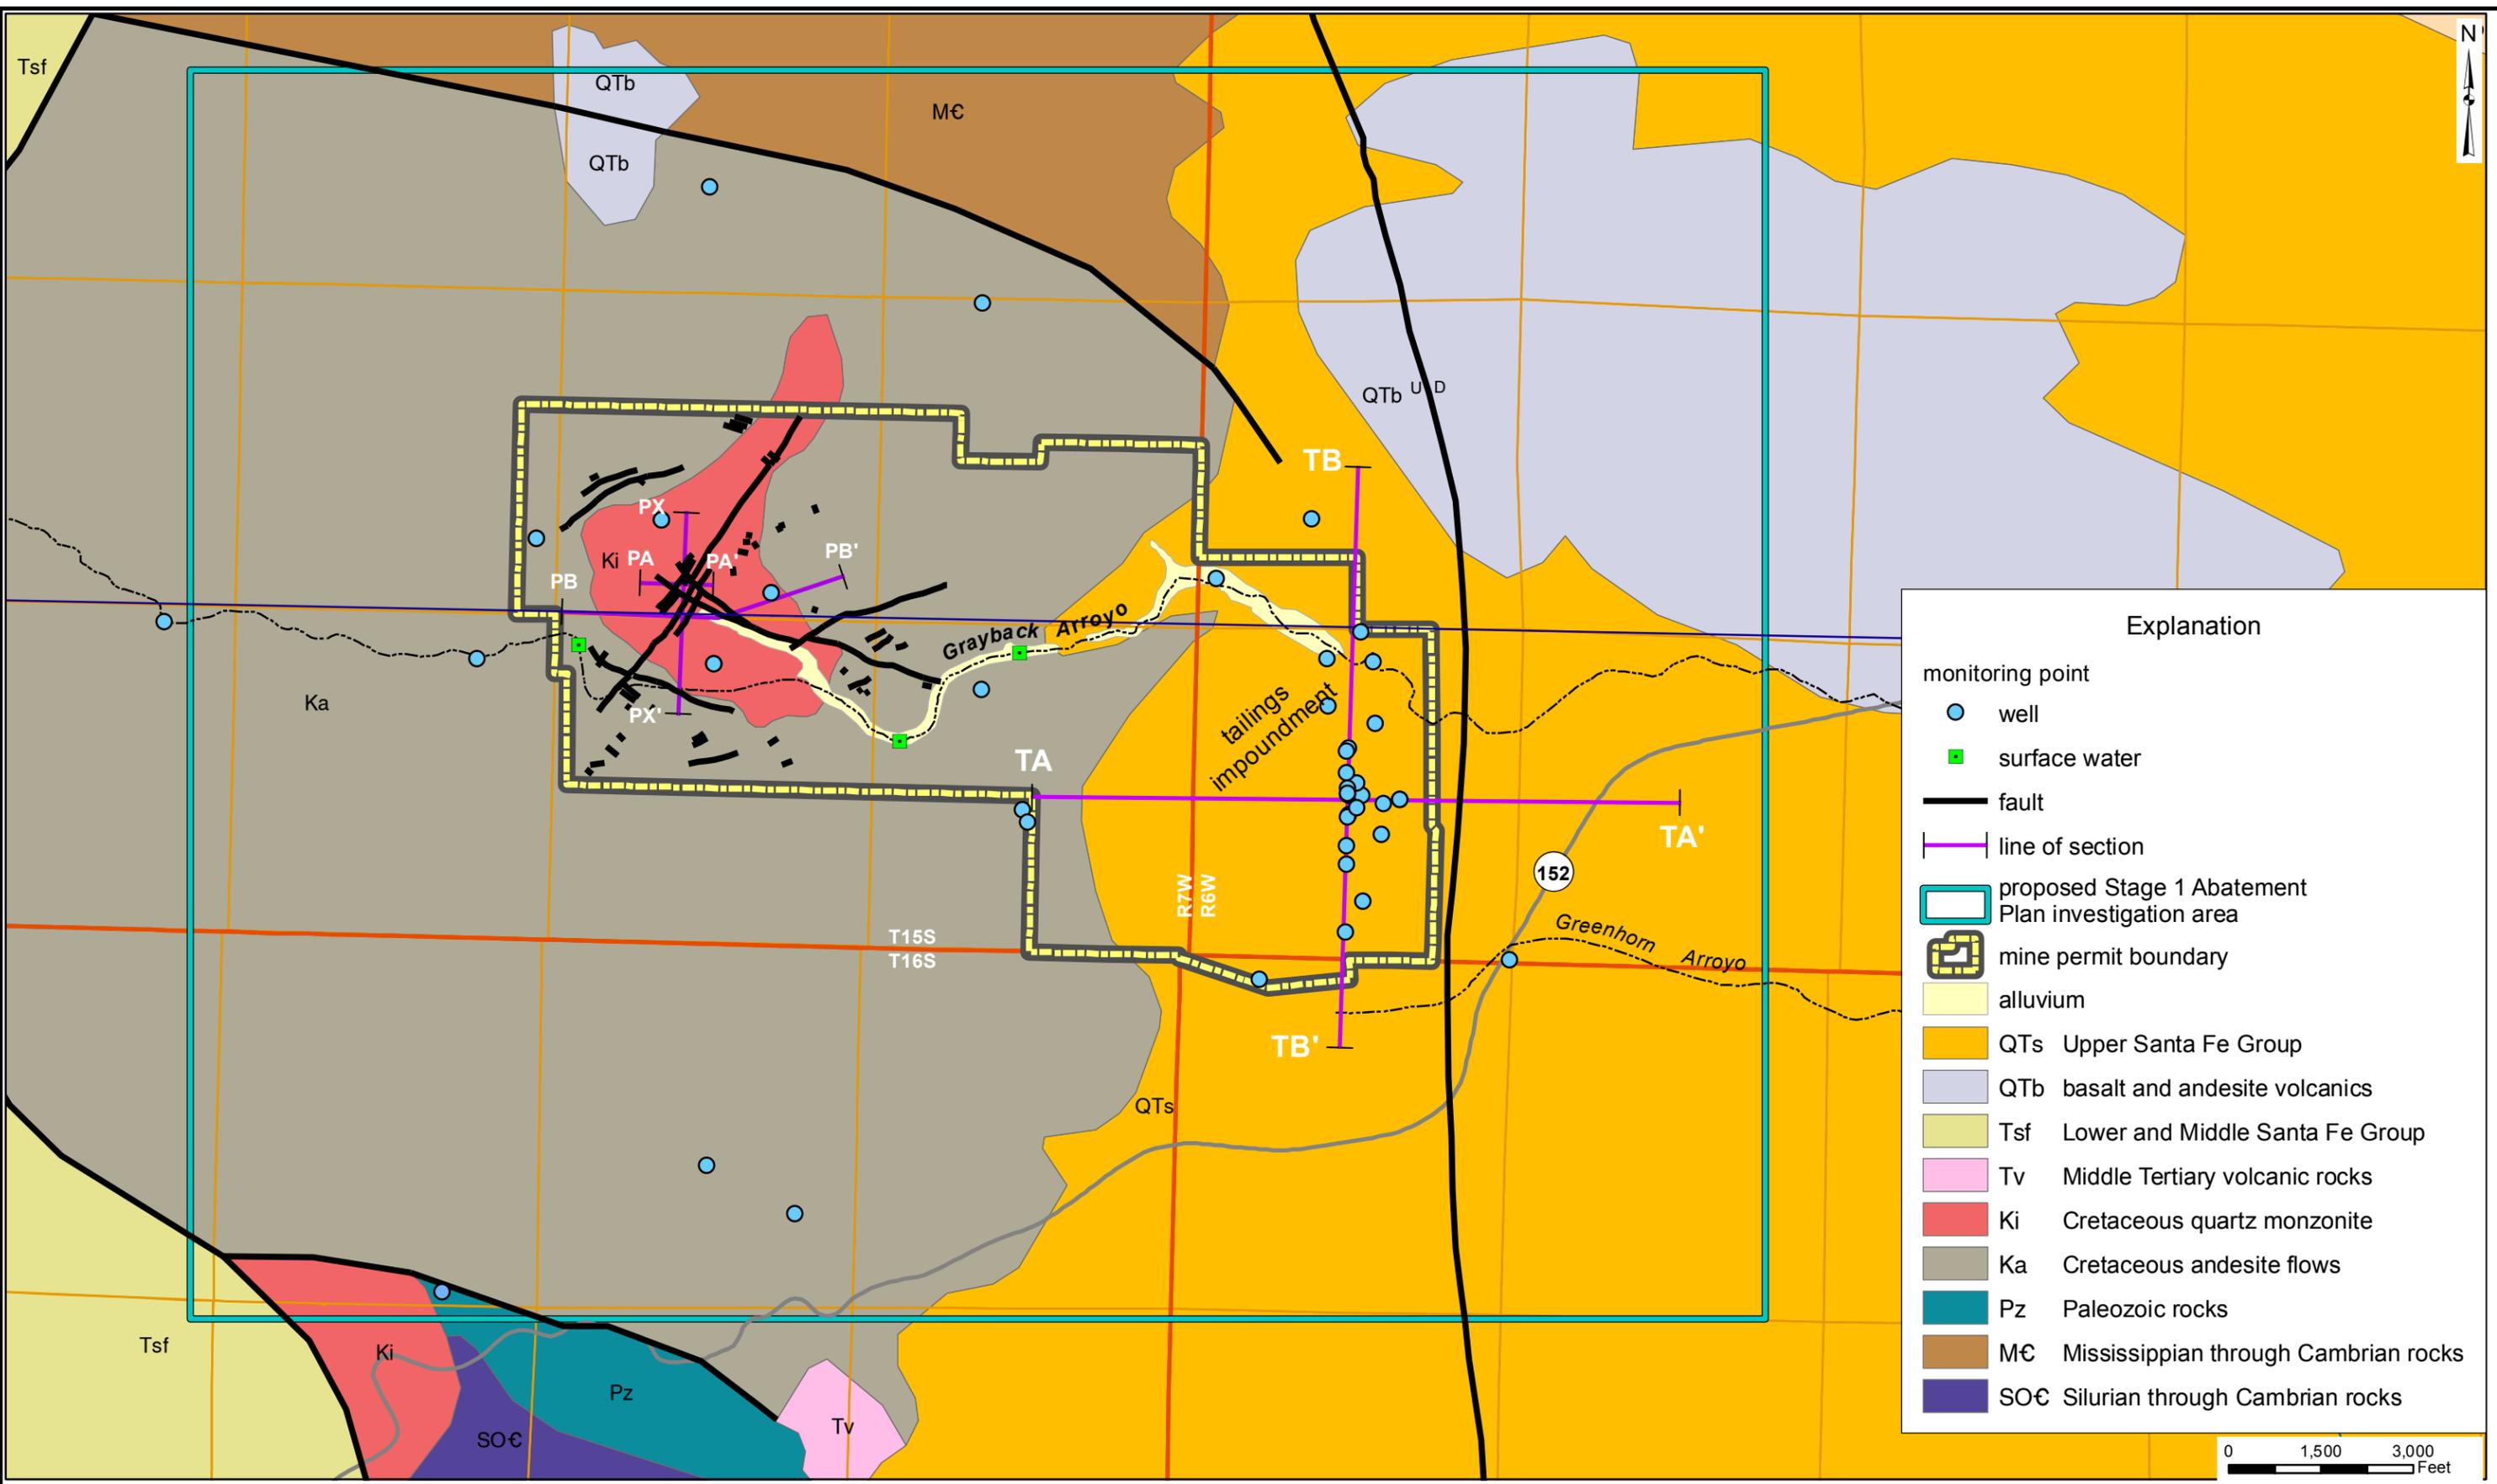
Figure 3. Geologic map showing distribution of hydrogeologic units within the area of investigation and lines of section for tailings impoundment area, Copper Flat Mine, Sierra County, New Mexico.

A summary of the geologic units and their characteristics is presented in Table 3. The distribution of geologic units is shown on Figure 3, and the subsurface conditions are illustrated on the hydrogeologic cross-sections presented as Figures 5 through 8.

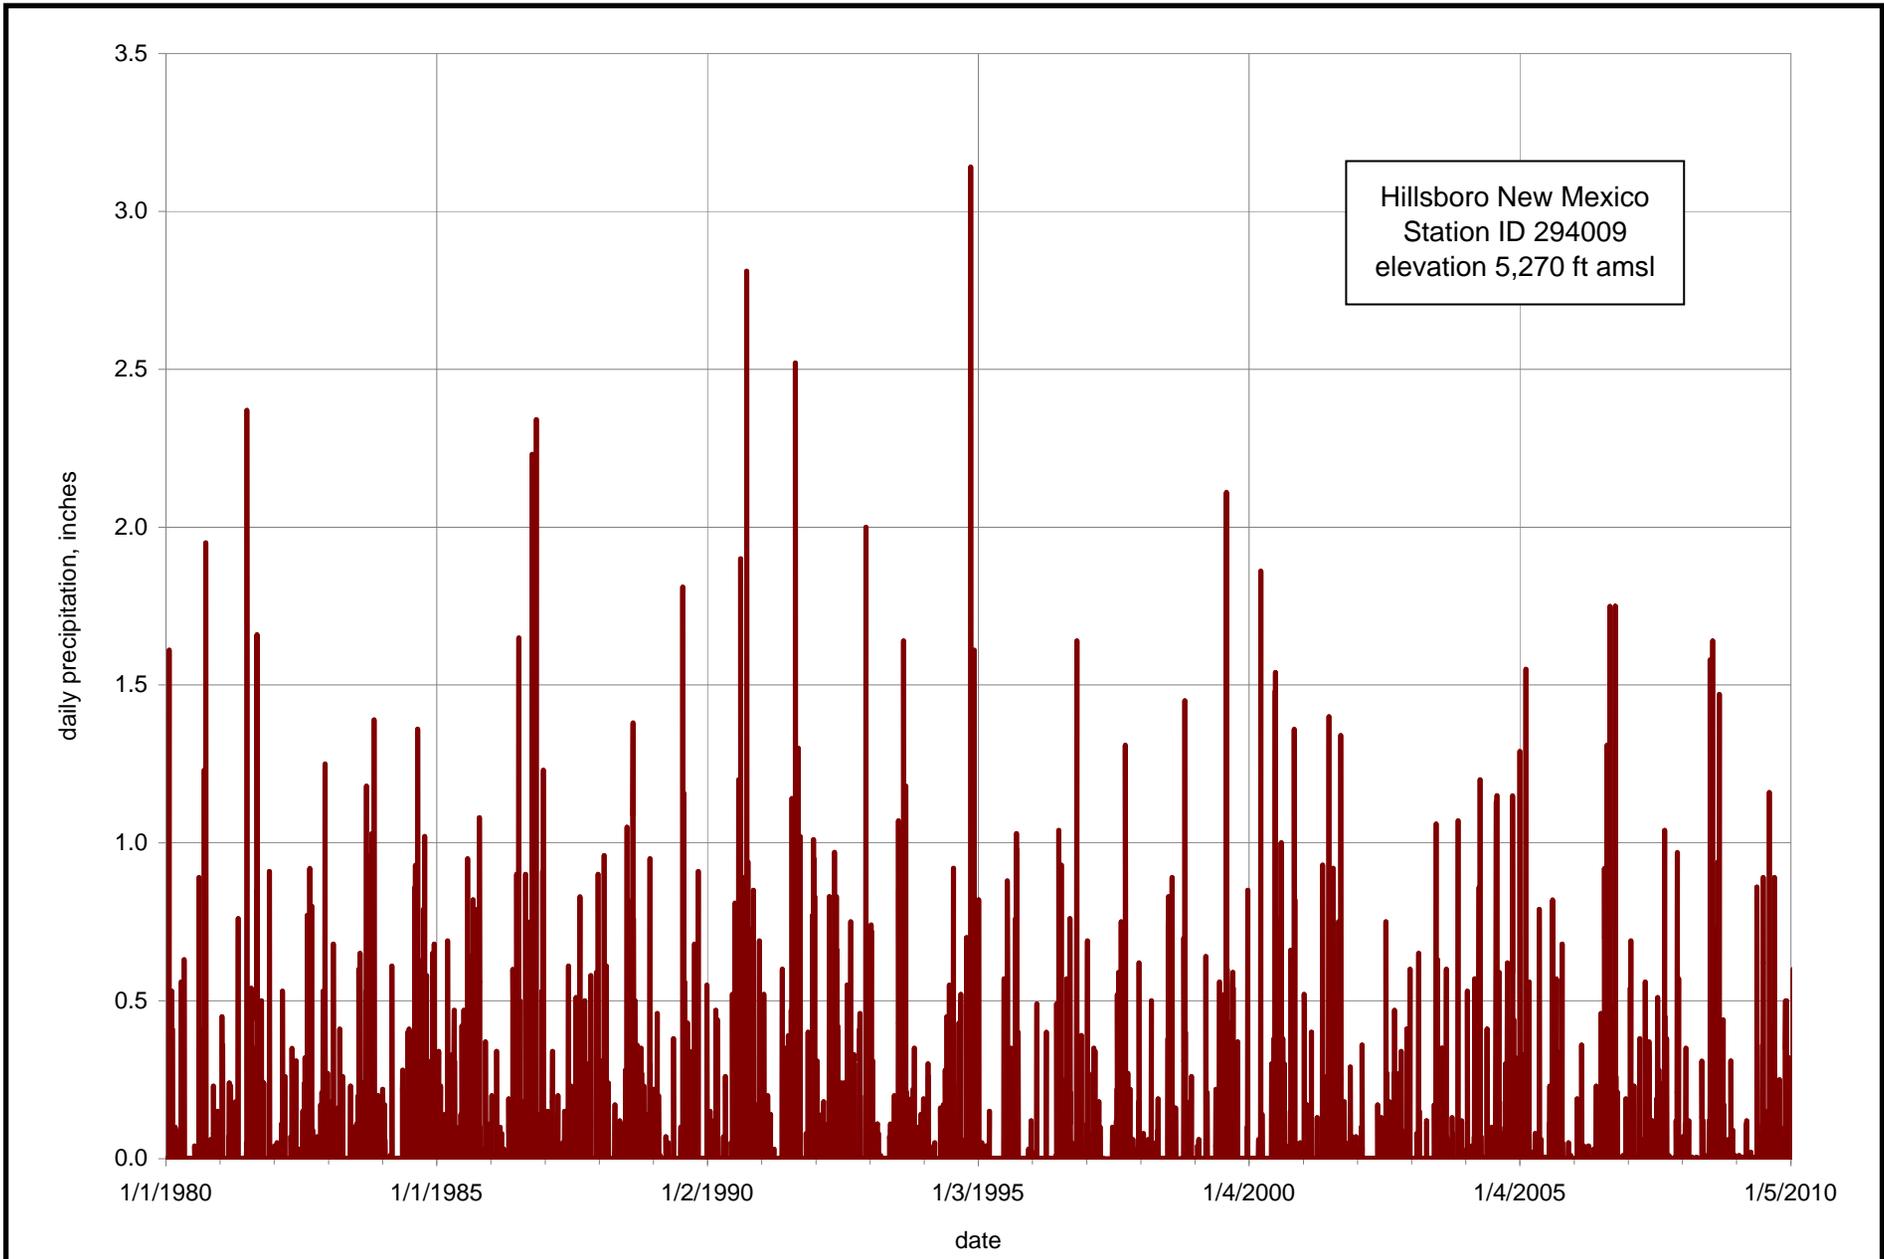
Figure 4. Graph of daily precipitation at Hillsboro, New Mexico for the time period 1980 to 2010.

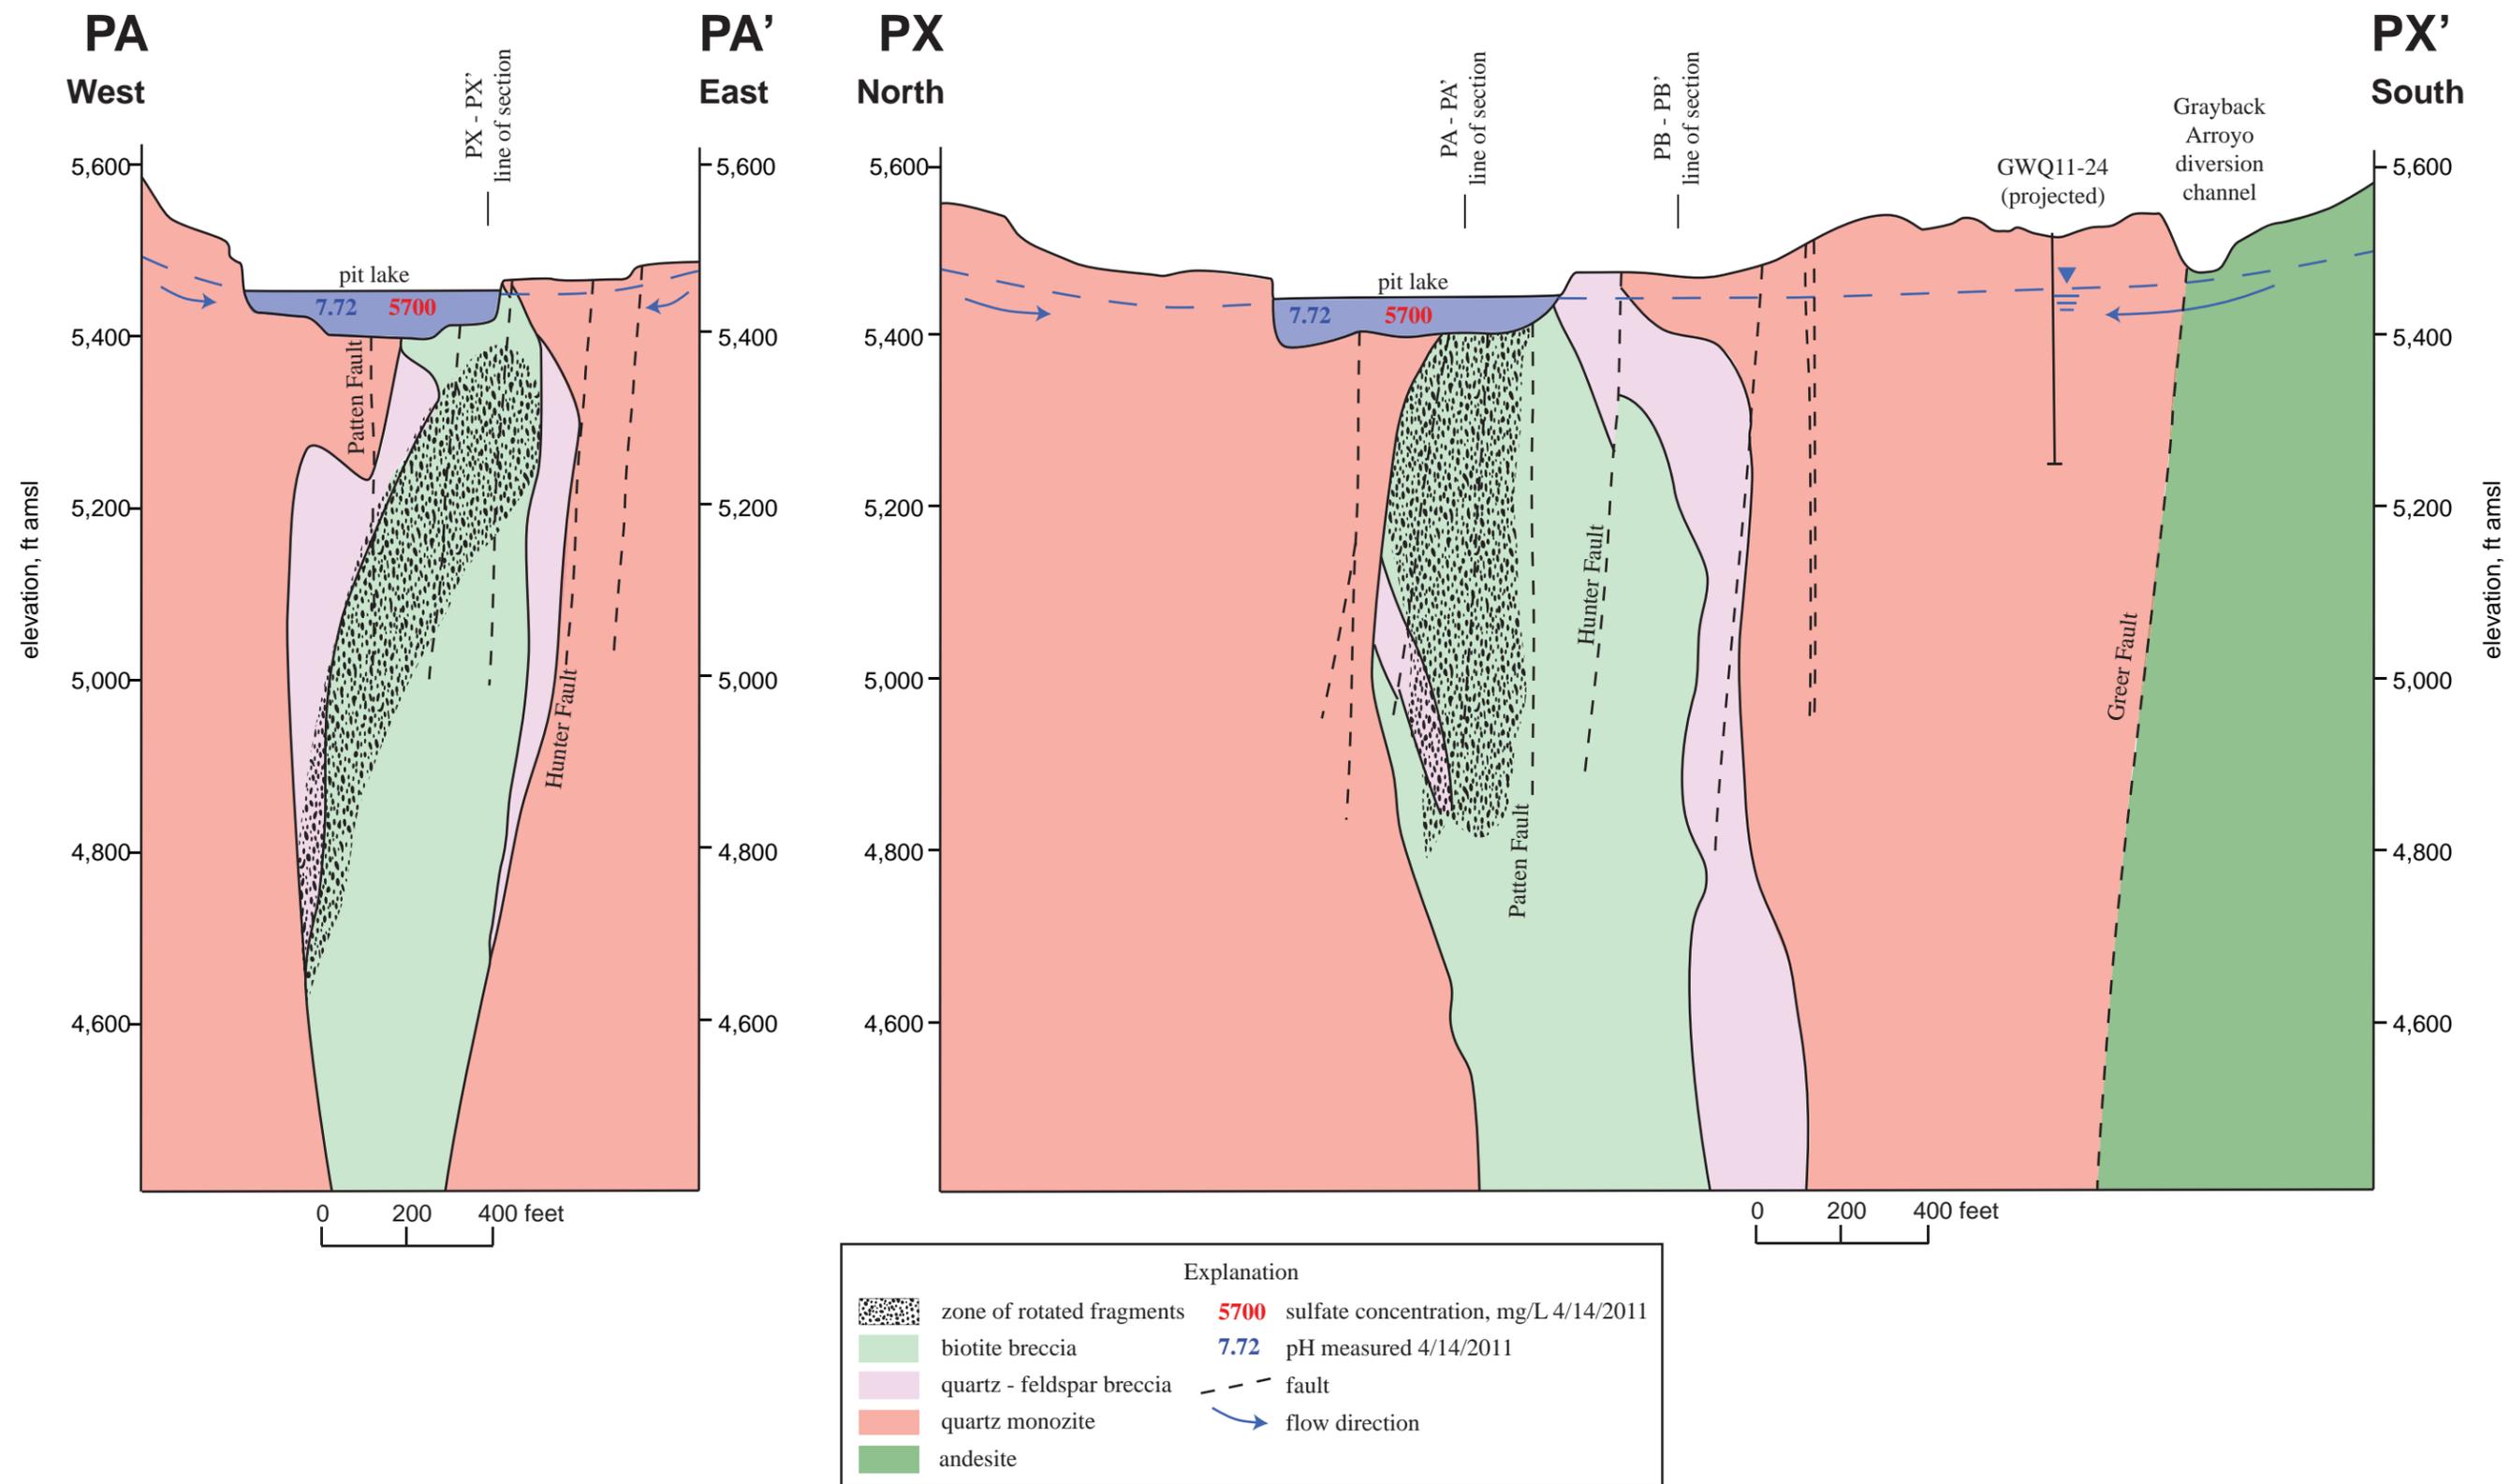
Figure 5. Hydrogeologic cross-sections PA-PA' and PX-PX', Copper Flat Mine pit lake area, Sierra County, New Mexico.

Piezometer nests GWQ96-22(A,B) and GWQ96-23(A,B) provide adequate monitoring of upgradient (GWQ96-22(A,B)) and downgradient (GWQ96-23(A,B)) groundwater-quality conditions. Figures 5 and 6 show the distribution of 2011 sulfate concentrations, and, along with the water-level elevation contours (Fig. 10), indicate the pit lake is a hydraulic sink with no impacts to groundwater. Recently constructed nested piezometers GWQ11-24(A,B) and GWQ11-25(A,B) have not been sampled, so the groundwater quality north and south of the pit has not been characterized.

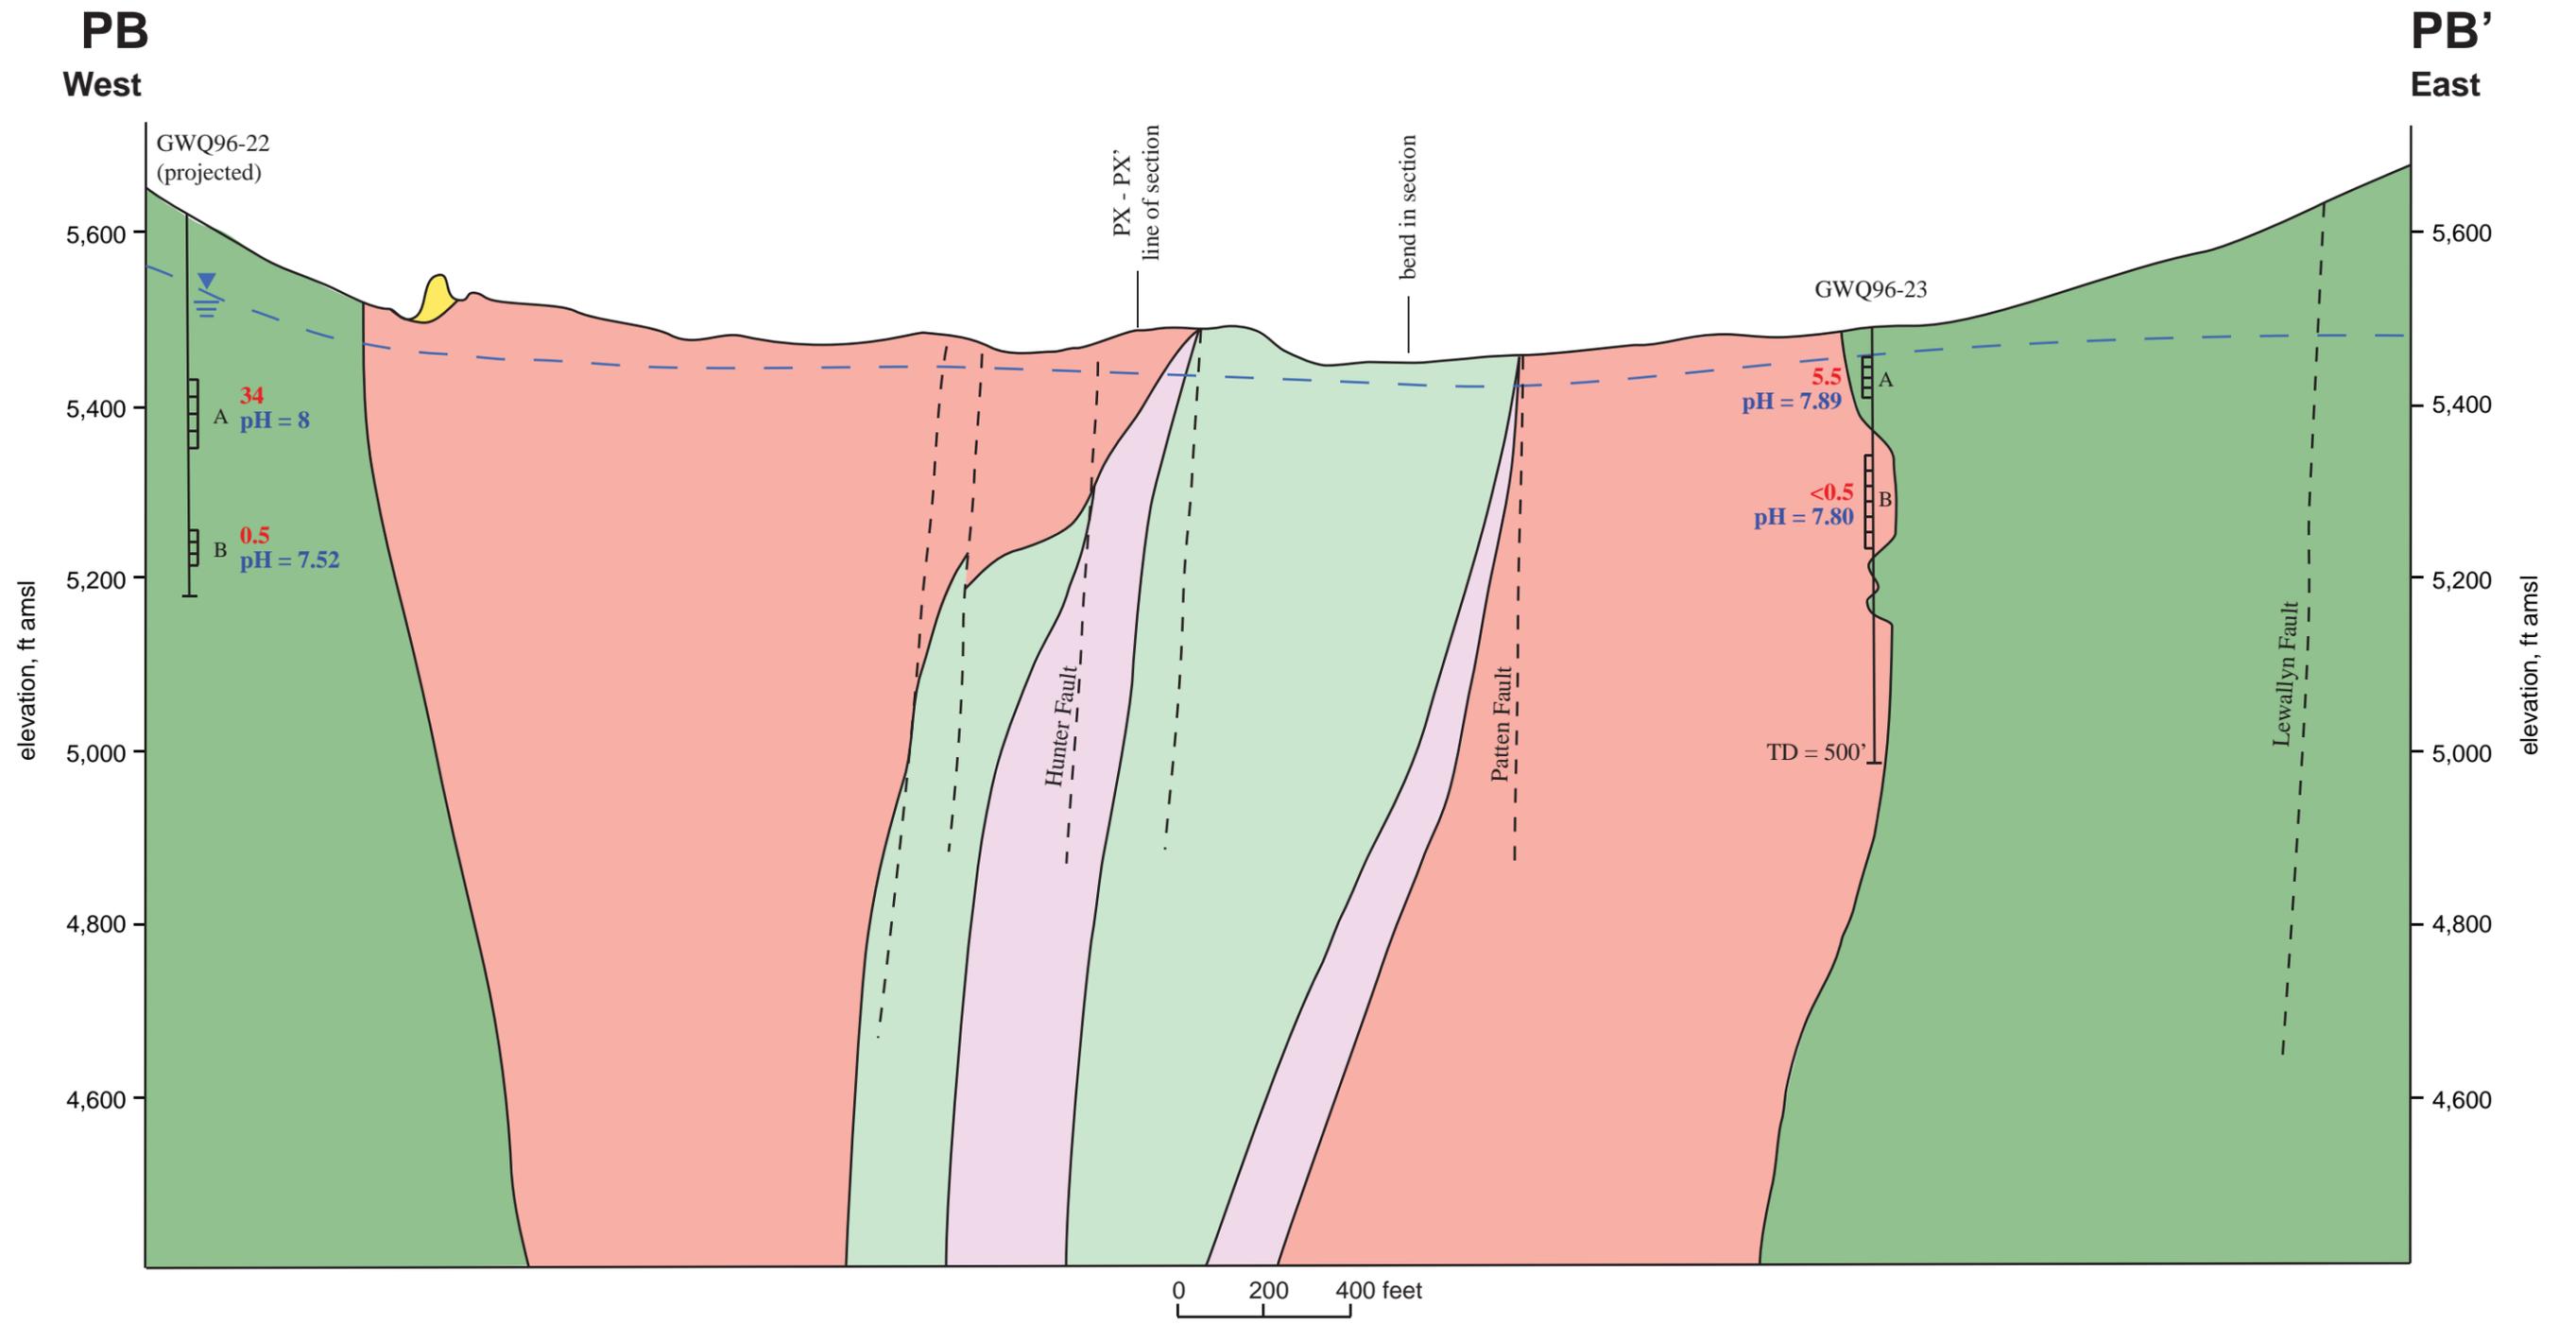
Explanation	
 alluvium	5.5 sulfate concentration, mg/L (October 2010)
 biotite breccia	7.52 pH (October 2010)
 quartz - feldspar breccia	- - - fault
 quartz monozite	
 andesite

Figure 6. Hydrogeologic cross-section PB-PB', Copper Flat Mine pit lake area, Sierra County, New Mexico.

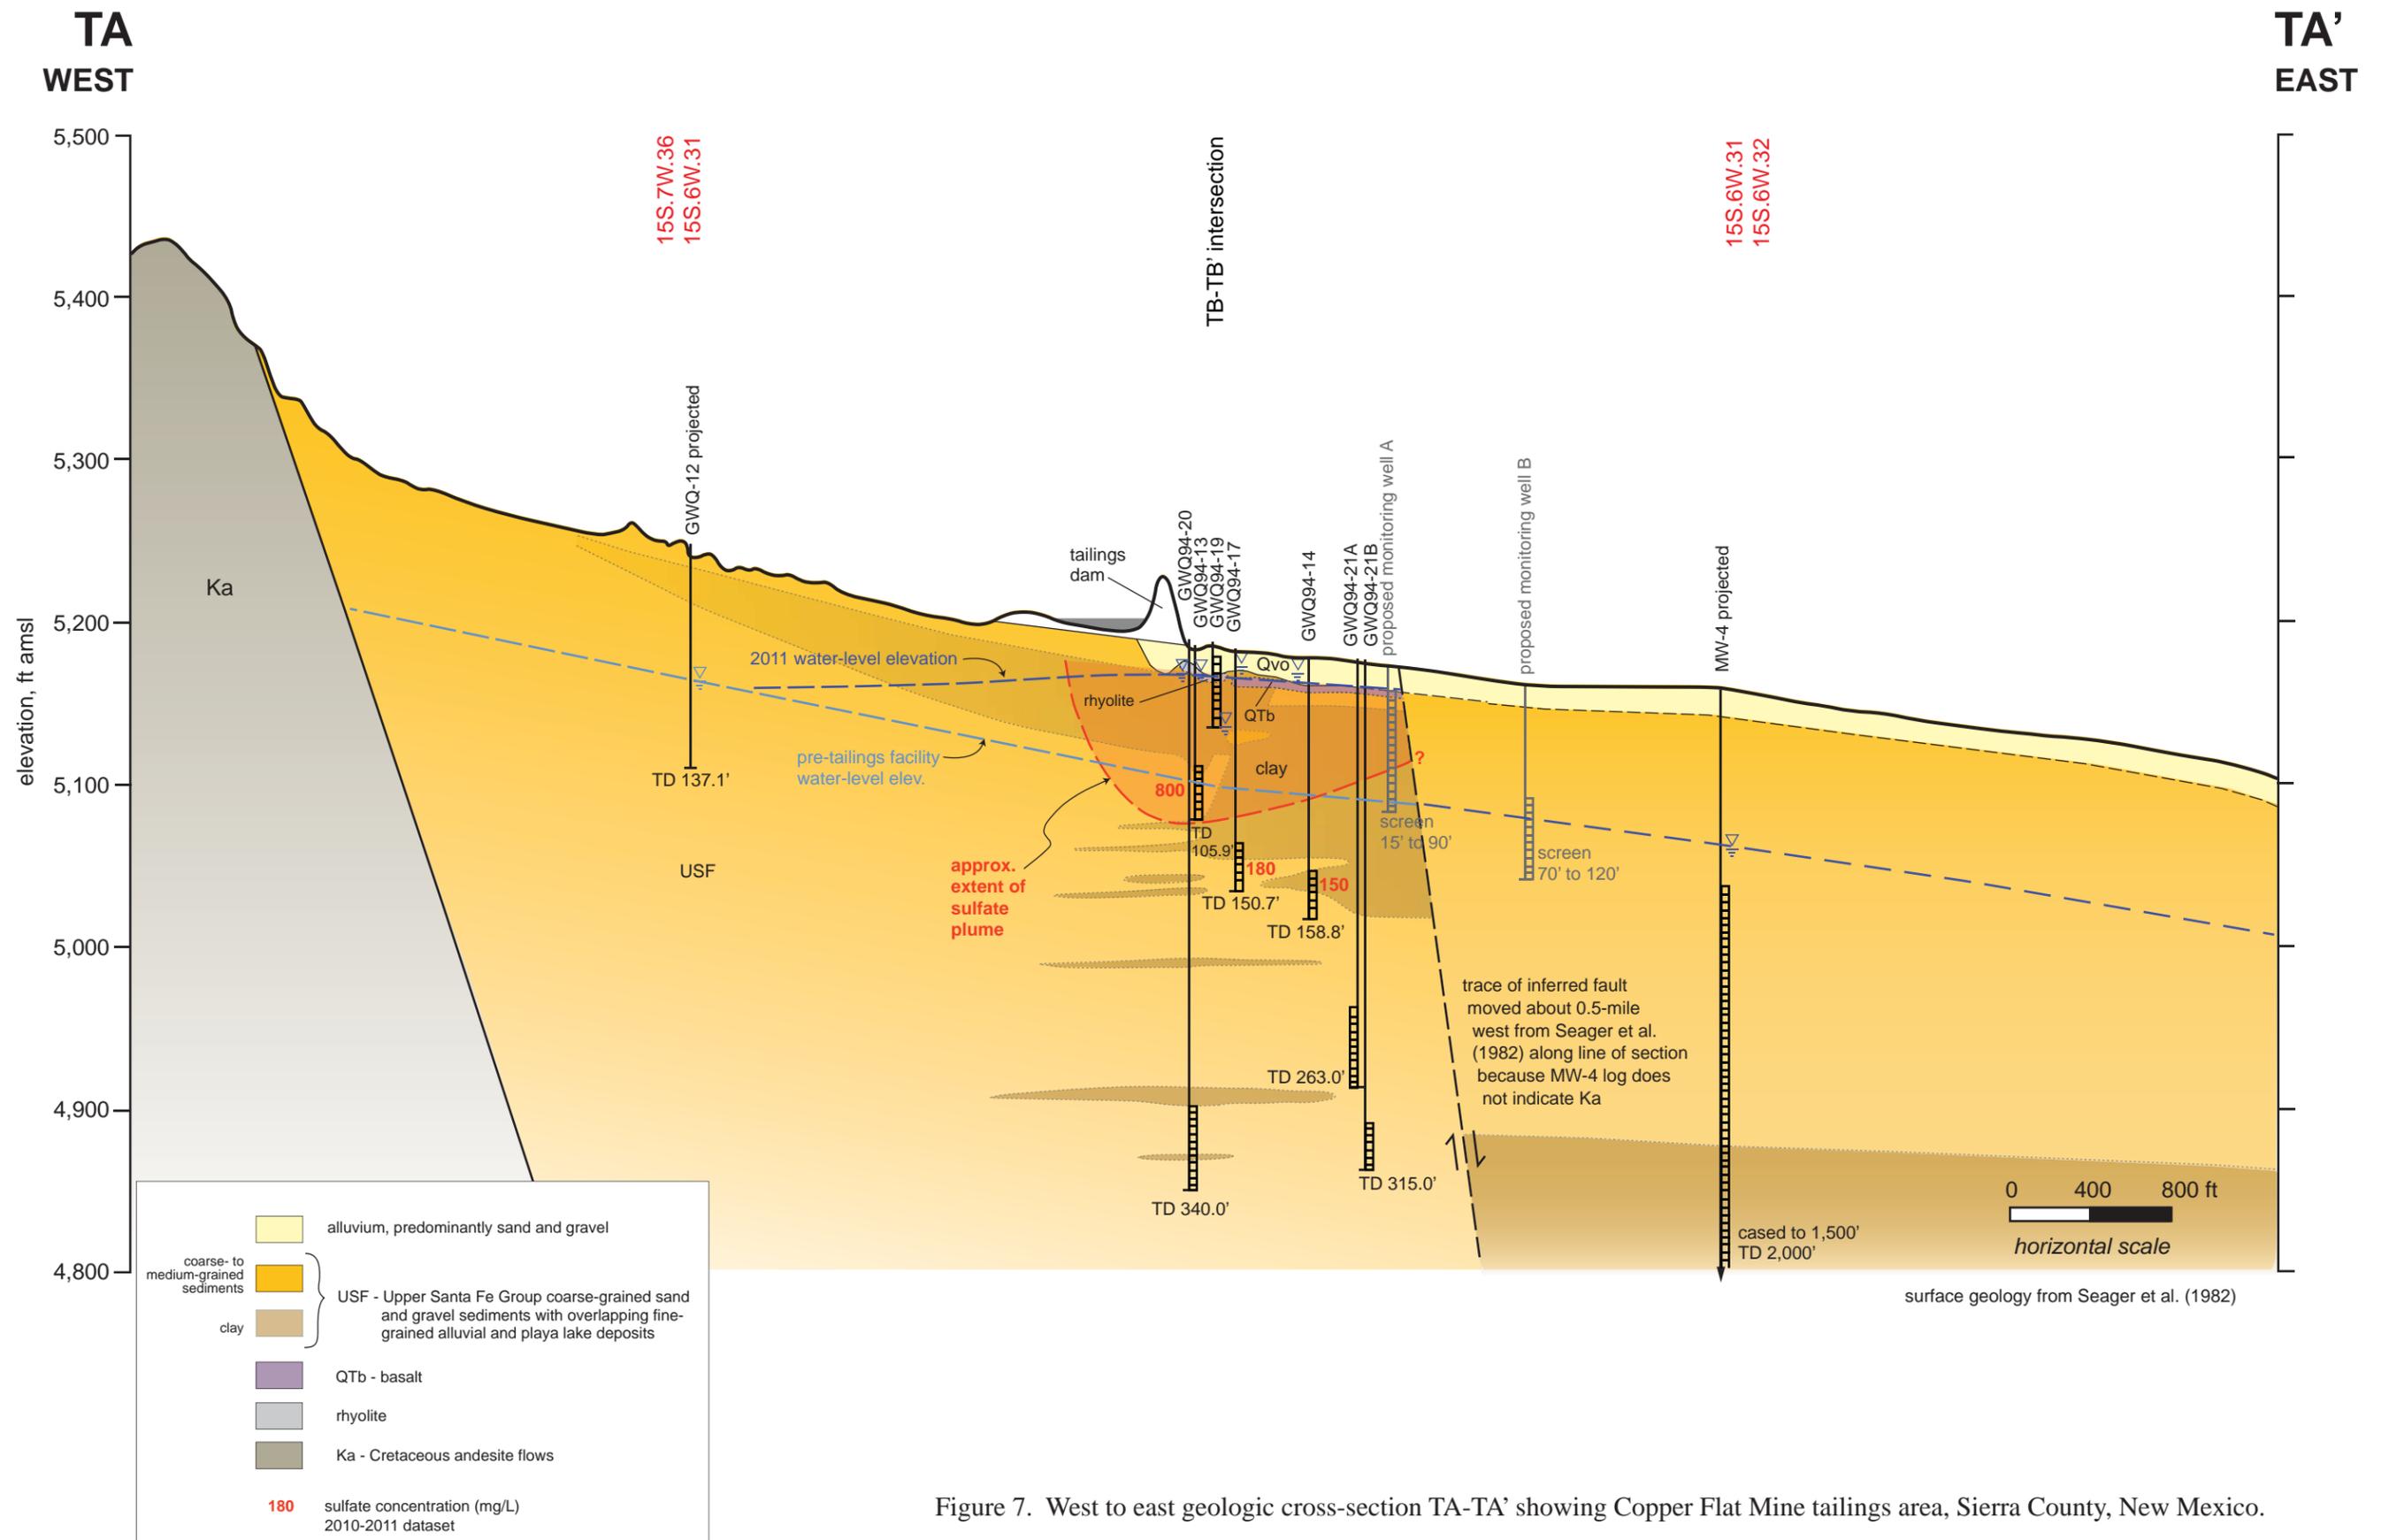
Figure 7. West to east geologic cross-section TA-TA' showing Copper Flat Mine tailings area, Sierra County, New Mexico.

The groundwater monitoring network for the tailings impoundment has adequately defined the horizontal and vertical extent of groundwater impacts, except for the lateral extent on the east and downgradient side (see Figs. 7, 8, and 14). The eastern most monitoring wells, GWQ94-21A and GWQ94-21B are completed too deep to characterize the lateral extent of groundwater impacts.

Proposed investigation for the tailings impoundment facility includes the drilling of one or two monitoring wells downgradient of the known extent of the sulfate plume. Downgradient monitoring wells GWQ94-14 and GWQ94-21 are too deep to assess the lateral extent of the sulfate plume (Fig. 7). Proposed monitoring well locations are shown on Figures 7 and 17; the actual locations may depend on land ownership and access, and may slightly vary from the proposed location.

1. Install the first monitoring well (proposed monitoring well A) located east of GWQ94-21, but west of the fault zone shown on Figure 7. If proposed monitoring well A does not define the eastward extent of the sulfate plume, proposed monitoring well B will be drilled east of the projected fault zone. A 60-ft screen interval is proposed for monitoring well A to accommodate the possibility of the groundwater mound lowered to the pre-tailings water-level elevation.
2. Data from existing and proposed monitoring wells will be used to assess the sulfate plume extent and stability. Known aquifer properties, water-level trends, and vertical head distribution will be used to assess the stability of the sulfate plume and potential tracer velocity under current conditions.
