**AMENDMENT TO THE
STAGE I ABATEMENT PLAN PROPOSAL
FOR THE COPPER FLAT MINE**

JOHN SHOMAKER & ASSOCIATES, INC.
Water-Resource and Environmental Consultants
2611 Broadbent Parkway NE
Albuquerque, New Mexico 87107
505-345-3407
www.shomaker.com

New Mexico Copper Corporation
2425 San Pedro Dr. NE, Suite 100
Albuquerque, New Mexico 87110

October 14, 2011

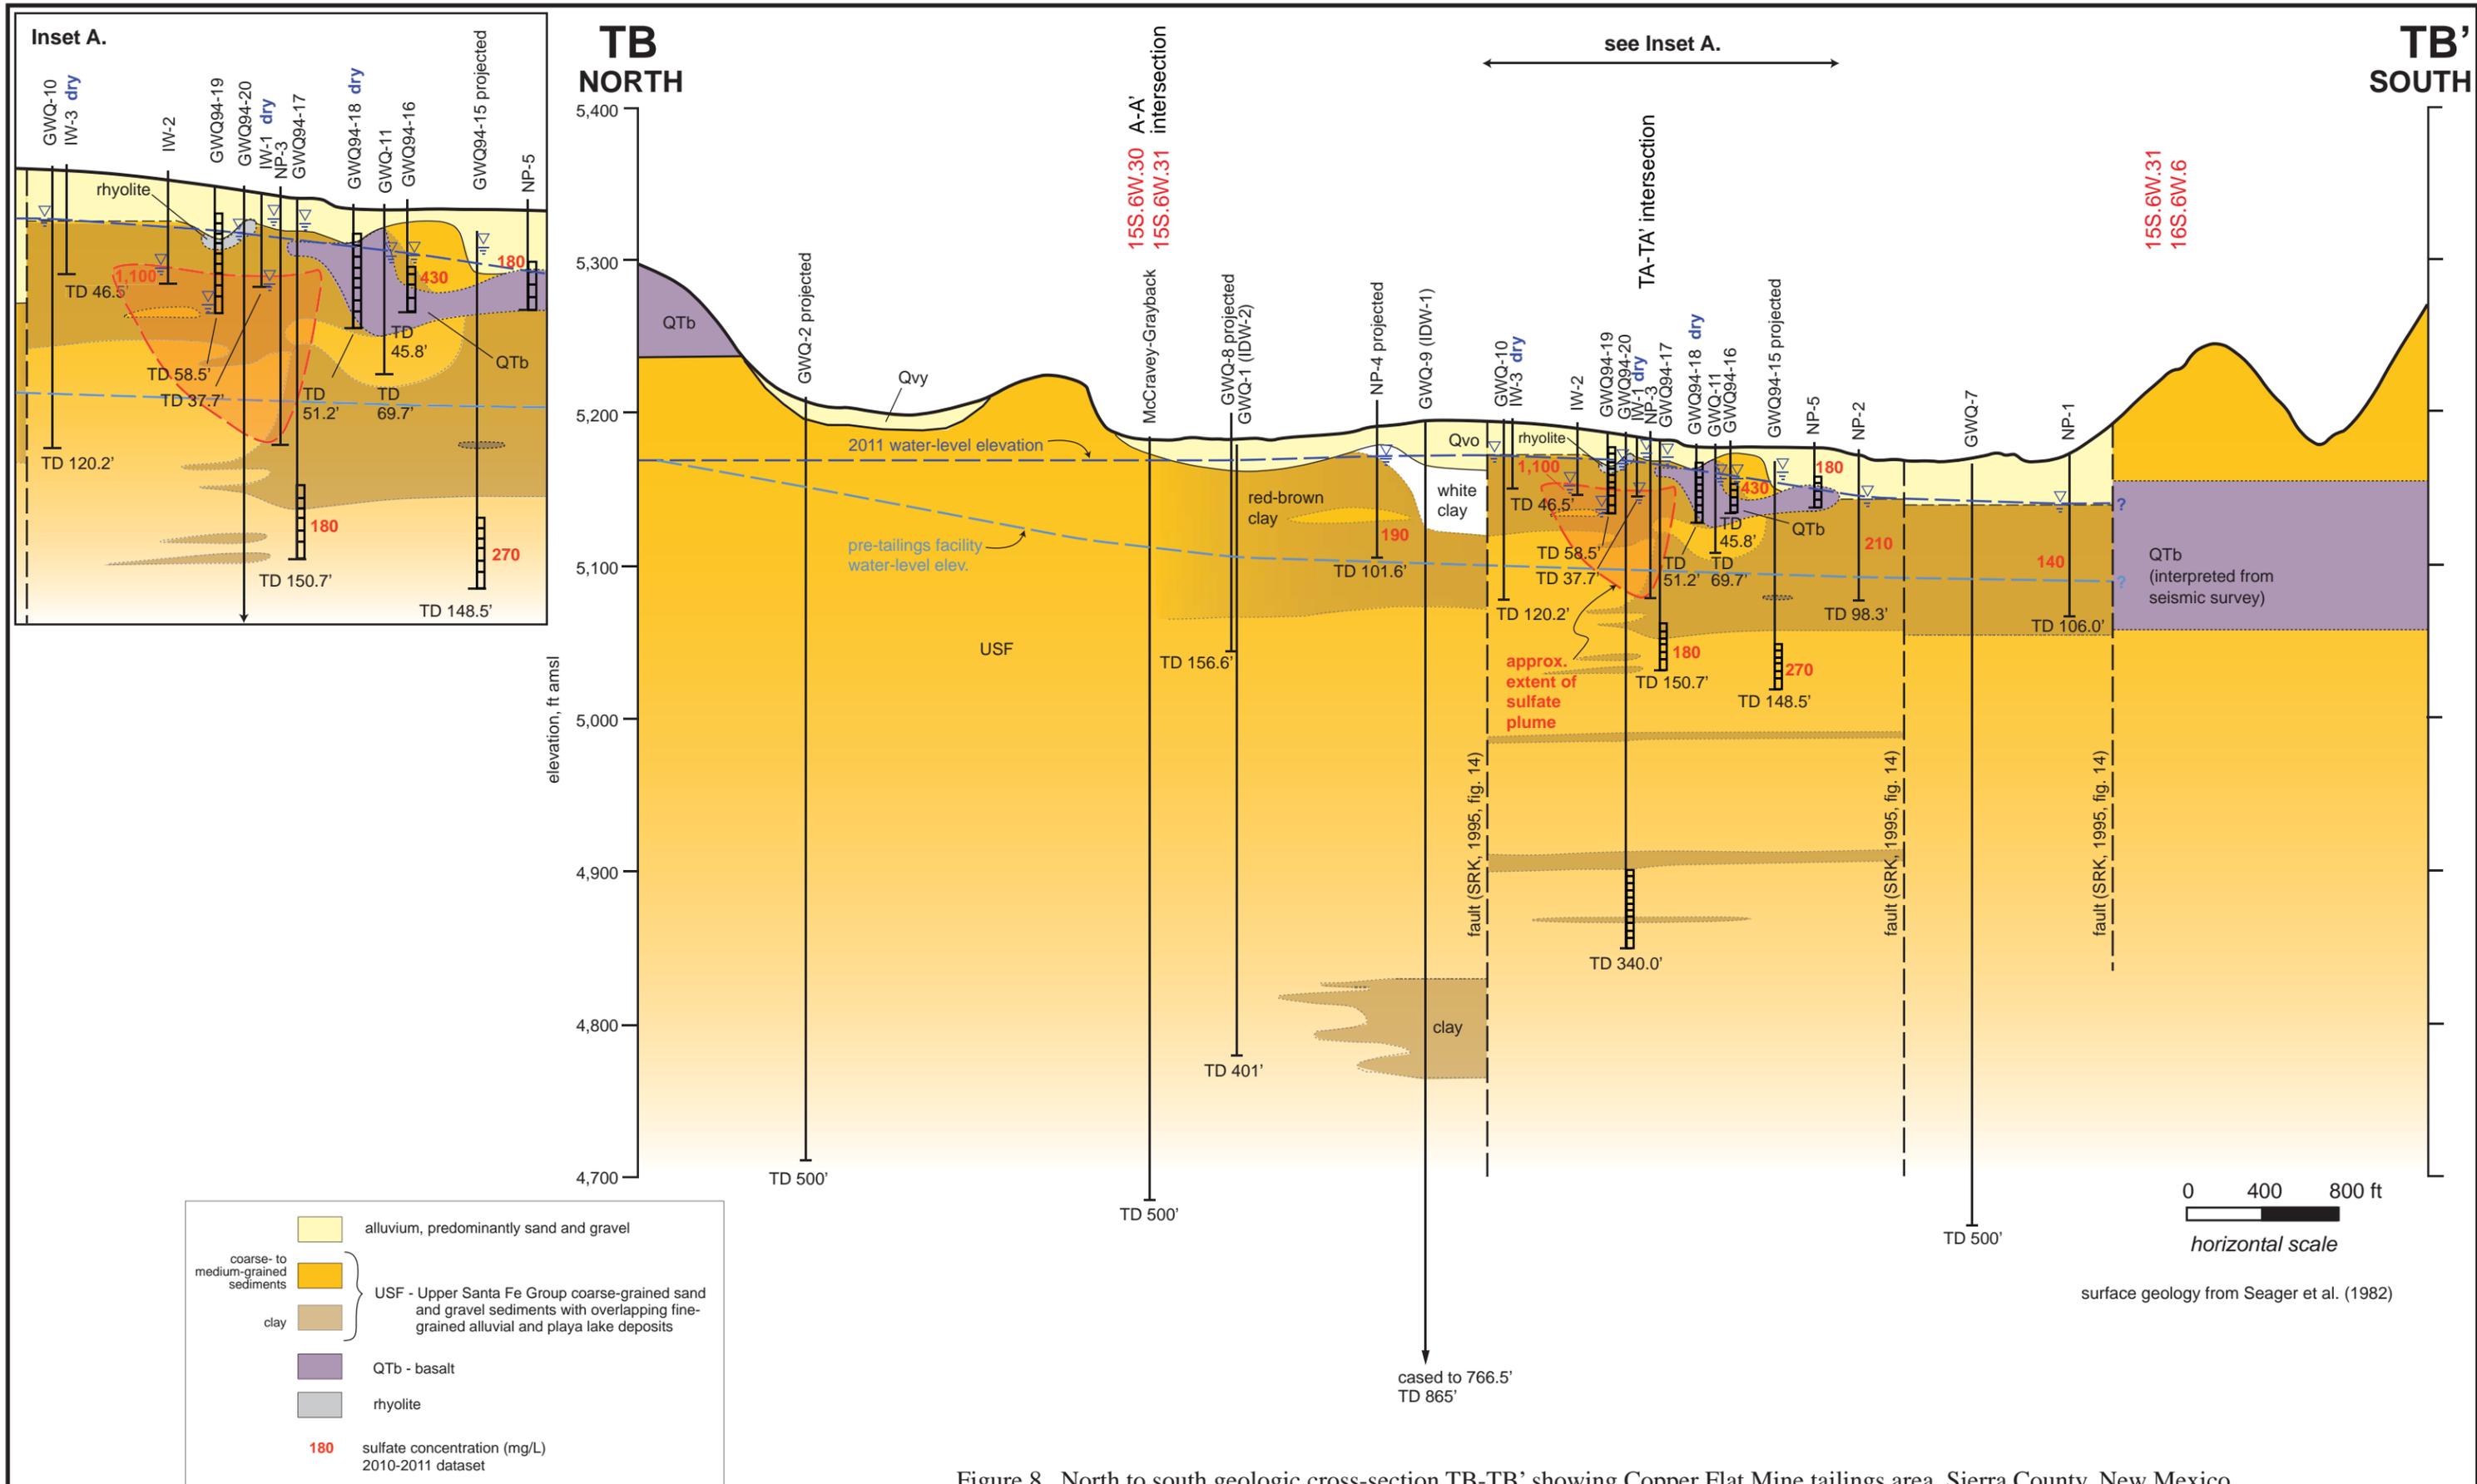
Figure 8. North to south geologic cross-section TB-TB' showing Copper Flat Mine tailings area, Sierra County, New Mexico.

A summary of the geologic units and their characteristics is presented in Table 3. The distribution of geologic units is shown on Figure 3, and the subsurface conditions are illustrated on the hydrogeologic cross-sections presented as Figures 5 through 8.

The groundwater monitoring network for the tailings impoundment has adequately defined the horizontal and vertical extent of groundwater impacts, except for the lateral extent on the east and downgradient side (see Figs. 7, 8, and 14). The eastern most monitoring wells, GWQ94-21A and GWQ94-21B are completed too deep to characterize the lateral extent of groundwater impacts.

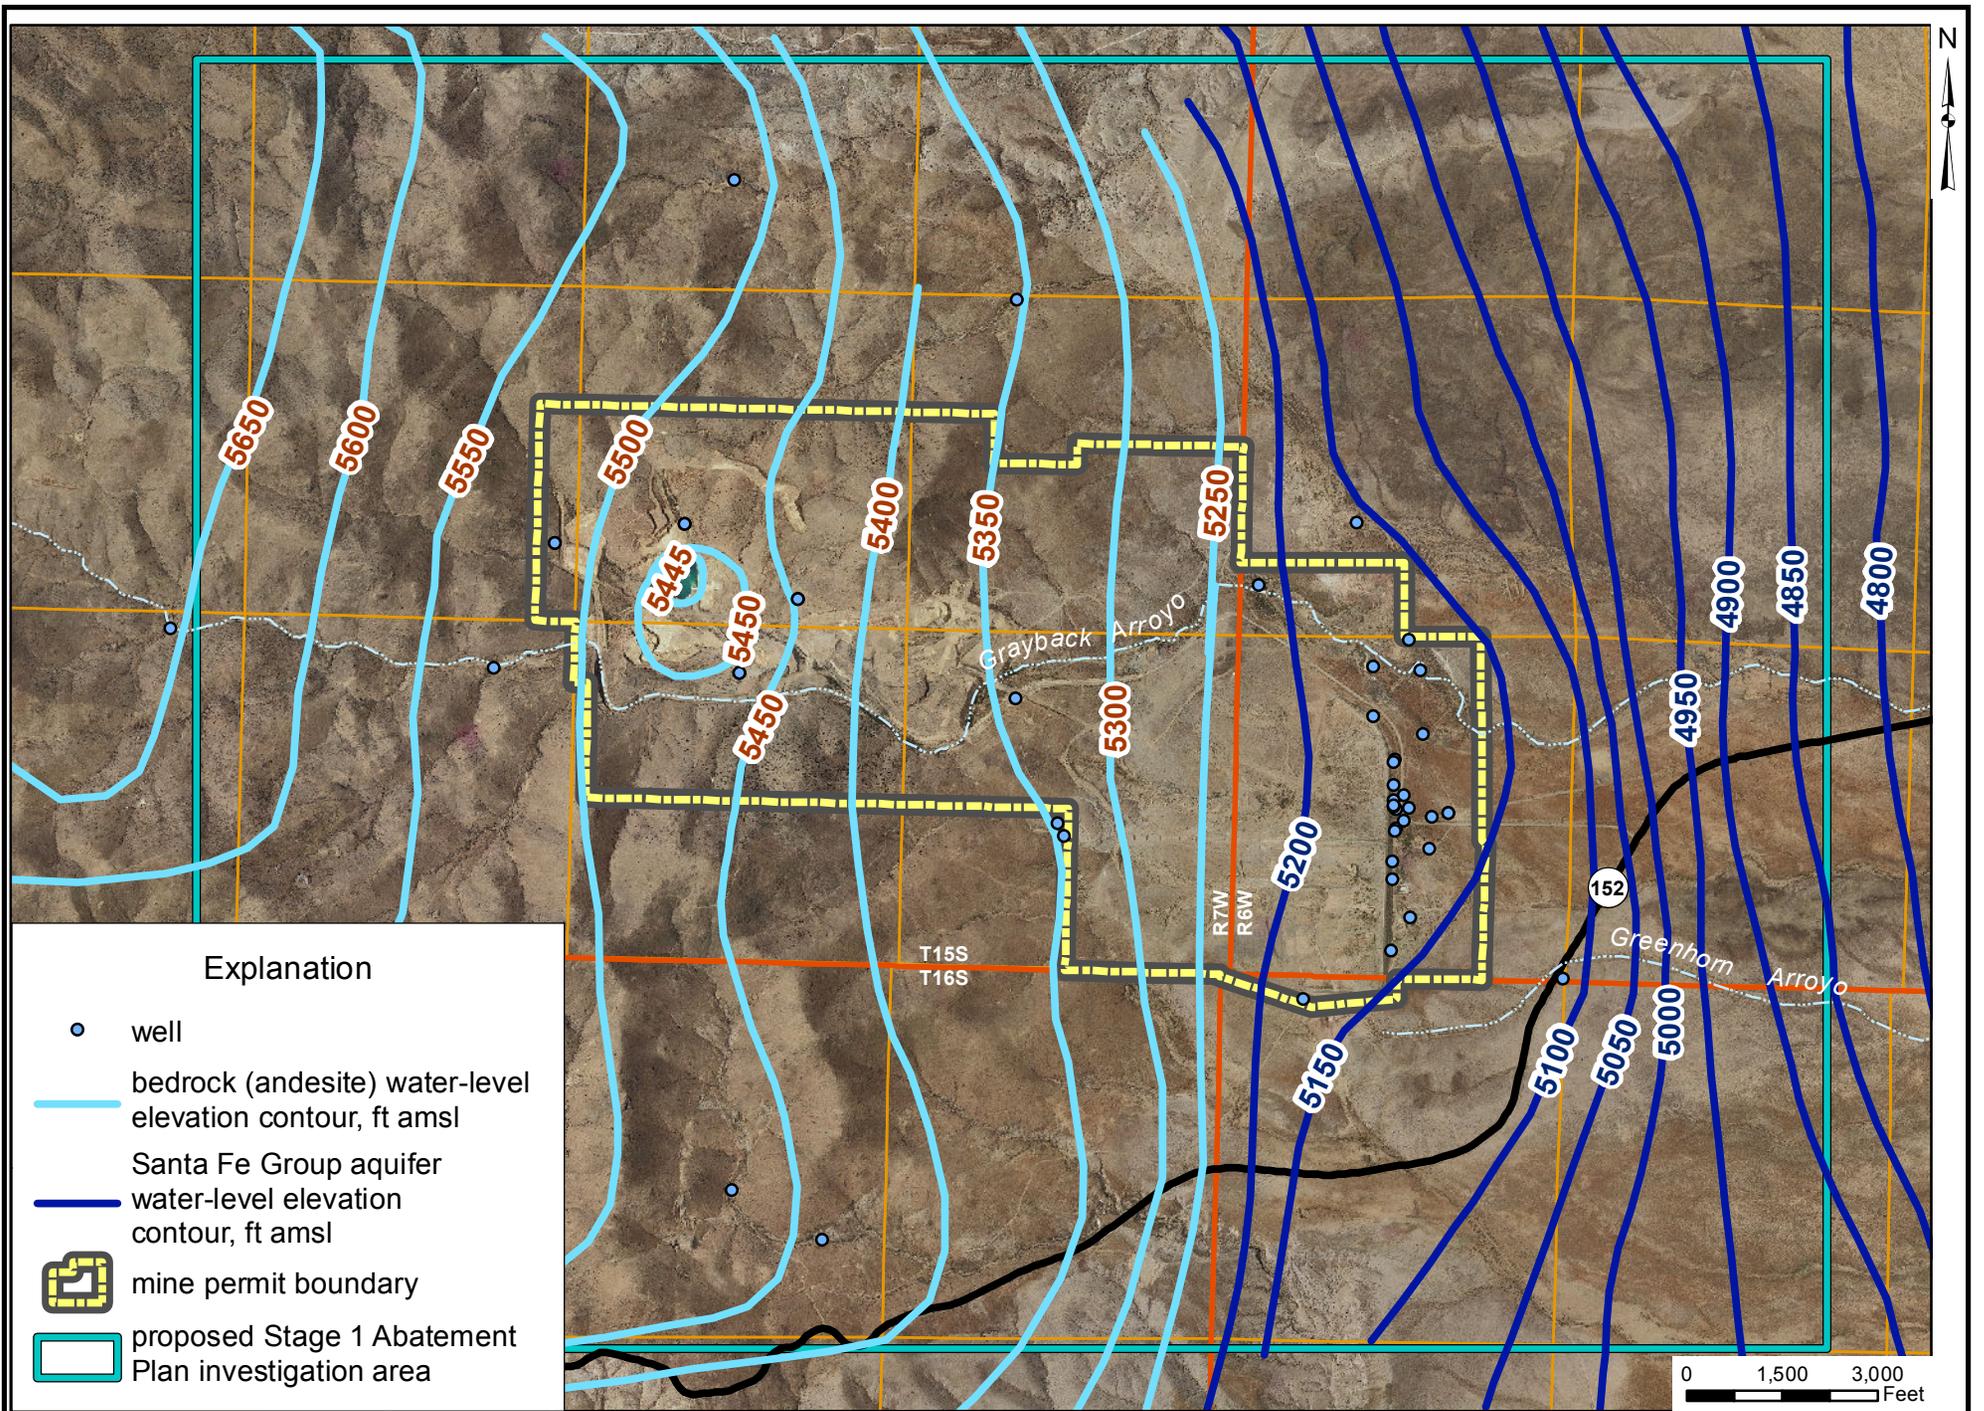
Figure 9. Water-level elevation contour map for Stage 1 Abatement Plan area of investigation, Copper Flat Mine, Sierra County, New Mexico.

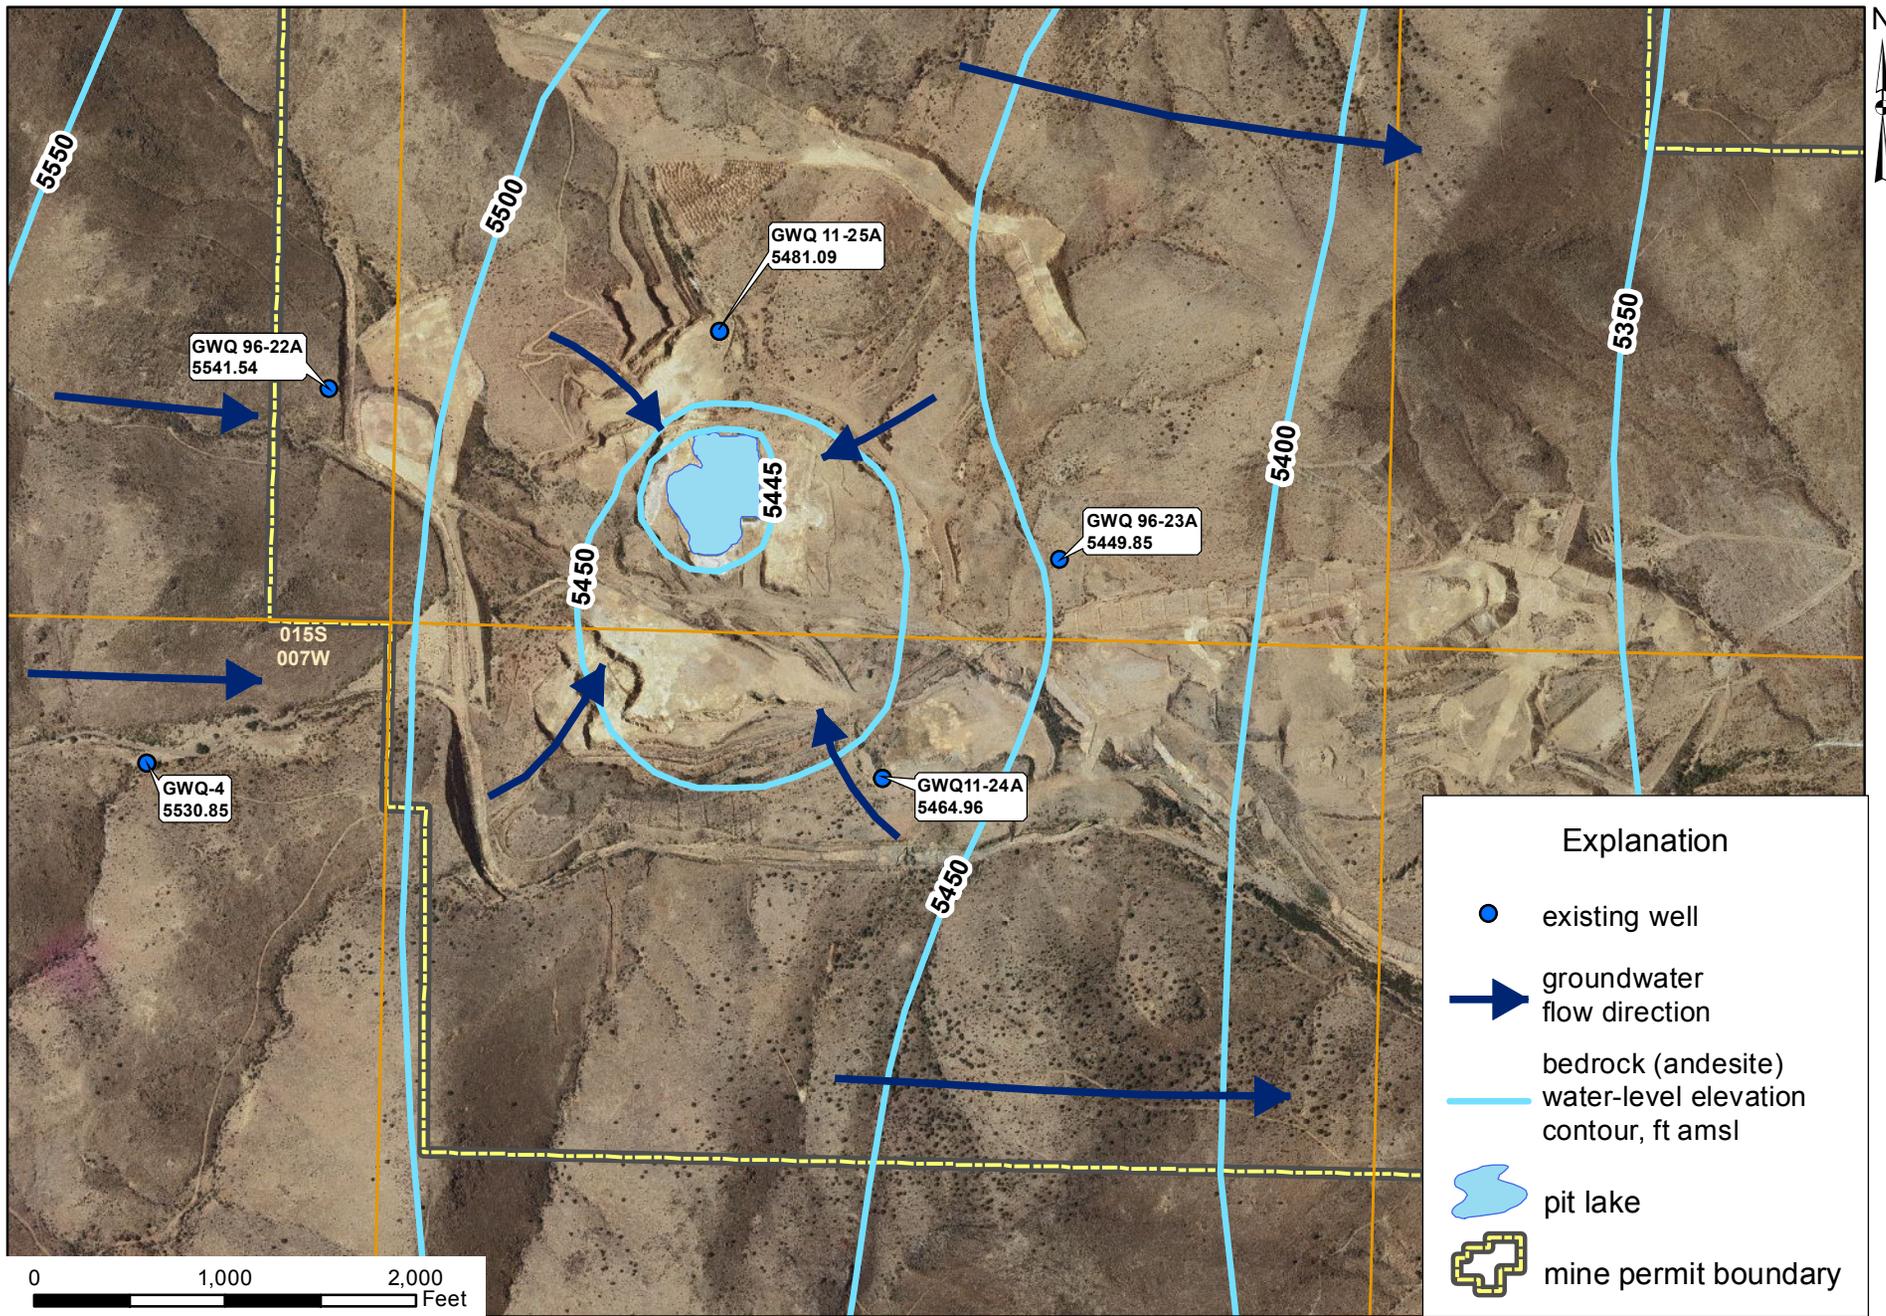
Figure 10. Aerial photograph showing water-level elevation contours and direction of groundwater flow for the Copper Flat Mine pit lake area, Sierra County, New Mexico.

Piezometer nests GWQ96-22(A,B) and GWQ96-23(A,B) provide adequate monitoring of upgradient (GWQ96-22(A,B)) and downgradient (GWQ96-23(A,B)) groundwater-quality conditions. Figures 5 and 6 show the distribution of 2011 sulfate concentrations, and, along with the water-level elevation contours (Fig. 10), indicate the pit lake is a hydraulic sink with no impacts to groundwater. Recently constructed nested piezometers GWQ11-24(A,B) and GWQ11-25(A,B) have not been sampled, so the groundwater quality north and south of the pit has not been characterized.

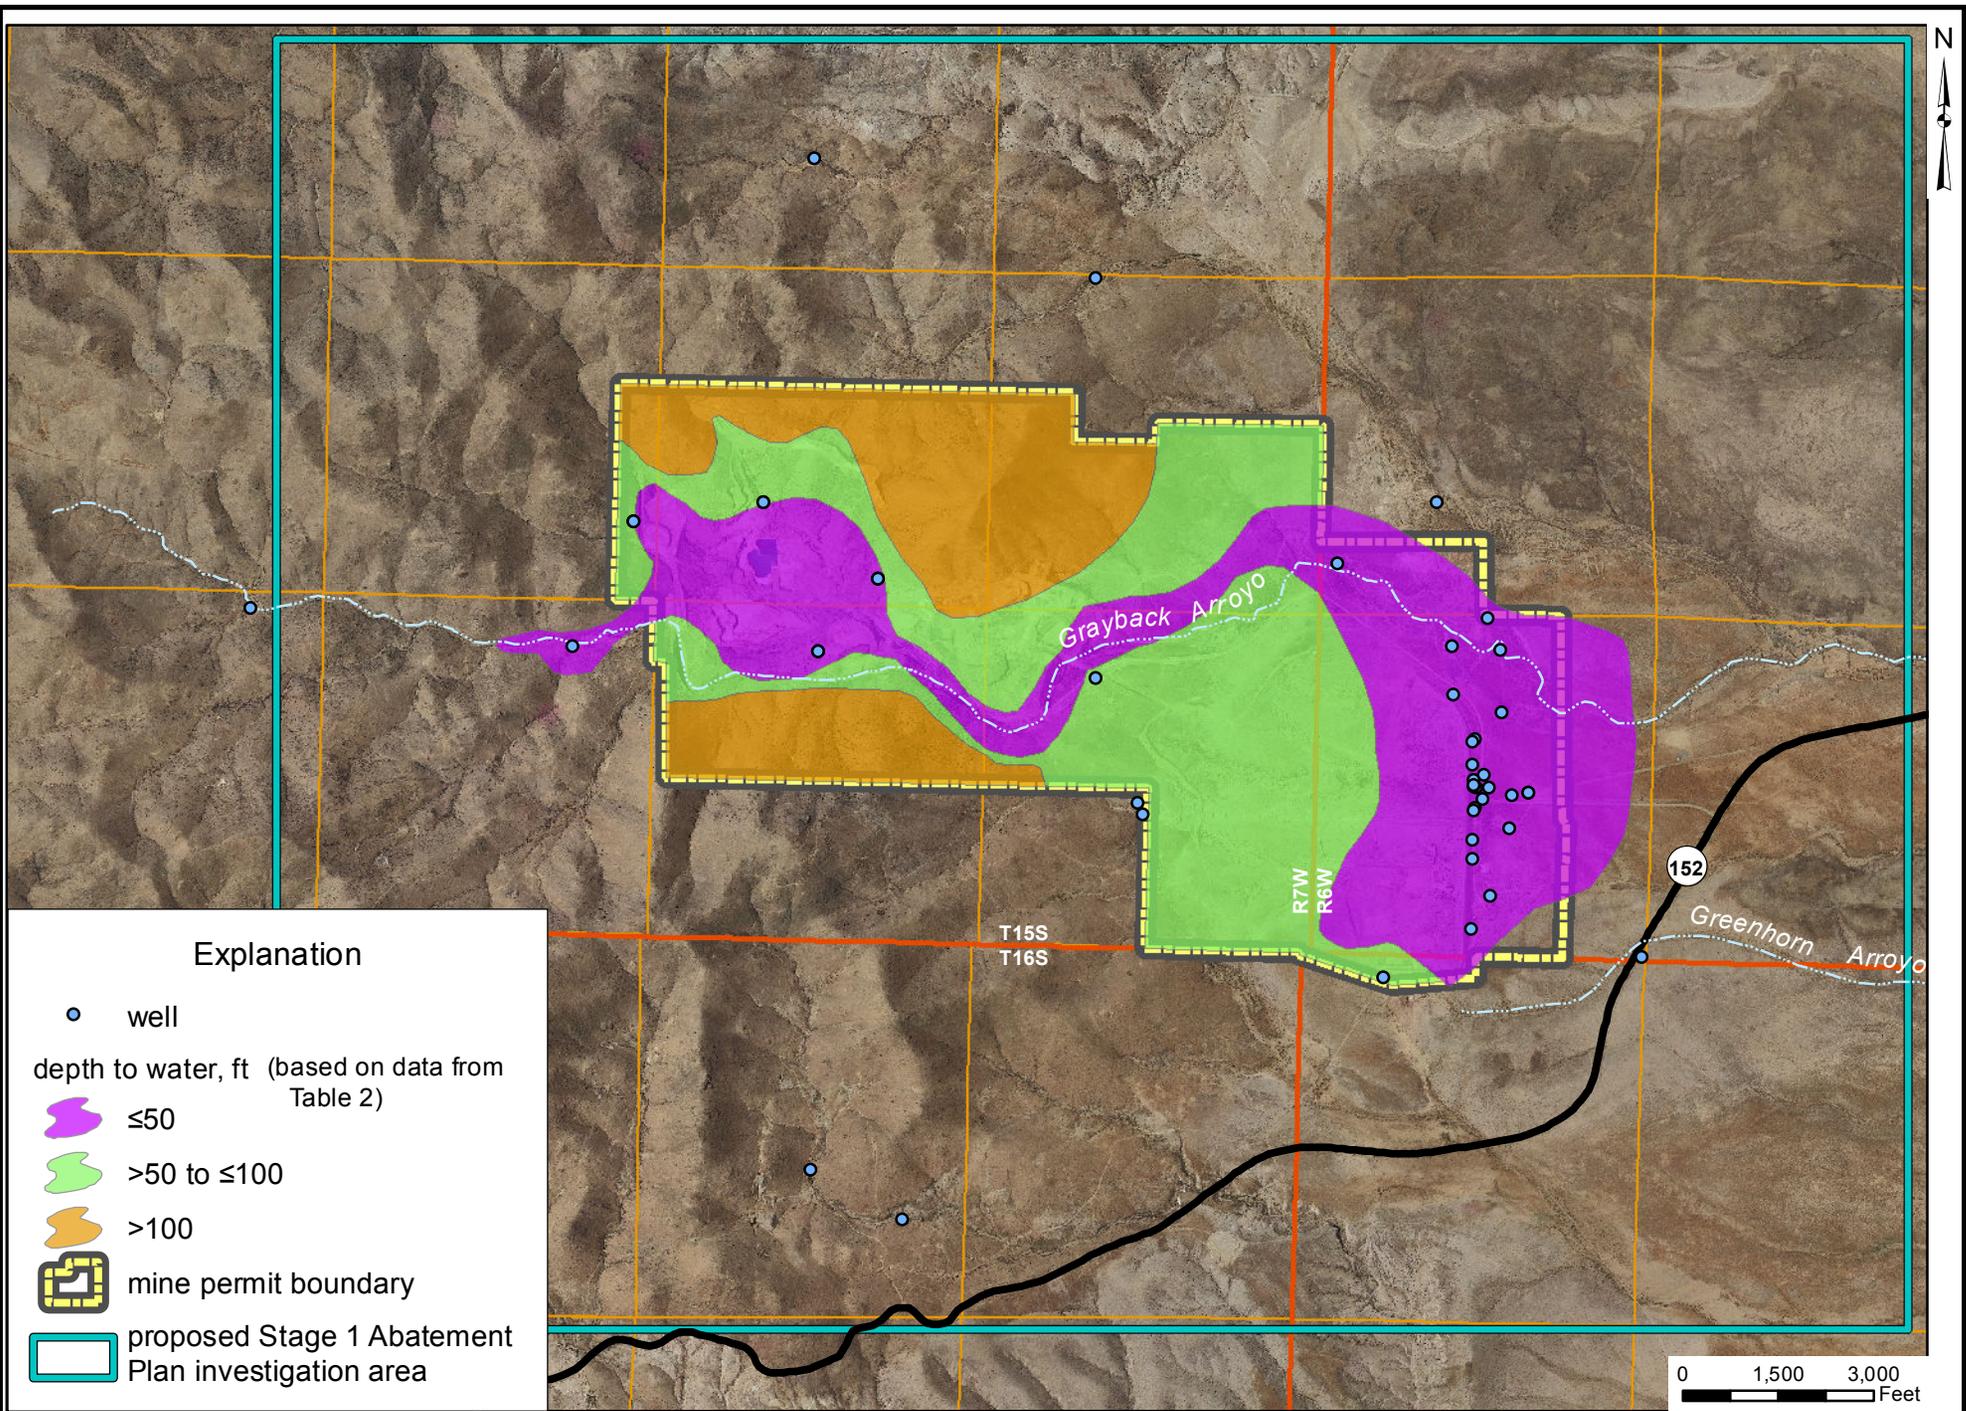
Figure 11. Map showing depth to water in the Copper Flat Mine permit boundary facilities, Sierra County, New Mexico.

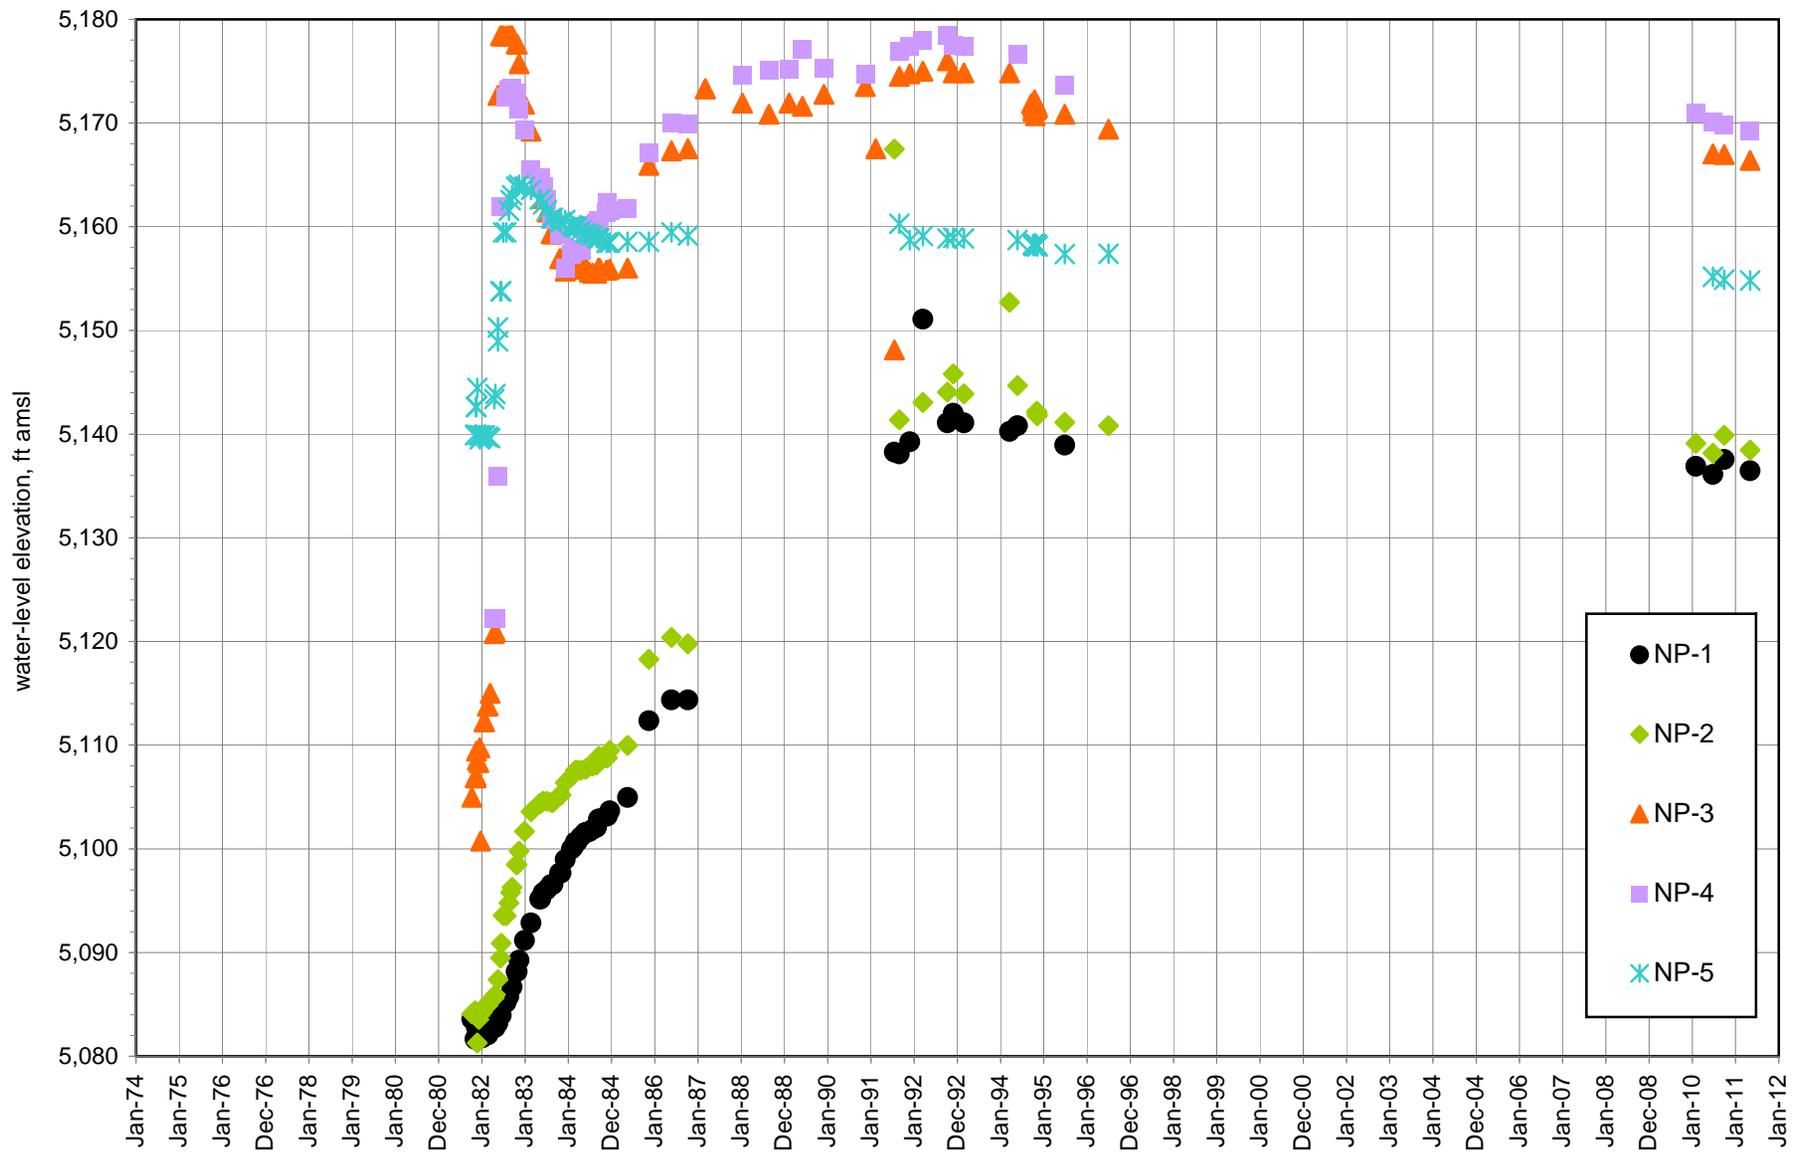
Figure 12. Graph showing historical water levels for monitoring wells NP-1 through NP-5, Copper Flat Mine tailings facility, Sierra County, New Mexico.

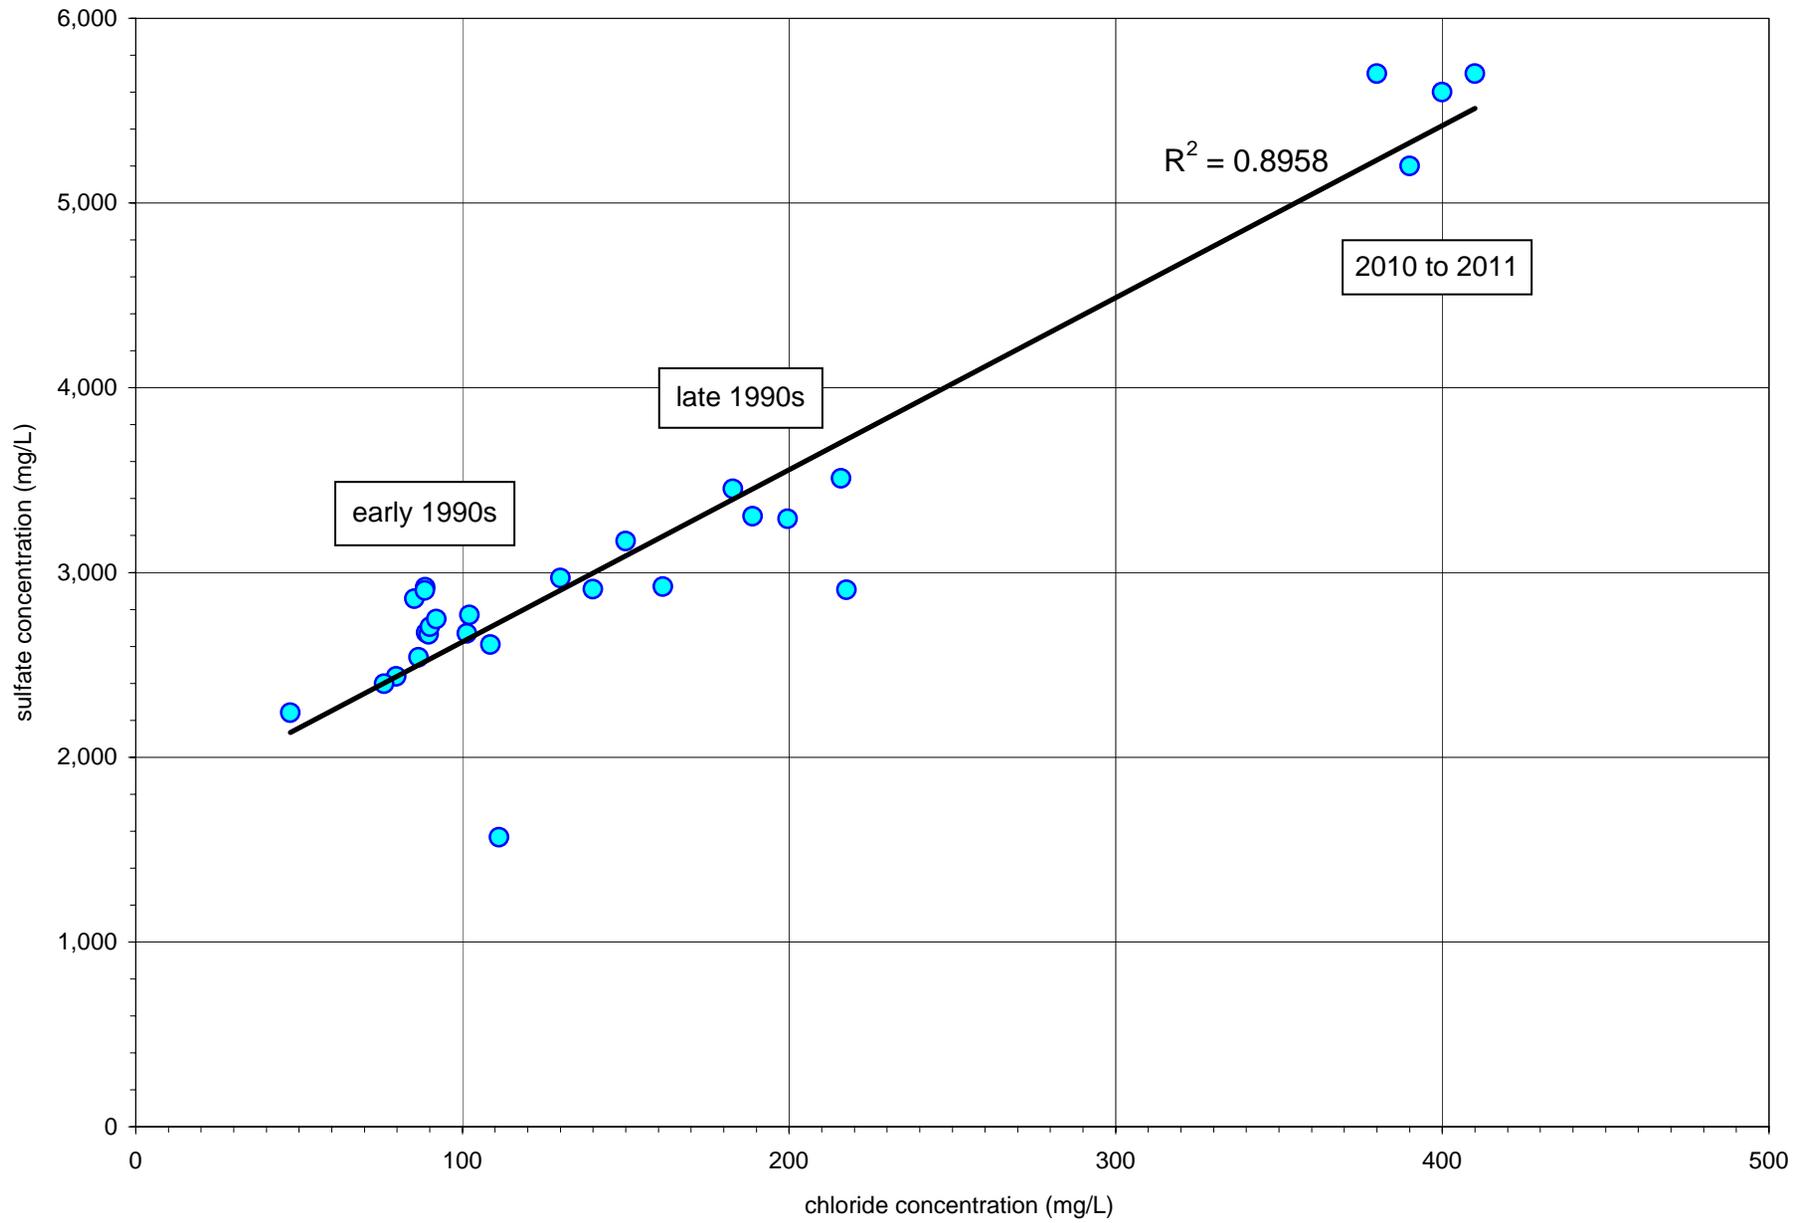
Figure 13. Graph of sulfate versus chloride concentrations for Copper Flat Mine pit lake, Sierra County, New Mexico.

As shown by time-series graphs presented in Raugust (2003) and the Stage 1 Abatement Plan (INTERA, 2011), the sulfate and TDS concentrations in the pit lake have increased since the late 1980s. The increase in pit lake sulfate and TDS concentrations since the early 1990s is due to evaporation instead of pit wall seepage. Figure 13 is a plot of pit lake sulfate and chloride

concentrations. The observed trend between sulfate and chloride increases linearly with respect to time. If the increasing sulfate concentrations were due to pit wall seepage, sulfate concentrations would increase without an increase in chloride (pit wall seepage has low chloride concentration; see Appendix A). Furthermore, if the increase in sulfate concentrations was due to pit wall seepage and evaporation, the trend on Figure 13 would show sulfate concentrations increasing at a rate greater than the chloride concentrations.

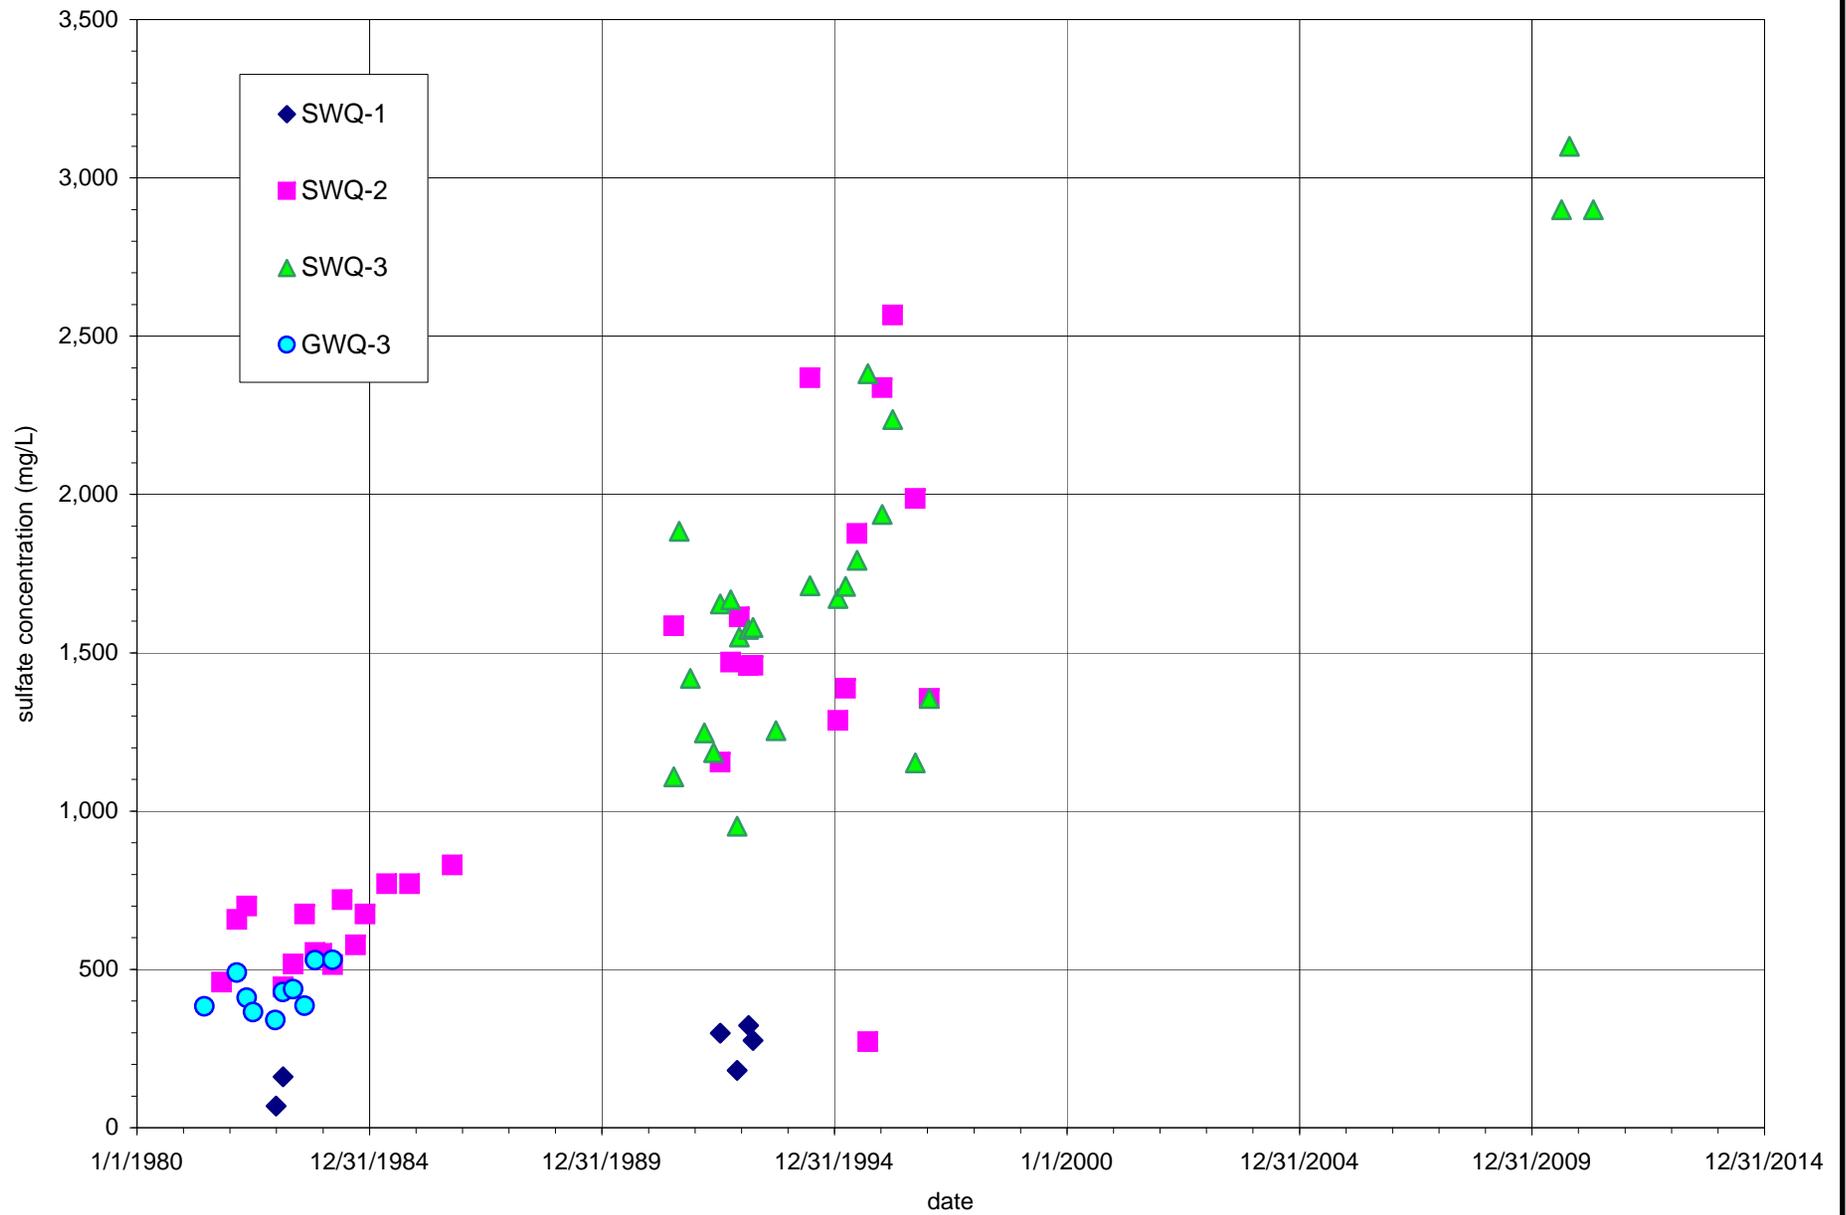
Figure 14. Time-series sulfate concentration plot for SWQ-1, SWQ-2, SWQ-3, and GWQ-3, Copper Flat Mine, Sierra County, New Mexico.

Surface water quality monitoring points SWQ-2 and SWQ-3 have shown increases in sulfate concentration over the last several decades. Figure 14 is a sulfate concentration time-series graph for SWQ-1, SWQ-2, SWQ-3, and GWQ-3. From Figure 14 it appears sulfate concentration has increased over time in Grayback Arroyo surface water downstream of the waste rock piles. However, an increase sulfate concentration is also observed in upgradient monitoring point SWQ-1.

Well GWQ-3 is downstream of SWQ-3 and the waste rock piles, and should be representative of groundwater along Grayback Arroyo. GWQ-3 sulfate concentrations resembled similar values to SWQ-2 in the early 1980s (Fig. 14), but there are no recent data to determine if sulfate concentrations have changed since the 1980s.

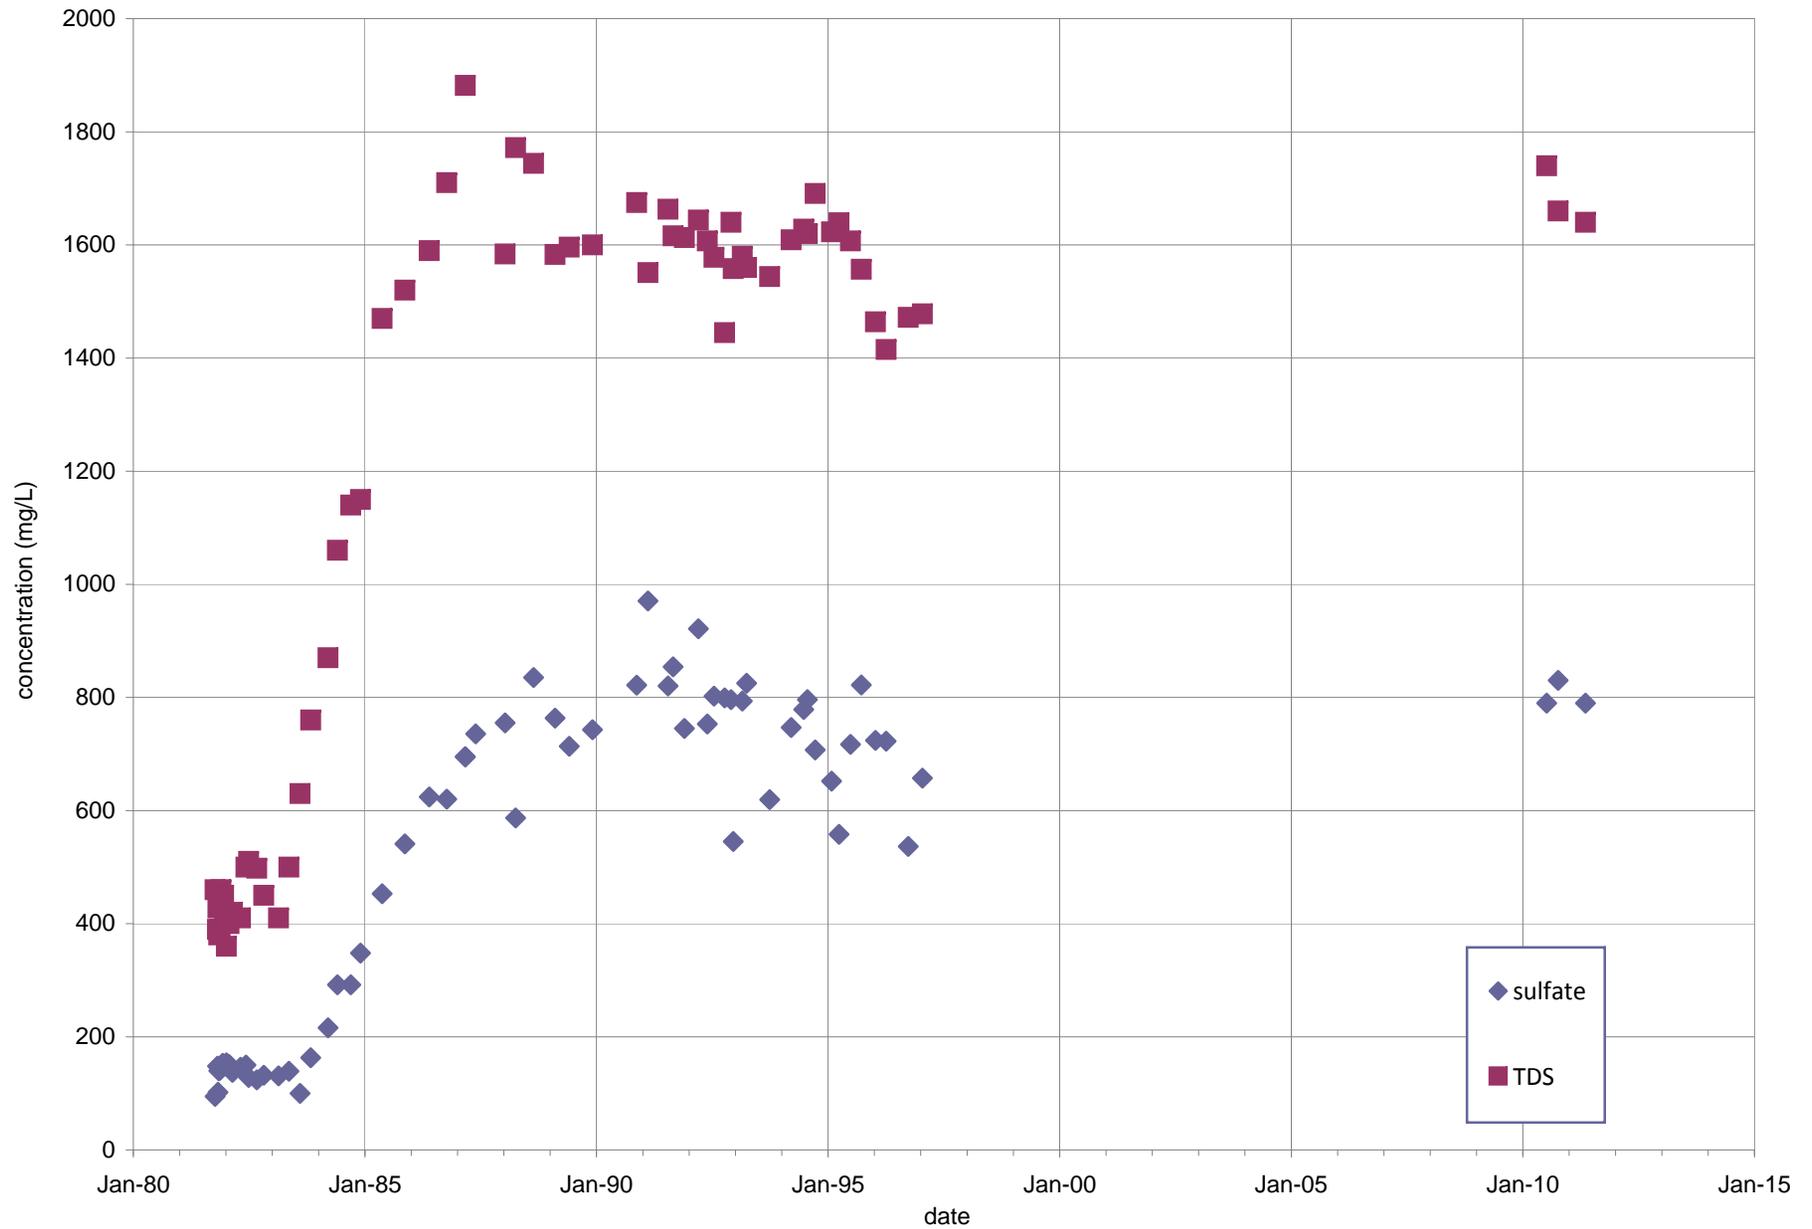
Figure 15. Time-series sulfate and total dissolved solids (TDS) concentrations plot for monitoring well NP-3, Copper Flat Mine tailings impoundment area, Sierra County, New Mexico.

Monitoring well NP-3 is located directly downgradient of the tailings impoundment, and has good historical dataset for evaluating trends. Figure 15 is a sulfate and TDS concentration time-series plot for monitoring well NP-3. After the construction and operation of the tailings impoundment in 1983, sulfate and TDS concentrations increased in NP-3 (Fig. 15). As indicated by the 2010 and 2011 sampling events, sulfate and TDS concentrations have remained fairly constant in NP-3. The groundwater mound created by the tailings impoundment (Fig. 11) shows a similar pattern of stability. The lack of change in depth to water and sulfate concentrations are evidence that the sulfate-rich groundwater mound is relatively stable and has not moved.
