**AMENDMENT TO THE
STAGE I ABATEMENT PLAN PROPOSAL
FOR THE COPPER FLAT MINE**

JOHN SHOMAKER & ASSOCIATES, INC.
Water-Resource and Environmental Consultants
2611 Broadbent Parkway NE
Albuquerque, New Mexico 87107
505-345-3407
www.shomaker.com

New Mexico Copper Corporation
2425 San Pedro Dr. NE, Suite 100
Albuquerque, New Mexico 87110

October 14, 2011

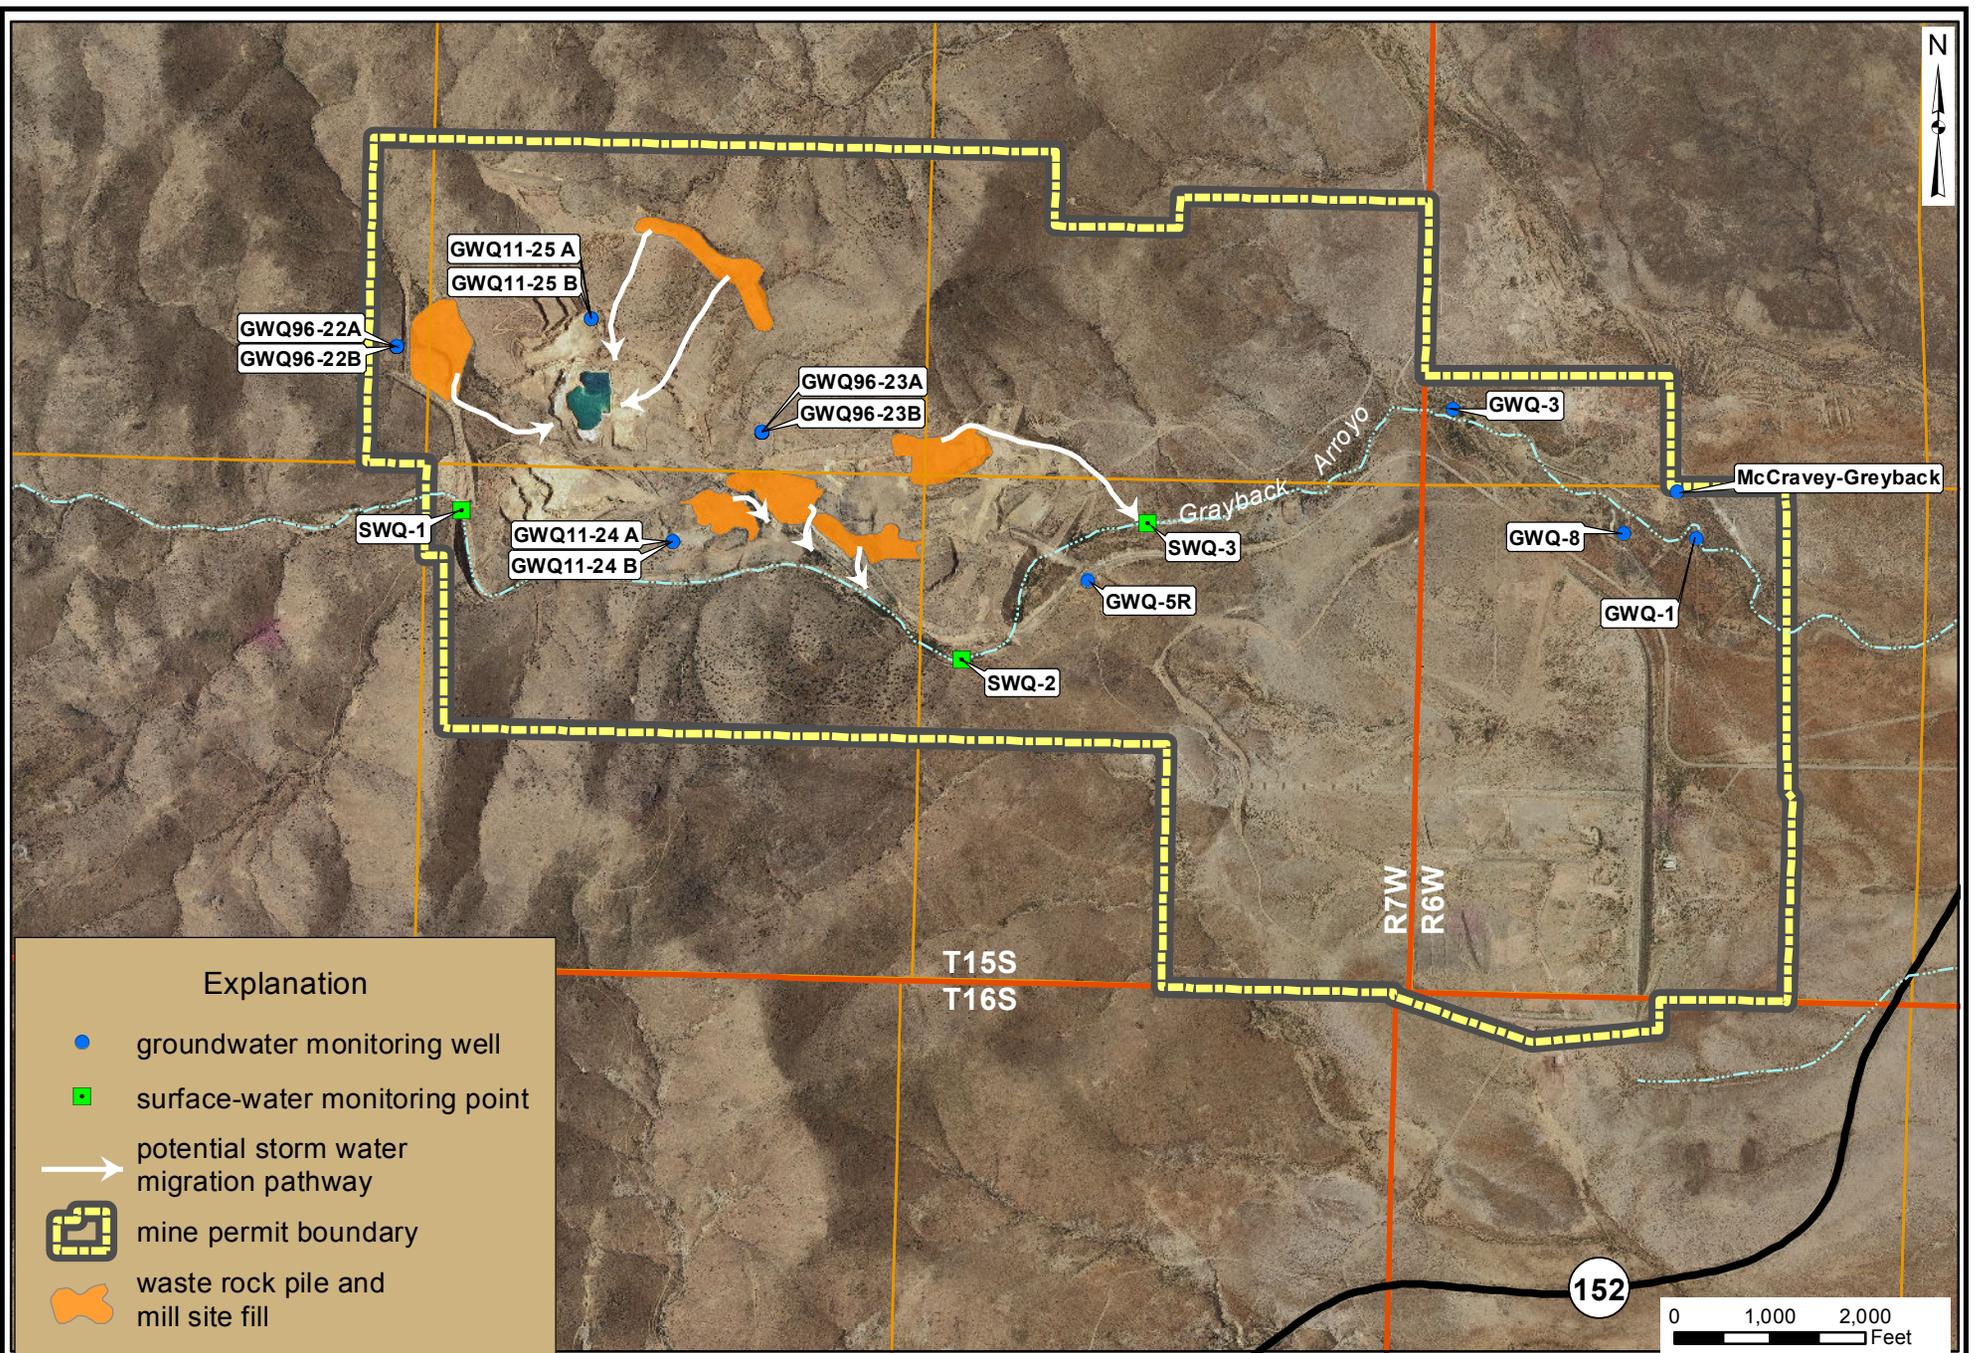
Figure 16. Map showing locations of waste-rock piles, surface-water and groundwater monitoring points, and potential waste-rock leachate migration pathways, Copper Flat Mine, Sierra County, New Mexico.

Discharges to groundwater from potential waste rock pile leachate would occur via storm-water runoff. Figure 16 shows the current potential storm-water runoff and migration pathways for each waste rock pile and mill site fill. The pit footprint will capture runoff from nearby waste rock piles to the north and northwest, and Grayback Arroyo will receive runoff from the waste rock piles east of the pit capture area. GWQ-3 is located in Grayback Arroyo, and is the best location downstream of the waste rock pile for detecting discharges to groundwater from the waste rock piles. All of the available data from GWQ-3 were collected in the 1980s, and additional data are needed to determine if groundwater-quality conditions have changed. For future mining operations, the surface runoff from the waste rock piles will be controlled as shown in the Mine Plan of Operations submitted to the Bureau of Land Management (BLM) in June 2011 and currently under review by the NMED.

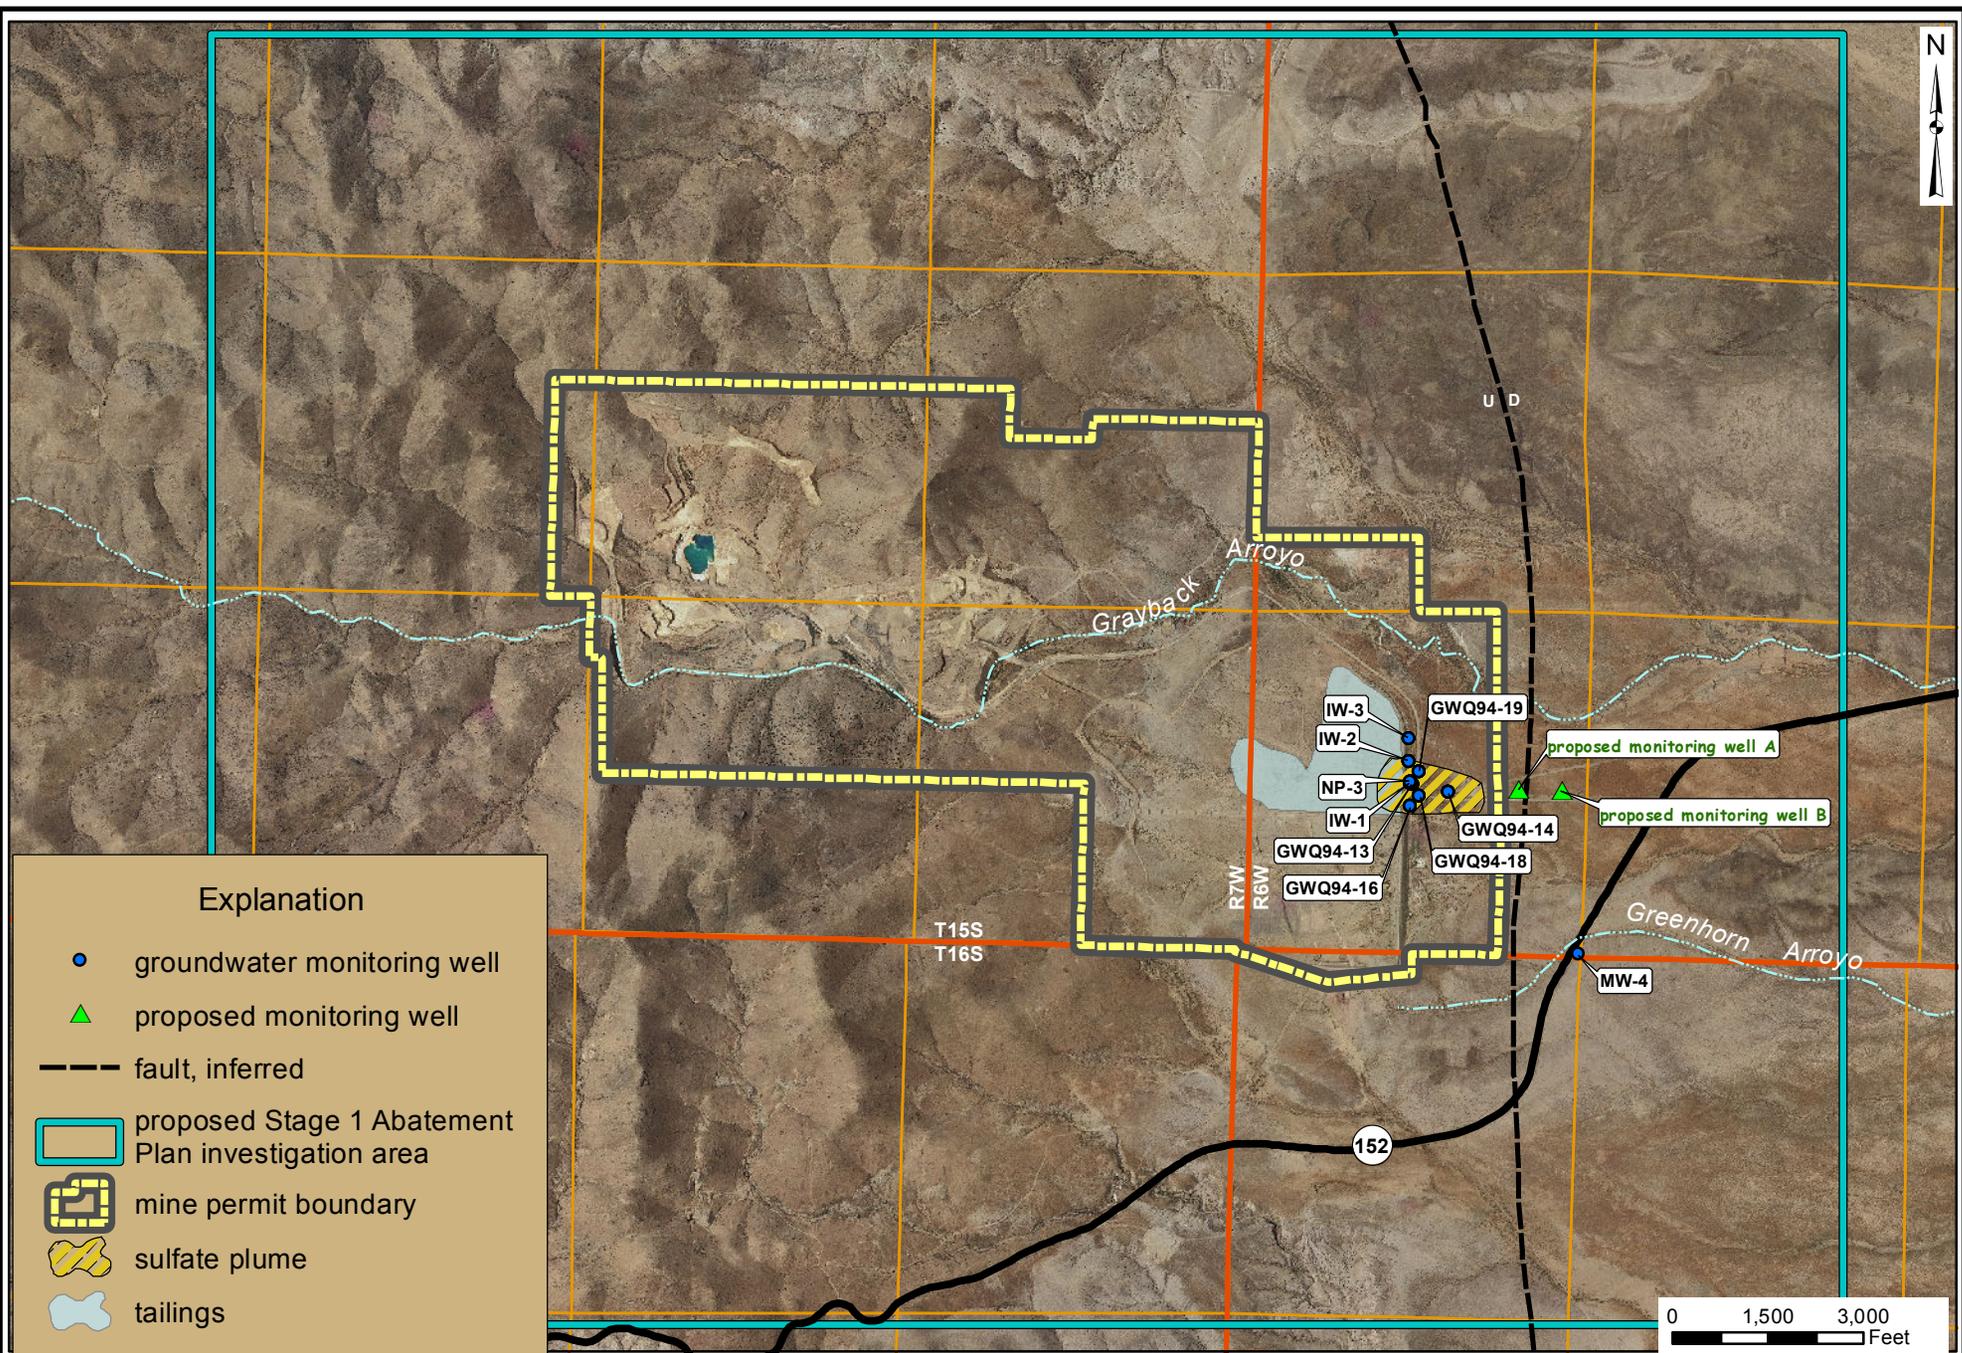
Figure 17. Map showing lateral extent of sulfate plume associated with Copper Flat Mine tailings impoundment facility and proposed monitoring wells, Sierra County, New Mexico.

Proposed investigation for the tailings impoundment facility includes the drilling of one or two monitoring wells downgradient of the known extent of the sulfate plume. Downgradient monitoring wells GWQ94-14 and GWQ94-21 are too deep to assess the lateral extent of the sulfate plume (Fig. 7). Proposed monitoring well locations are shown on Figures 7 and 17; the actual locations may depend on land ownership and access, and may slightly vary from the proposed location.

There are numerous monitoring wells in the vicinity of the tailings impoundment, and many of these are no longer needed for characterization and investigation of the sulfate plume. The proposed sampling plan for the tailings impoundment investigation includes the wells and parameters listed in Table 9. Several of the wells listed in Table 9 are currently dry, but data would be needed from these points if water were present. Access to MW-4 will depend on permitting from the land owner, and drilling, construction, and data collection from proposed monitoring well B is dependent on what is found at proposed monitoring well A.

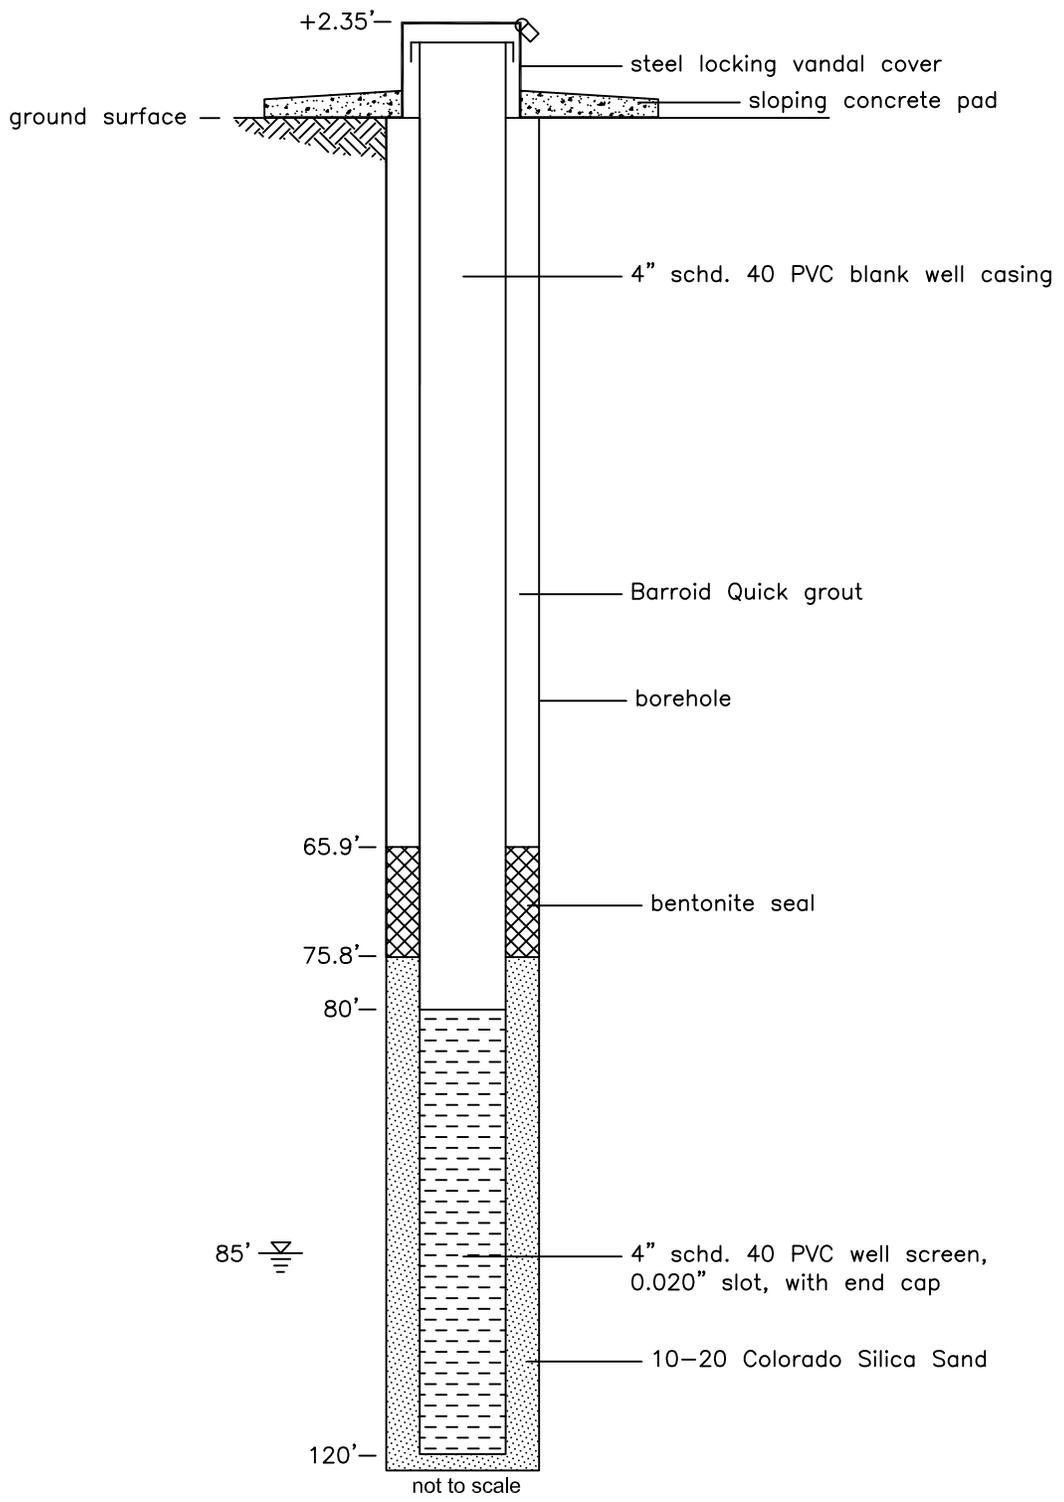
Well completion diagram for replacement monitoring well GWQ-5R.
 LRG-15080 POD 3, completed September 1, 2011.

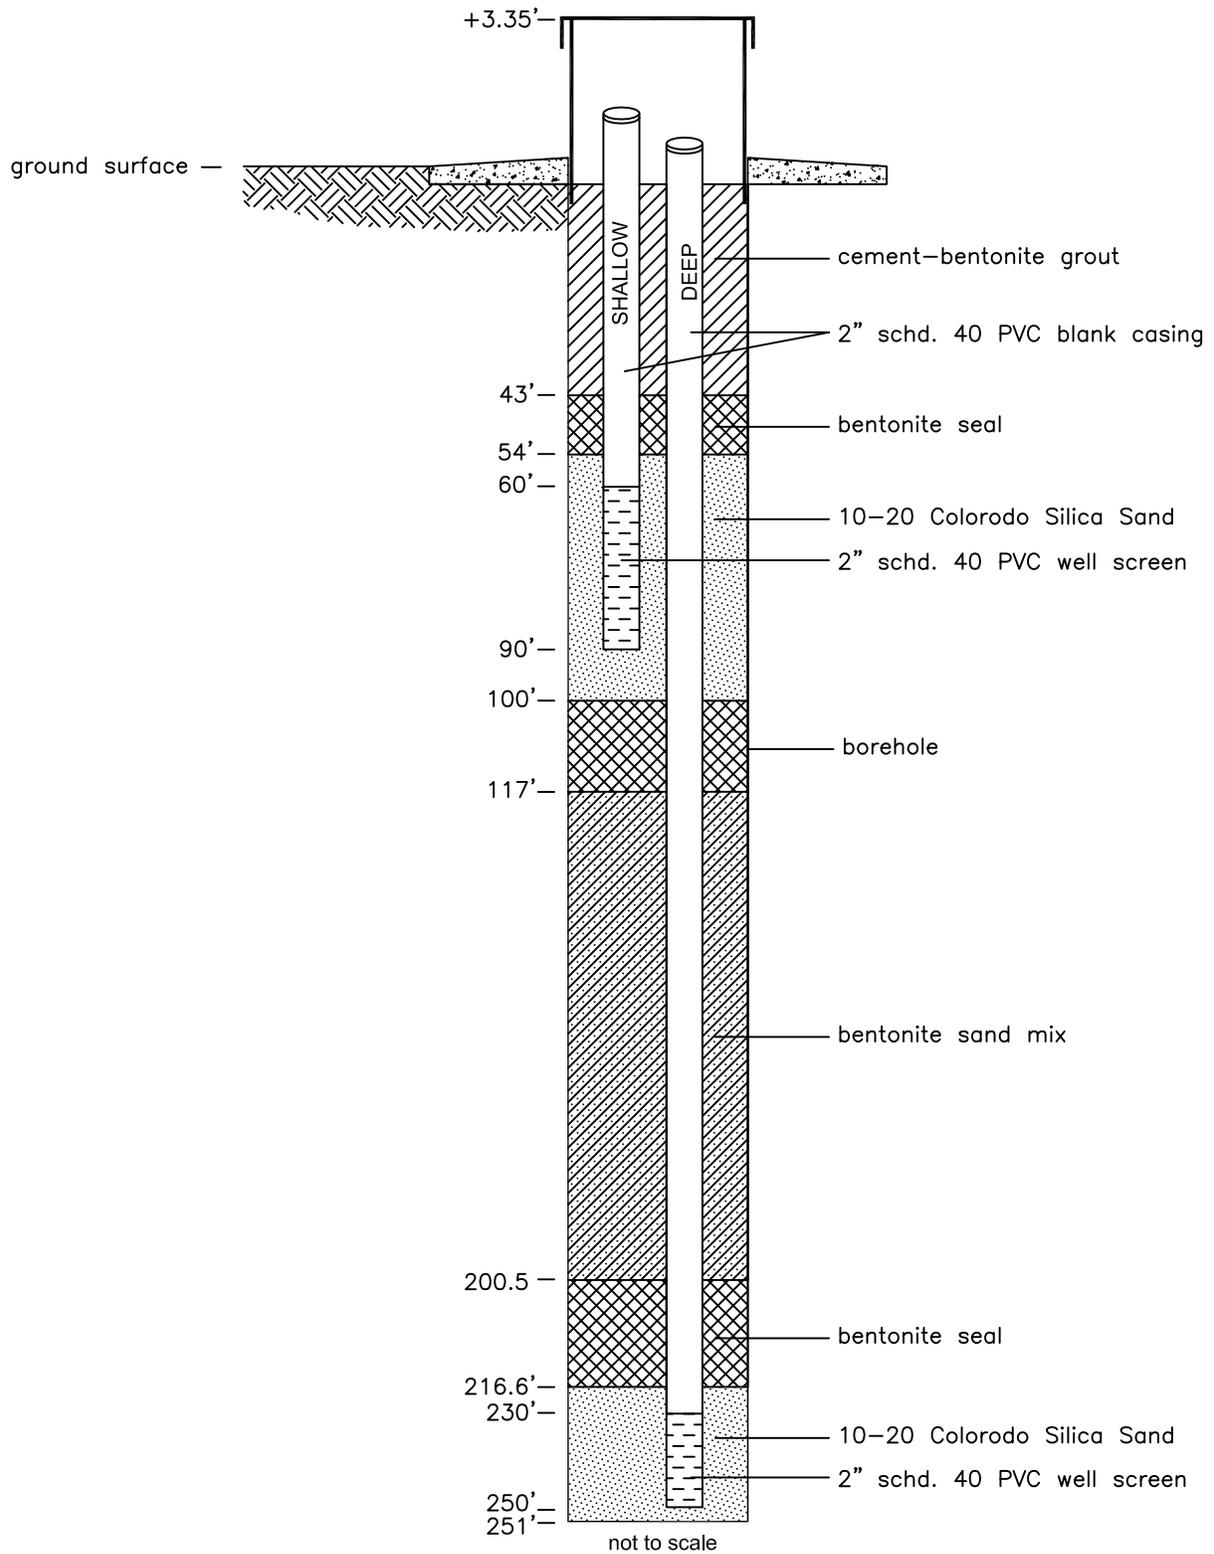
Well completion diagram of nested piezometer GWQ11-24.
 LRG-15080 POD 1, completed August 5, 2011.

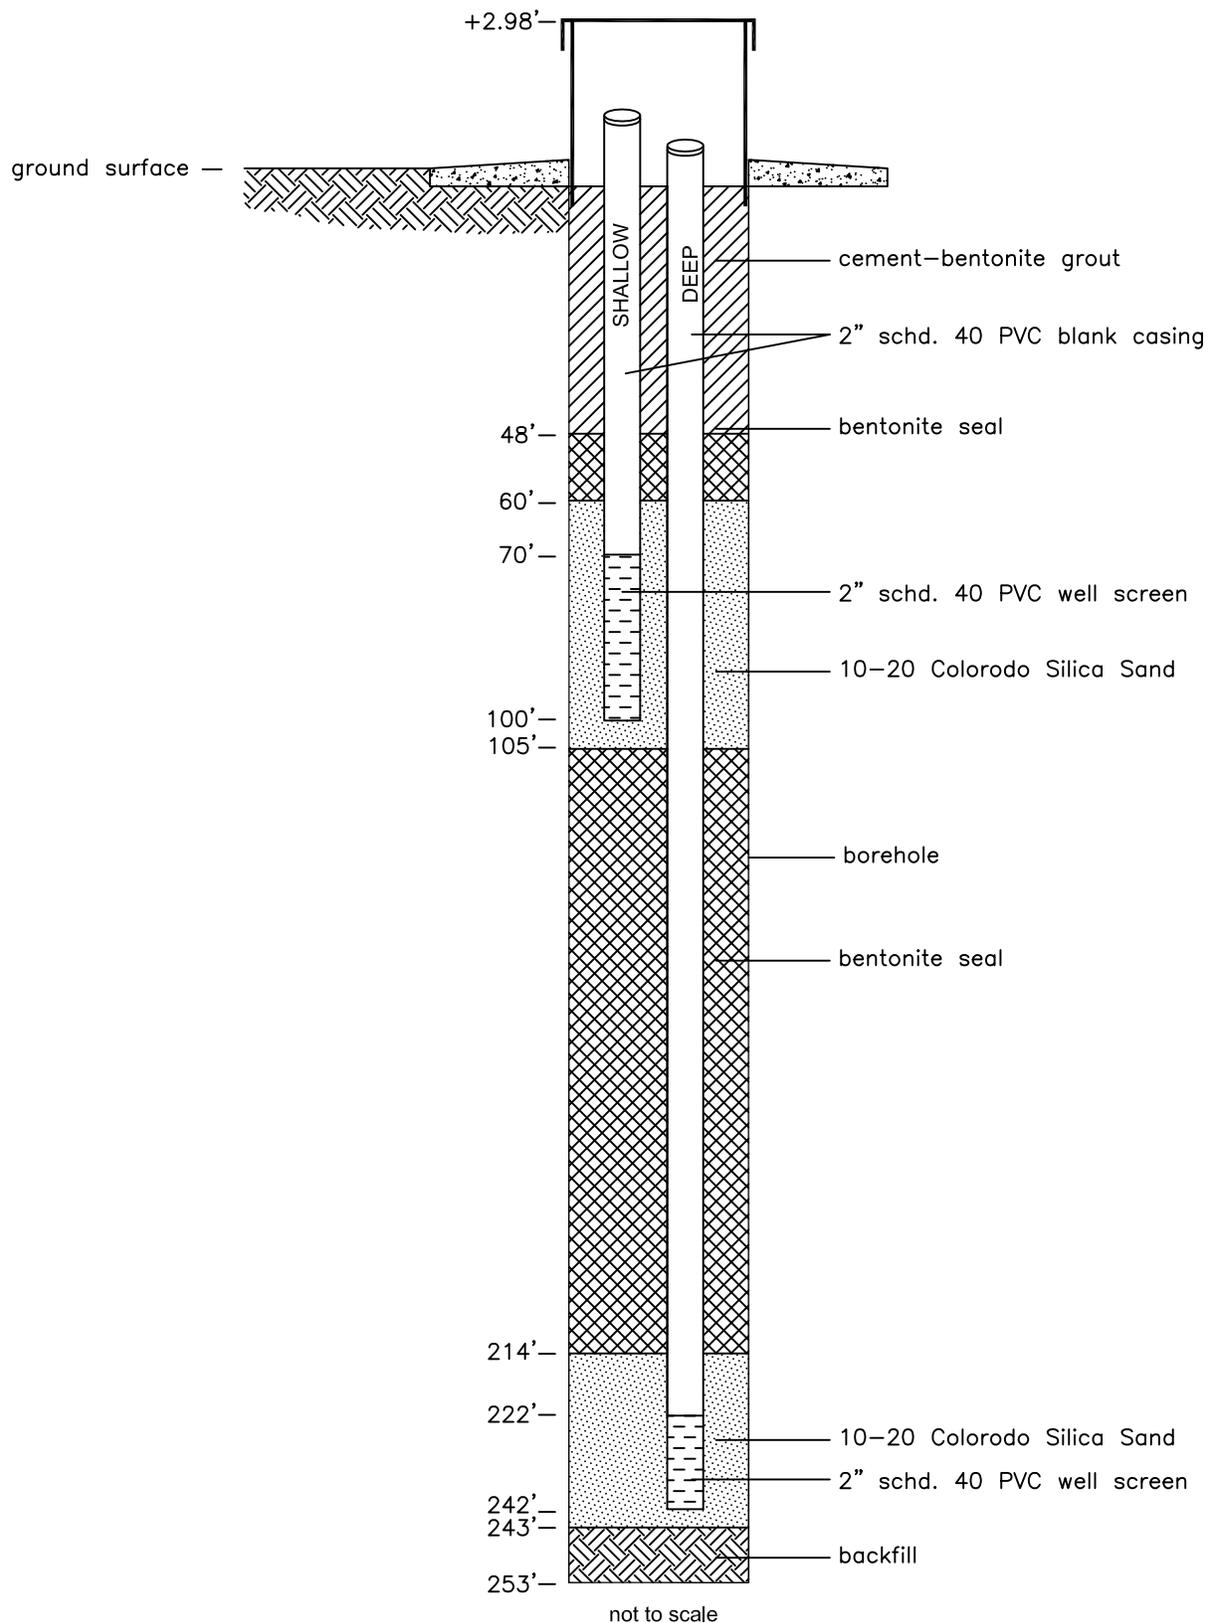
Well completion diagram of nested piezometer GWQ11-25.
 LRG-15080 POD 2, completed August 28, 2011.
