RE: BENZENE PLUME DELINEATION, CONTINGENCY SET-ASIDE FOR SOIL BORINGS, AND INJECTION TARGET DEPTH DETERMINATION SANTA FE COUNTY JUDICIAL COMPLEX, SANTA FE, NEW MEXICO CONTRACT #19-667-3200-0007 FACILITY #: 53763 RELEASE ID #: 4597 WPID #: 4072

EA Engineering, Science, and Technology, Inc., PBC (EA) is submitting this letter report documenting completion of field activities associated with benzene plume delineation (Deliverable ID 4072-4), contingency set-aside for soil borings (Deliverable ID 4072-5), and injection target depth determination (Deliverable ID 4072-13) for the Santa Fe County Judicial Complex (SFCJC) State Lead Site (the site) located at 327 Montezuma Avenue in Santa Fe, New Mexico (Figure 1). Field notes documenting activities completed for the above tasks are included in Attachment 1; photographic documentation of project activities is included in Attachment 2. Details and results of each of the three tasks are discussed below.

ATTACHMENT 2 PHOTOGRAPHIC DOCUMENTATION

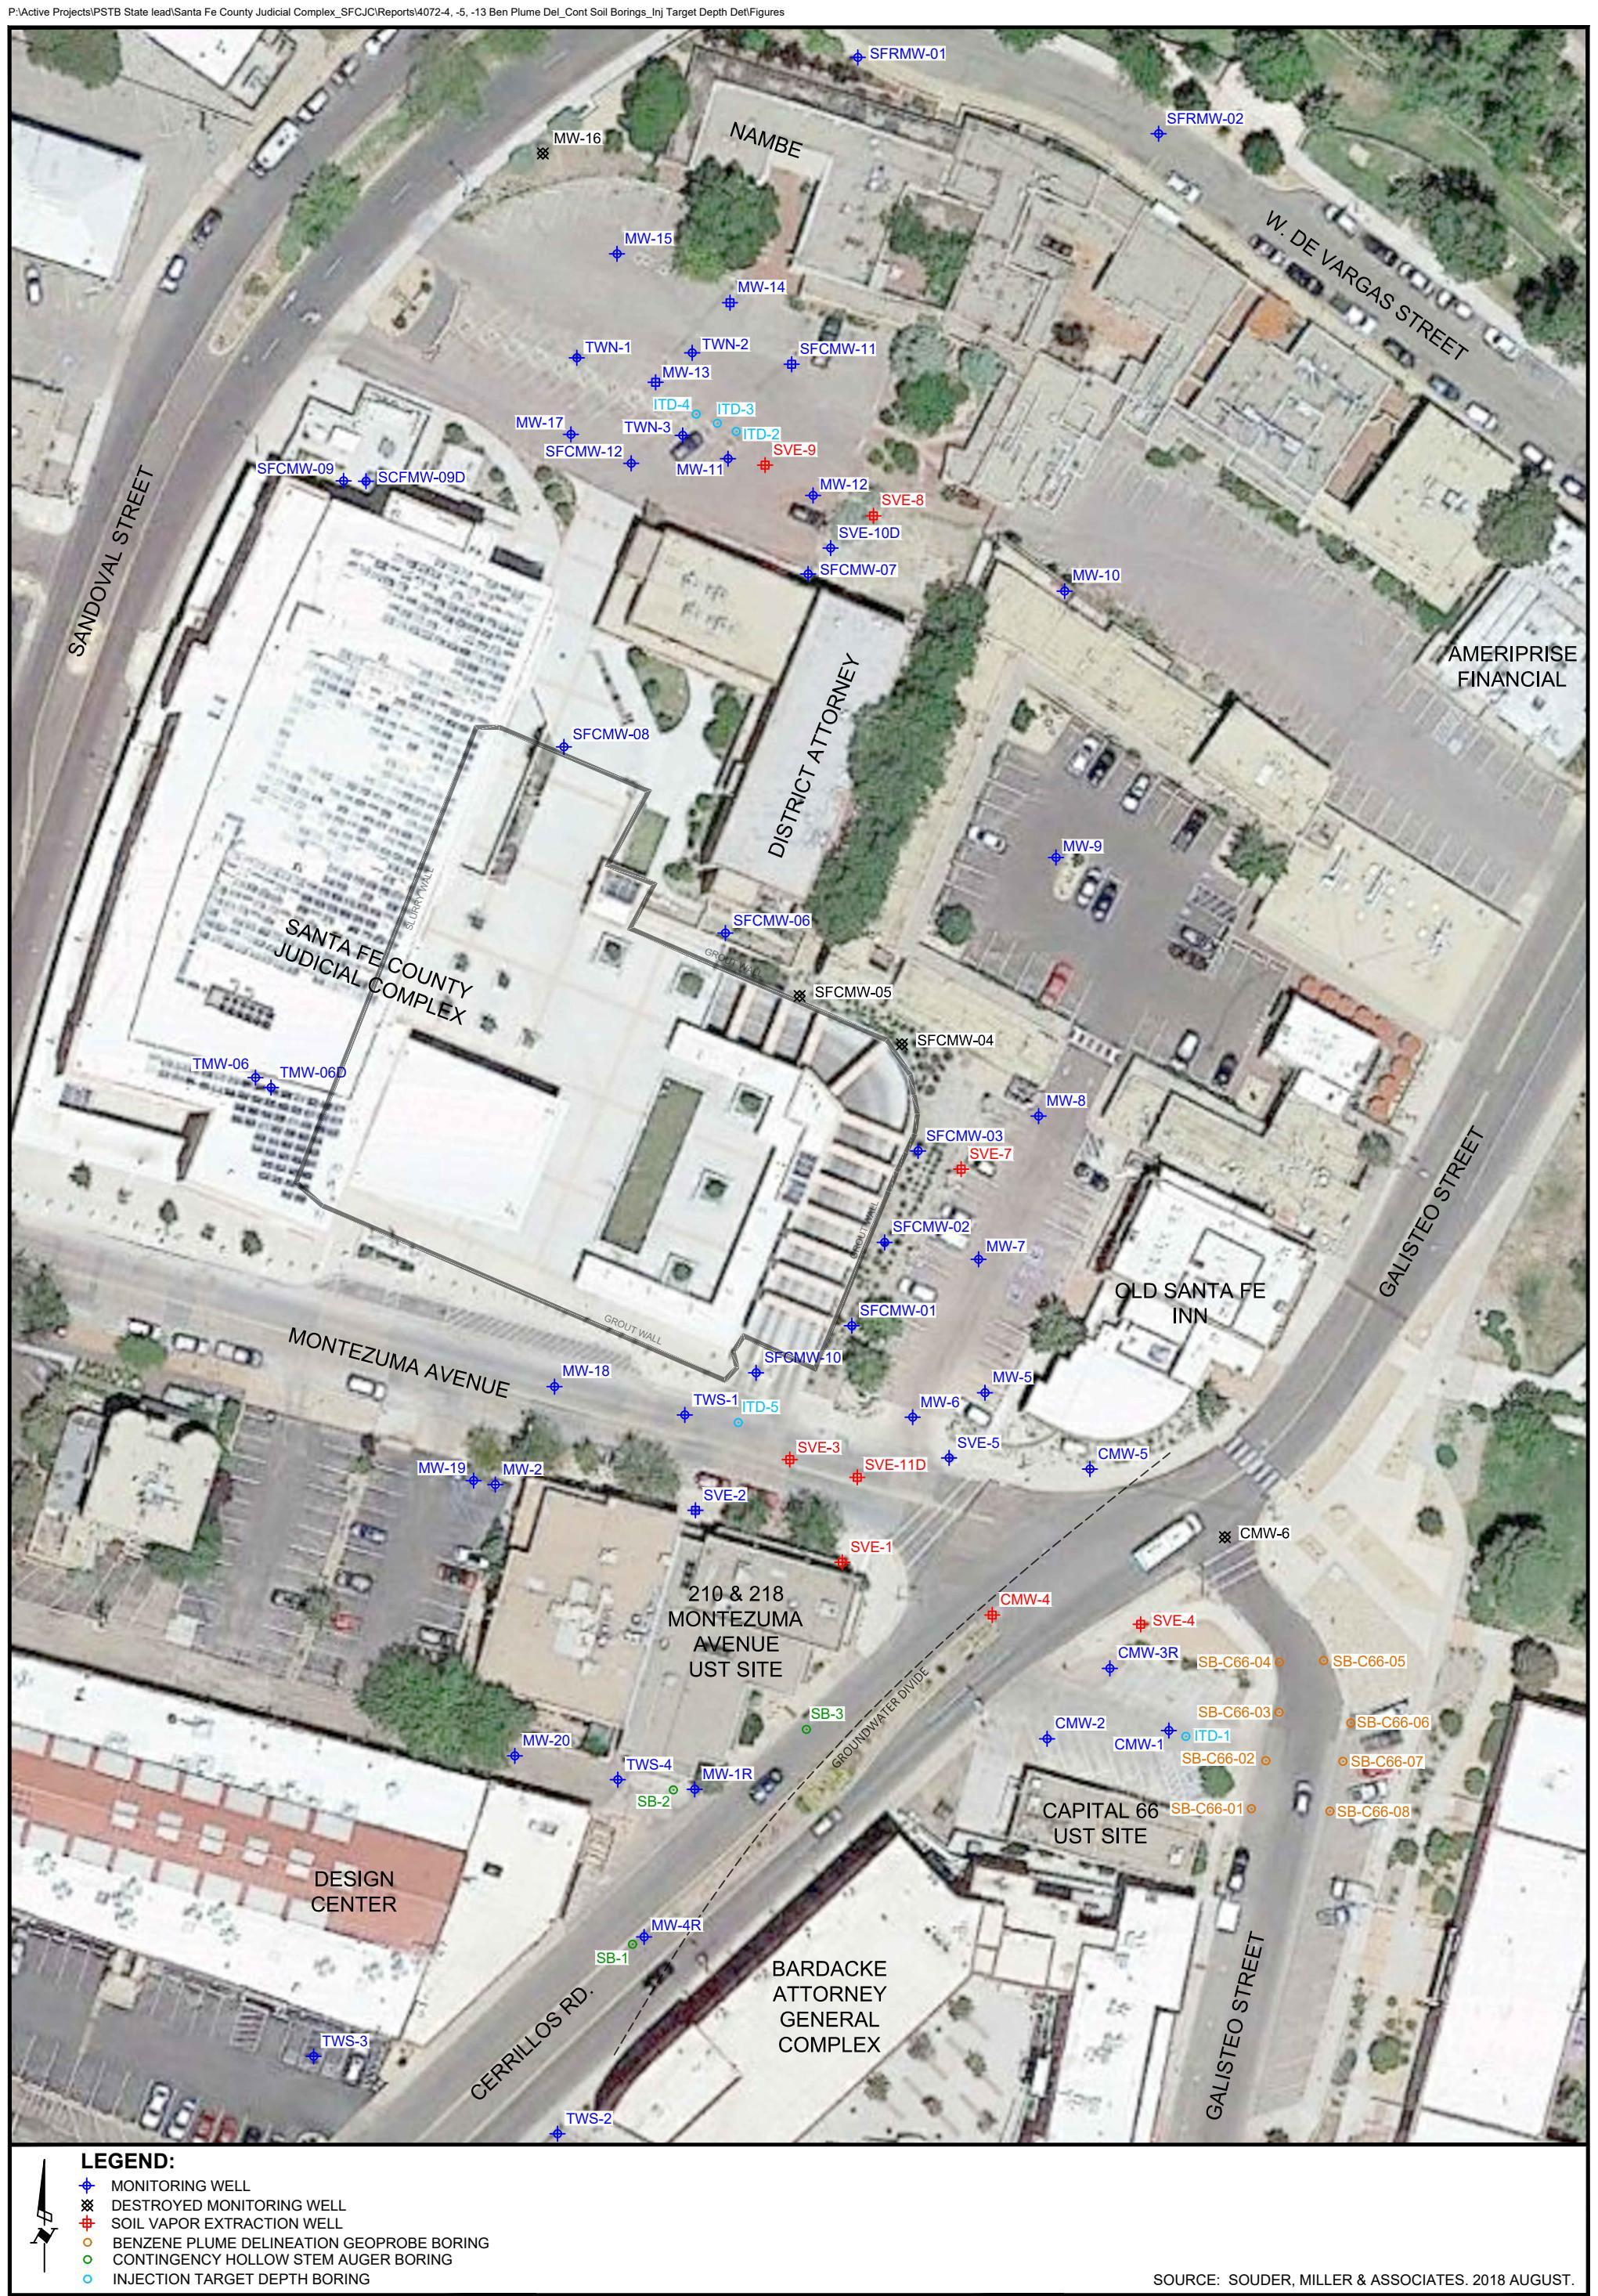
SANTA FE COUNTY JUDICIAL COMPLEX	PROJECT #: WORK PLAN PROJECT PHASE: 05 PROJECT MANAGER: MM
60 30 0 60	SANTA FE, NEW MEXICO	320 Gold Avenue, SW Suite 1300 Albuquerque, NM 87102
	FIGURE 2	Phone: (505) 224-9013
SCALE IN FEET	SOIL BORING LOCATIONS	EA ENGINEERING, SCIENCE, AND TECHNOLOGY, INC. PBC

A track-mounted, Geoprobe[®] 8040DT was used to advance 2.25-inch drive rod to approximately five feet below the water table at eight locations, designated SB-C66-01 through SB-C66-08 (Figure 2). In each of the soil borings, a 1.5-inch, Schedule 40 (SCH 40) polyvinyl-chloride (PVC) casing, with a 5-foot 0.010-inch-slot screen section, was temporarily installed in the soil boring to collect a grab groundwater sample for laboratory analysis. Groundwater samples were collected in each boring through ¼-inch poly tubing fitted with an inertial valve at the bottom. New tubing and inertial valves were used to collect samples from each boring. The groundwater was filtered with a 0.45-micron filter prior to being placed into laboratory-provided sample containers. The samples were collected so that no headspace was present in the sample vials.

From March 17 through 22, 2020, EA and Cascade advanced three soil borings in the Design Center plume area between the Design Center and the Attorney General building to determine the treatment zone thickness. Soil boring SB-1 was installed in Cerrillos Road adjacent to monitoring well MW-4R, soil boring SB-2 was installed in the alley adjacent to monitoring well MW-1R, and soil boring SB-3 was installed in the southbound lane of Cerrillos Road about 15 feet east of previously installed soil boring SB-1 (Figure 2).

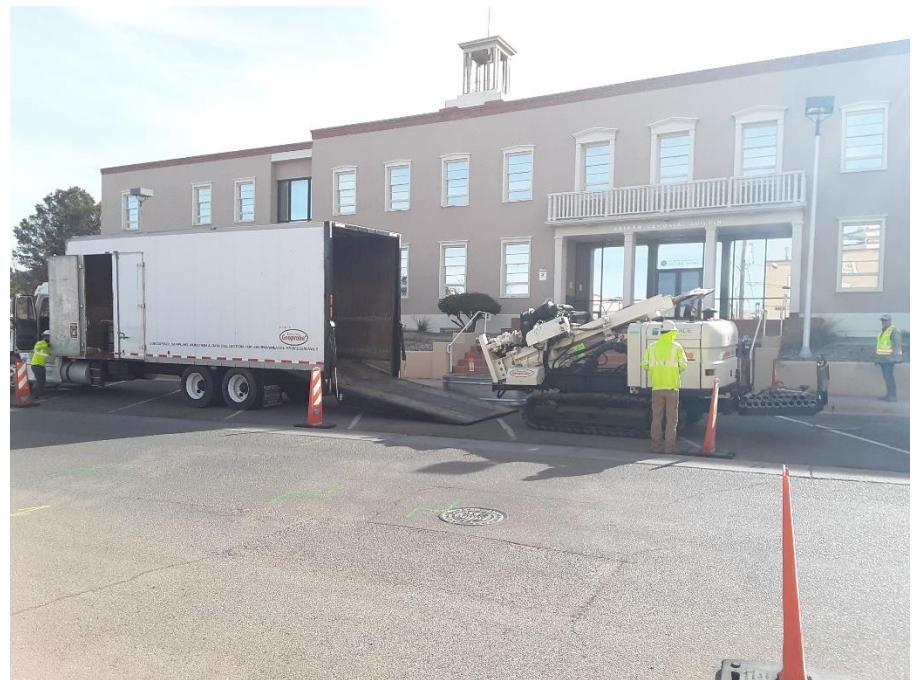
Photo 1: Cascade drilling crew unloading the Geoprobe 8040DT. Date: March 11, 2020

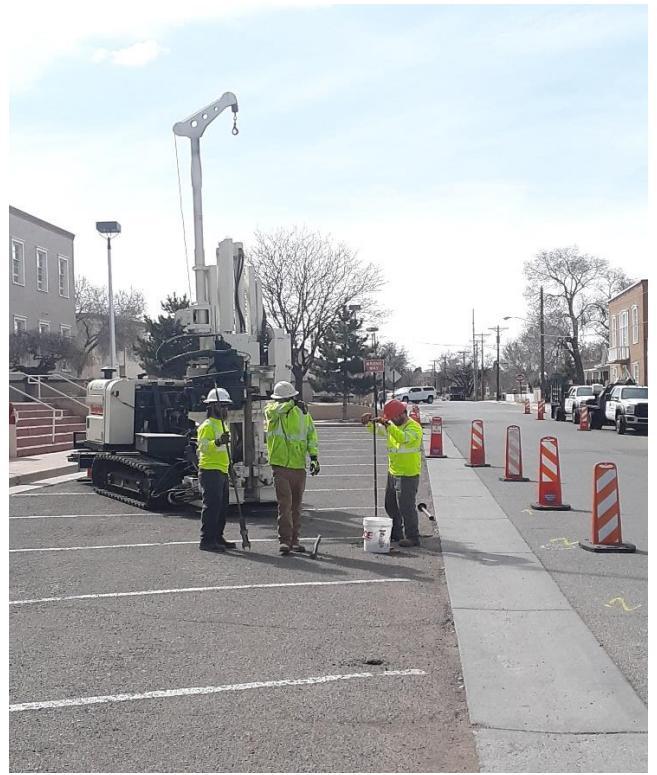
Photo 2: Potholing to confirm underground utility clearance prior to drilling. Date: March 11, 2020

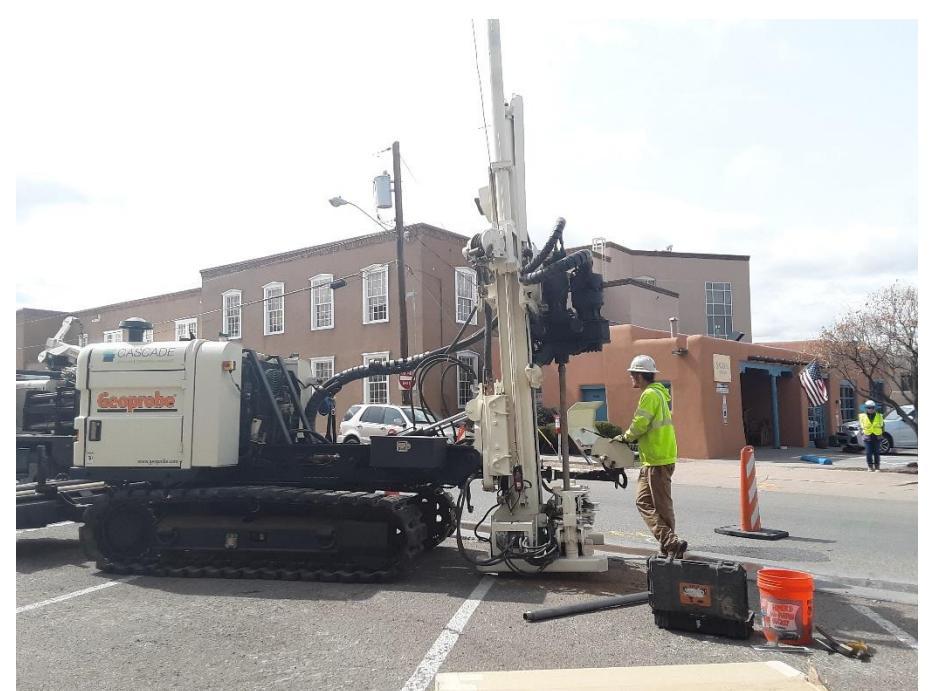
Photo 3: Advancing soil boring SB-C66-08 using direct-push technology for groundwater sampling. Date: March 11, 2020 Direct

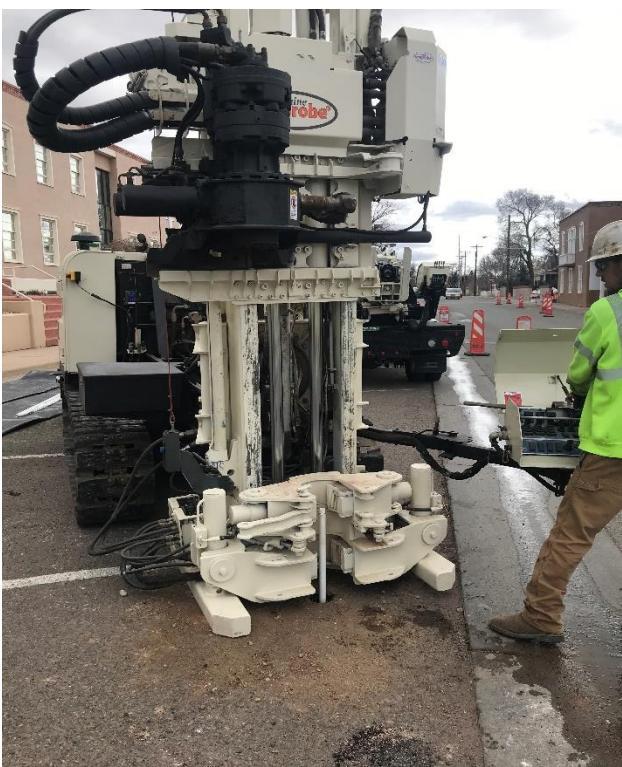
Photo 4: Installing temporary 1.5-inch PVC well in SB-C66-08 for groundwater sampling. Date: March 11, 2020 Direction: S

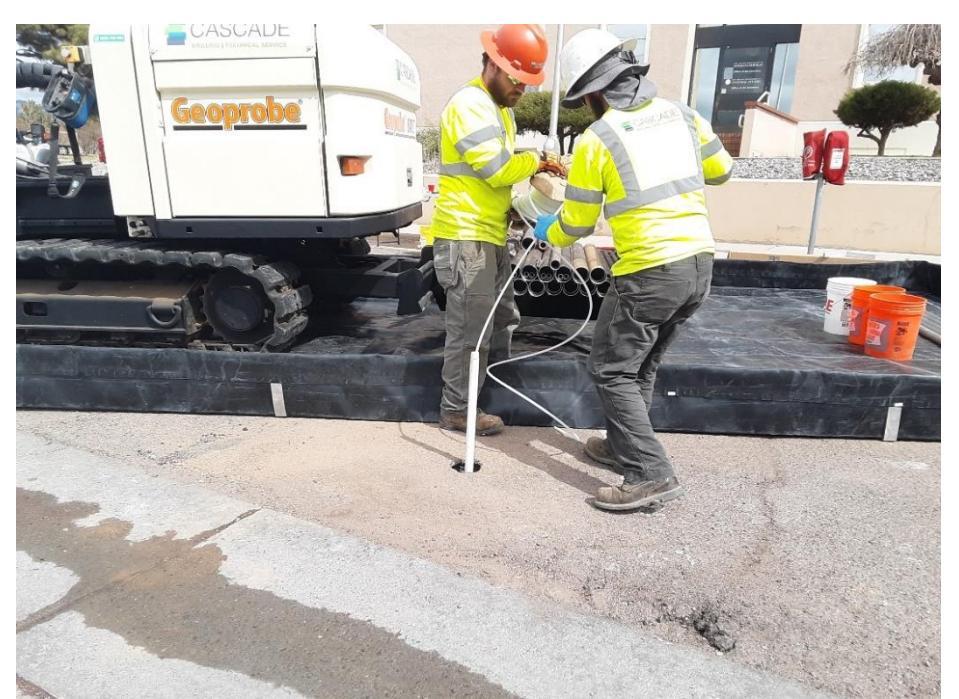
Photo 5: Installing poly tubing for groundwater sampling in temporary 1.5-inch PVC well set in SB-C66-08. Date: March 11, 2020

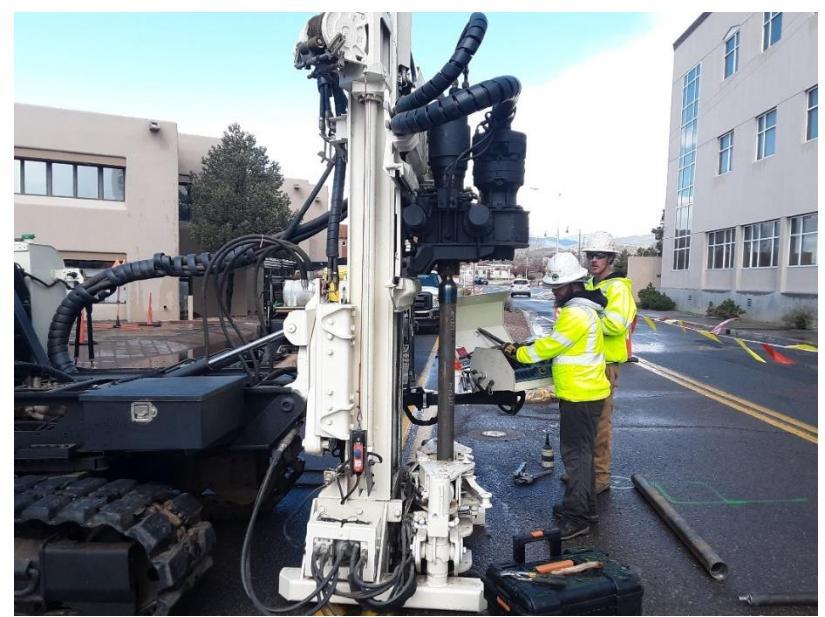
Photo 7: Attempting to advance contingency soil boring SB-1 using direct-push technology in Cerrillos Road adjacent to monitoring well MW-4R for treatment zone thickness determination. Date: March 14, 2020 Direction: N

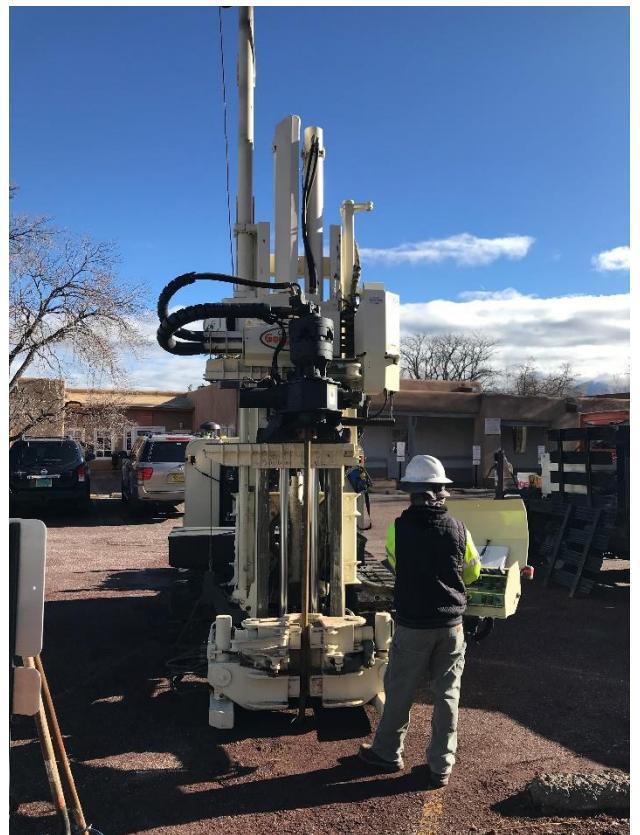
Photo 8: Attempting to advance soil boring to 45 ft bgs using direct-push technology in 200 W. De Vargas parking lot for injection depth determination. Date: March 15, 2020 Direc

In the De Vargas plume area, Cascade first attempted to drive the injection rods with the Geoprobe[®] 8040DT to the target depth of 45 ft bgs using direct push technology alone to determine if the subsurface lithology in a different area of the site would allow the rods to be driven to depth. The result was similar to the Capital 66 plume area, with the injection rods only being advanced to a total depth of 38 ft bgs before becoming wedged in the boring. Cascade believed that borehole friction due to flowing sands below the water table was preventing the rig from being able to drive the injection rods to the desired depth. Cascade stated that the rig had plenty of power to push the rods to between 36 and 38 ft bgs but getting the rods back out of the

ground afterwards was the problem. This issue caused numerous delays. For example, because of the pull-back force, the asphalt in the De Vargas parking lot was damaged and had to repaired. The Geoprobe foot caused a one to two feet deep indentation in the asphalt and underlying soil while trying to pull the rods out of the ground.

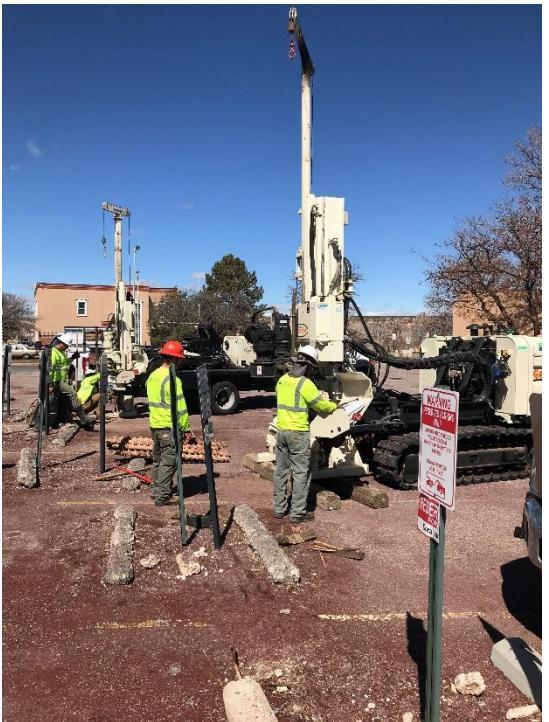
Photo 9: Trying different drilling rigs and tooling configurations to advance soil borings to 45 ft bgs in 200 W. De Vargas parking lot for injection depth determination. Date: March 15, 2020 Direction: W

During the two days in the De Vargas plume area, Cascade attempted various tooling options in several borings to reach the injection target depth. This was a good exercise because it allowed Cascade to get a good feel for the drilling conditions and tooling options that will be required during full-scale injection. Cascade determined that a combination of 3.25-inch solid stem augers and direct push could reach the desired injection depths in a reasonable timeframe.

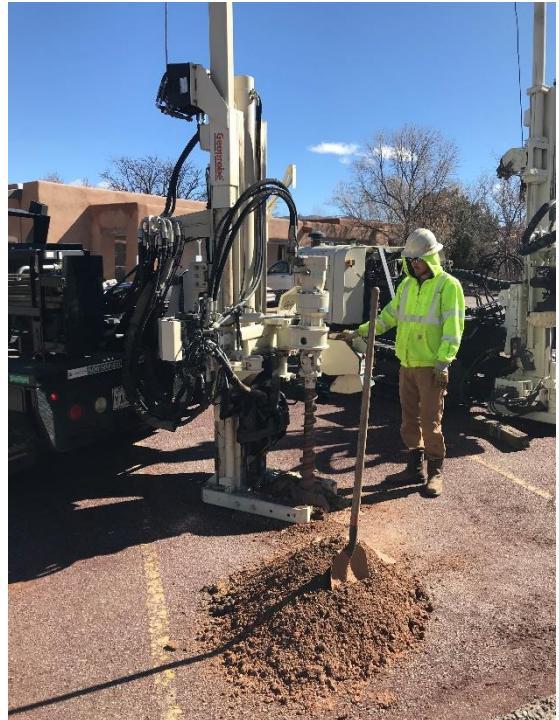
Photo 10: Advancing soil boring to 45 ft bgs in 200 W. De Vargas parking lot with solid stem augers then reentry with direct push rods to total depth. Date: March 15, 2020 Direction: S

A confirmation of this tooling combination was determined to be successful in the SFCJC and Capital 66 plume areas and will be used for full-scale injection activities. Two Geoprobe[®] rigs will be used – one rig predrilling the boring via small diameter solid stem augers; the second rig will follow inserting injection rods into the predrilled boring for injection of PetroFix[®]. Details of the injection procedure will be developed and presented in the Final Remediation Plan (FRP) for the site.

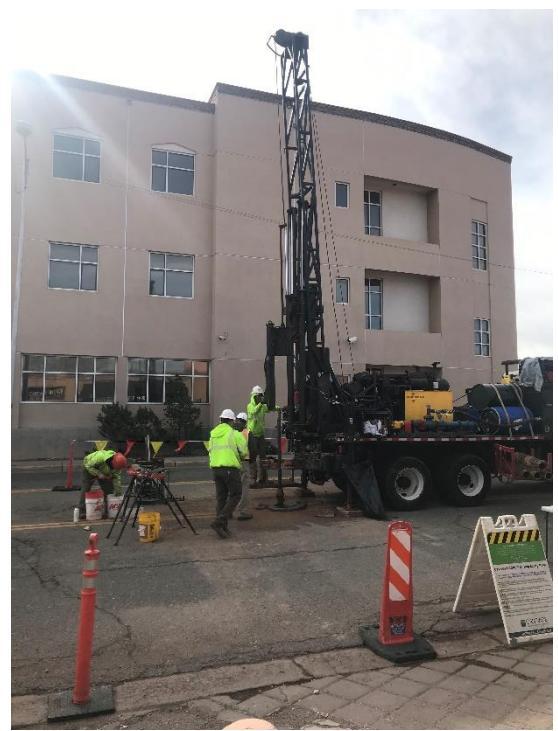
Photo 11: Advancing contingency soil boring SB-1 in Cerrillos Road using hollow stem auger adjacent to monitoring well MW-4R for treatment zone thickness determination. Date: March 18, 2020

A hollow stem auger (HSA) drilling rig was mobilized to the site by Cascade to complete this task after it was determined during previous tasks that the Geoprobe[®] 8040DT could not reach the required boring depths to complete this task due to the difficult drilling conditions encountered in the area. Mobilization of the HSA rig to the site was delayed due to extenuating circumstances with COVID-19. The delay allowed the drillers to complete asphalt restoration/repair and other tasks around the project area.

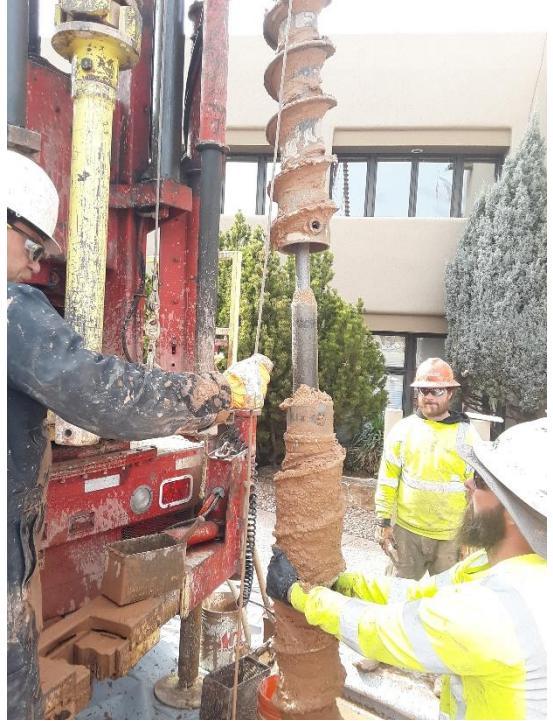
Photo 12: Advancing contingency soil boring SB-3 in Cerrillos Road using hollow stem auger for treatment zone thickness determination. Date: March 22, 2020 Direction: E
