2017/2018 2nd Quarter Groundwater Monitoring Report:

Chevron Isleta Site
3401 Isleta Boulevard
Albuquerque, New Mexico
Bernalillo County

NMED PSTB Facility No. 30681
NMED PSTB Deliverable ID# 3918-2

Date of Report: May 7, 2018

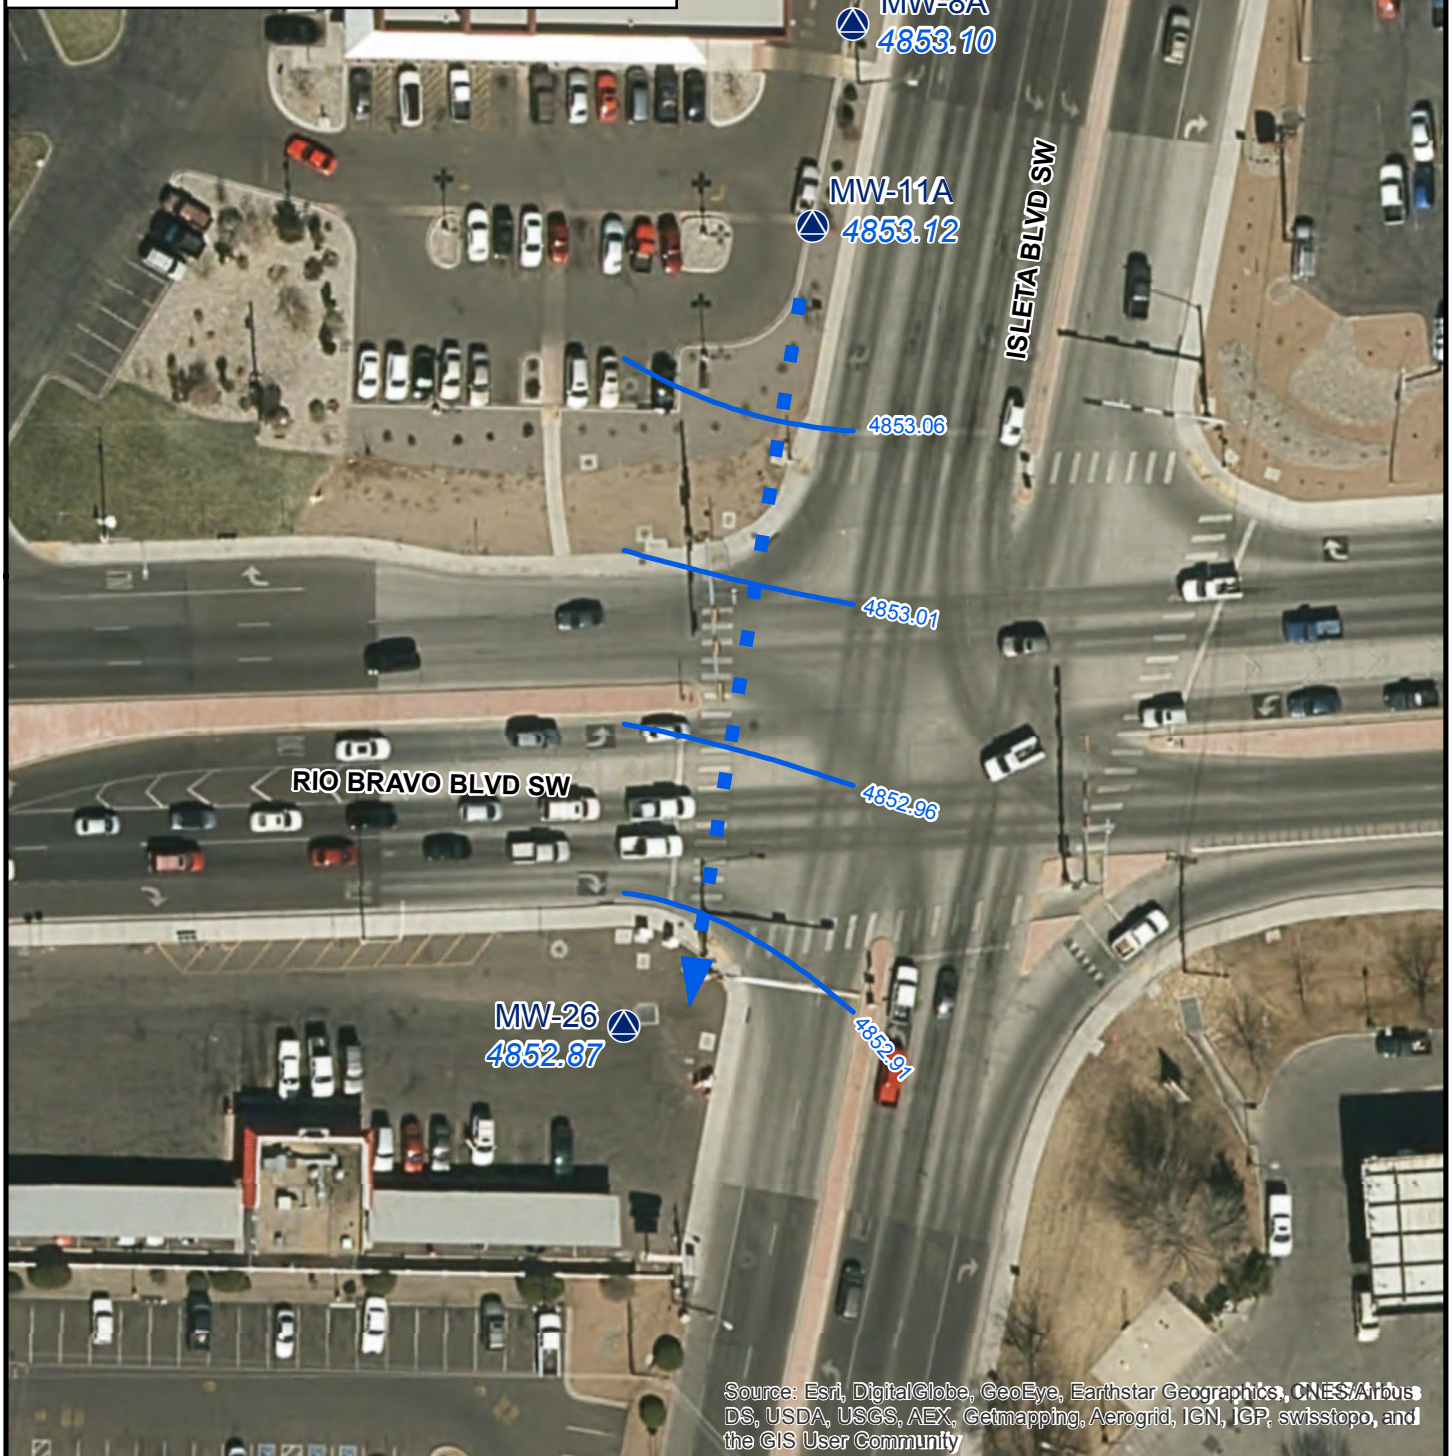
FIGURE 3

On April 17, 2018, prior to monitor well purging and sampling, fluid levels and total depths were measured in each well with an electronic oil/water interface probe. Monitor wells were gauged in order of increasing contamination to minimize cross contamination and the interface probe was decontaminated prior to each use. During this event, groundwater elevations declined by an average of 0.49 ft and were within their historic fluctuation range. Groundwater flowed at an approximate gradient of 0.0007 ft/ft (see calculation below) to the south (Figure 3), relatively consistent with historic conditions. Historic fluid level data are summarized in Table 1.

$$(4853.10 - 4852.87) / 325 = 0.23 / 325 = \mathbf{0.0007 \text{ ft/ft}}$$

WATER TABLE MAP
CHEVRON ISLETA
3401 ISLETA BOULEVARD SW
ALBUQUERQUE, NM

Gauging Date
4/17/2018

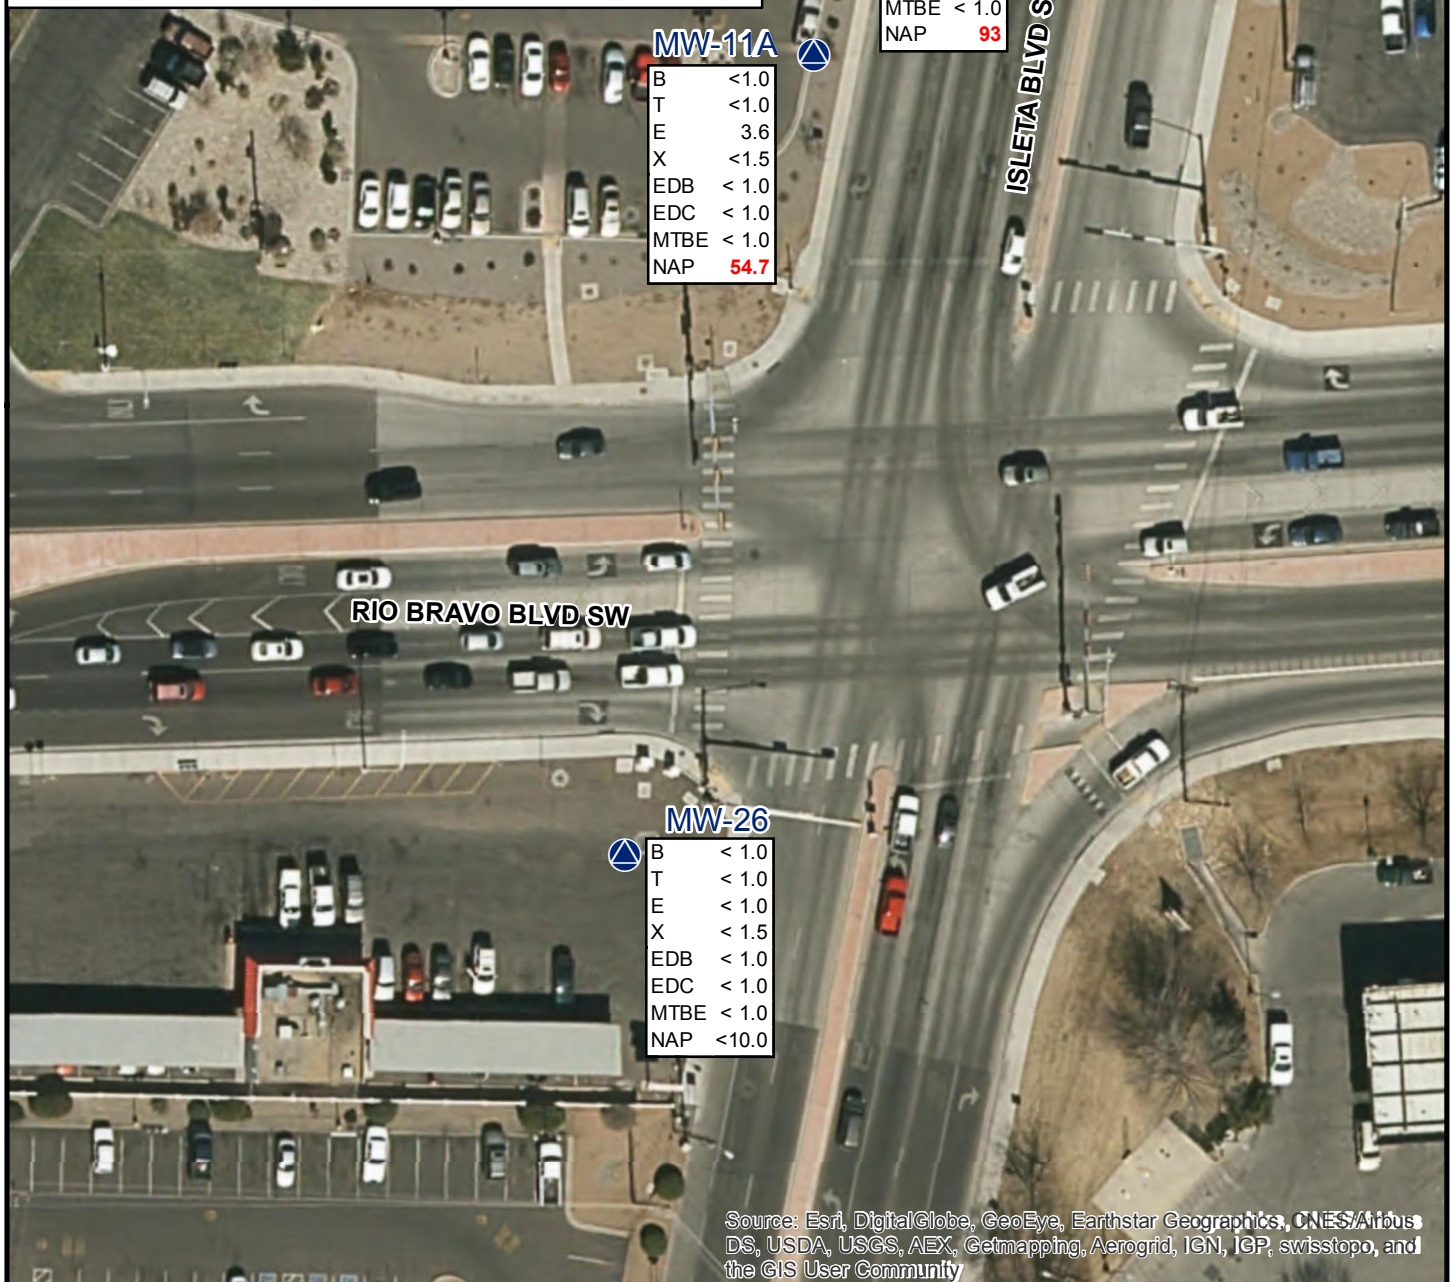
On April 17, 2018, water levels were within their historic fluctuation range. Since October 2017, water levels have declined by an average of 0.49 ft (Table 1). Dissolved benzene and/or naphthalenes at monitor wells MW-8A and MW-11A continue to be the primary contaminants of concern at the site (Figure 4).

DISSOLVED ORGANIC RESULTS MAP
CHEVRON ISLETA
3401 ISLETA BOULEVARD SW
ALBUQUERQUE, NM

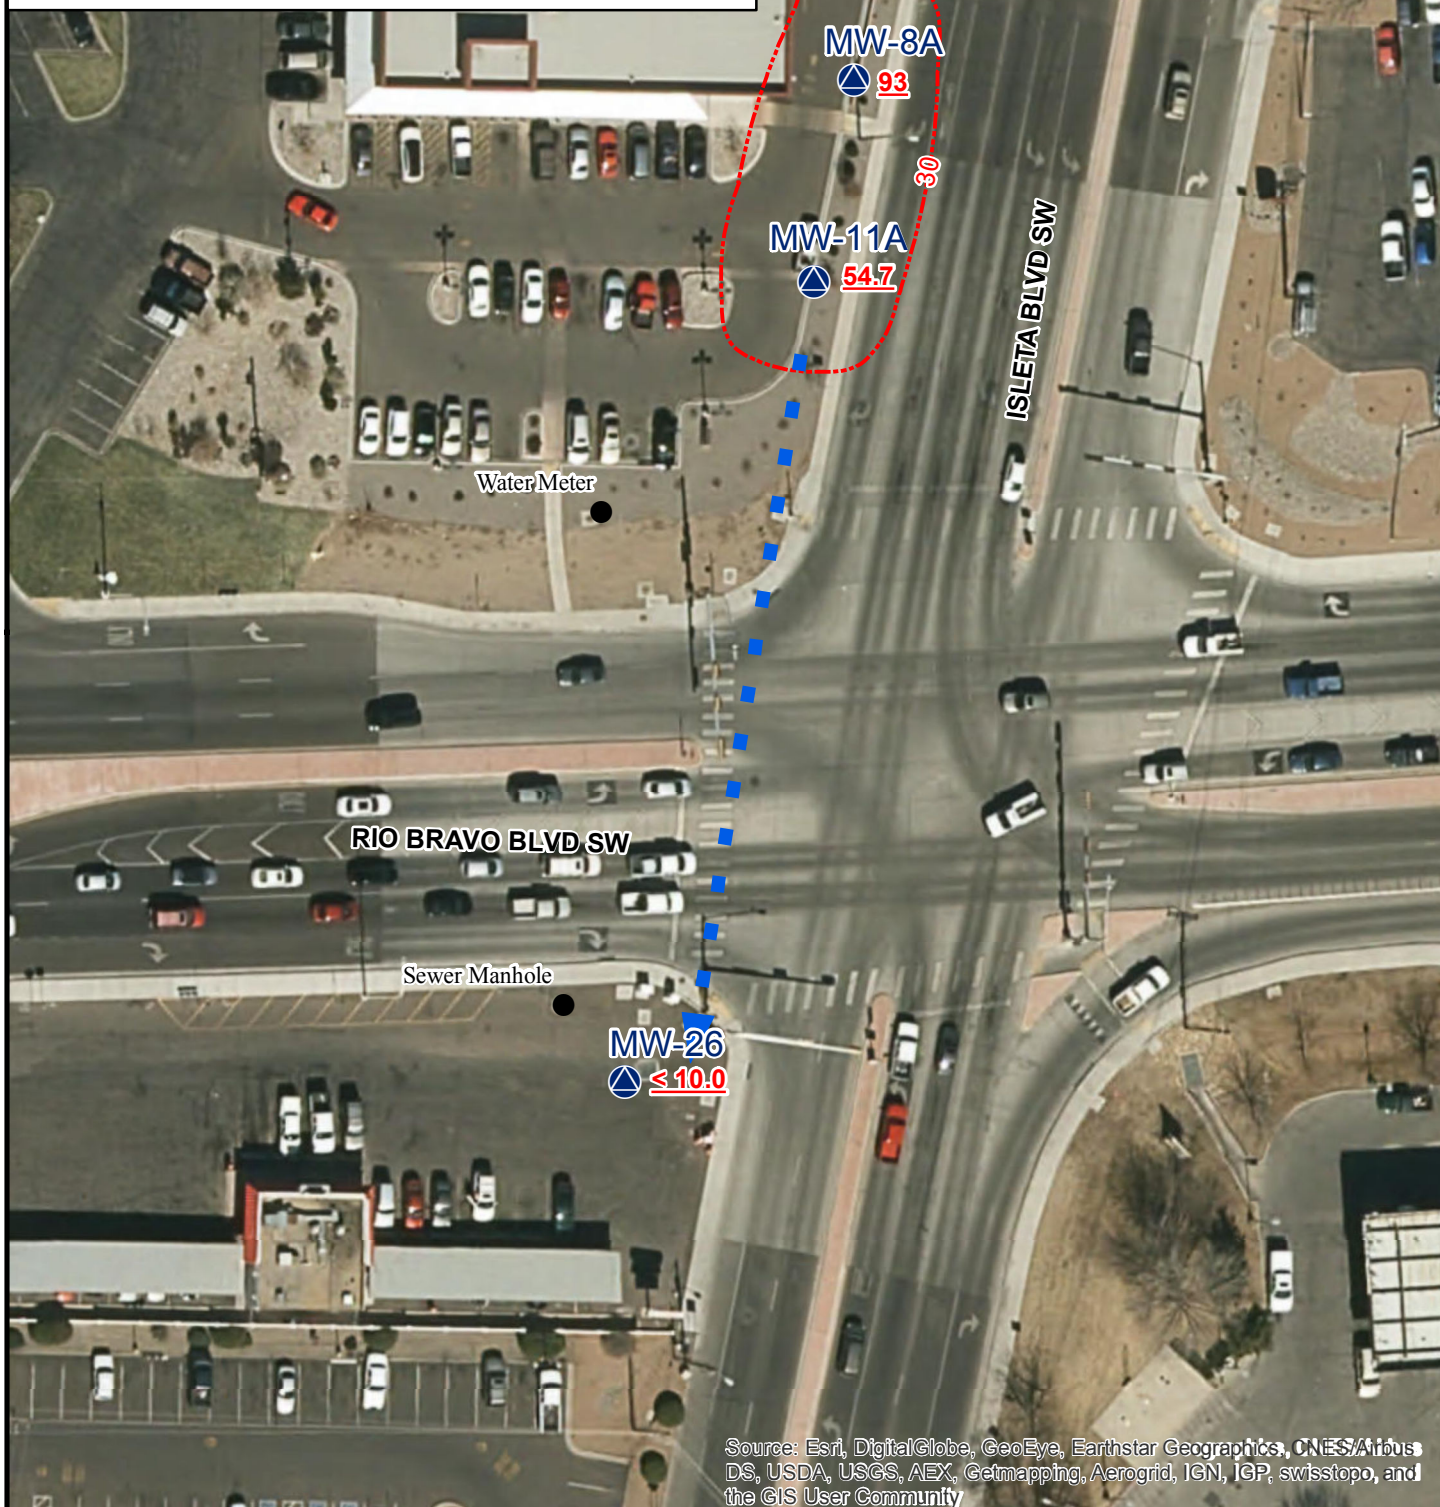
Based on groundwater flow direction and laboratory data, the dissolved phase hydrocarbon plume of contamination appears to have migrated off-site underneath the southbound turn lane of Isleta Boulevard, but have not migrated underneath Rio Bravo Boulevard to MW-26. Historic and recent groundwater analytical data indicate that the plume is generally shrinking over time (Figure 5).

----- Dissolved Naphthalenes Isoconcentration Line (Inferred, ug/L)

Therefore, based on the data and observations found in this report and correspondence with NMED-PSTB personnel, AECOM recommends continued groundwater monitoring of natural attenuation parameters and contaminant concentrations at the site. And application of BOSS 200 to remediate the remaining contaminants in the vicinity of MW-8A. AECOM is currently contracting with the NMED PSTB through the small purchase PO program to perform an injection at the site this year.

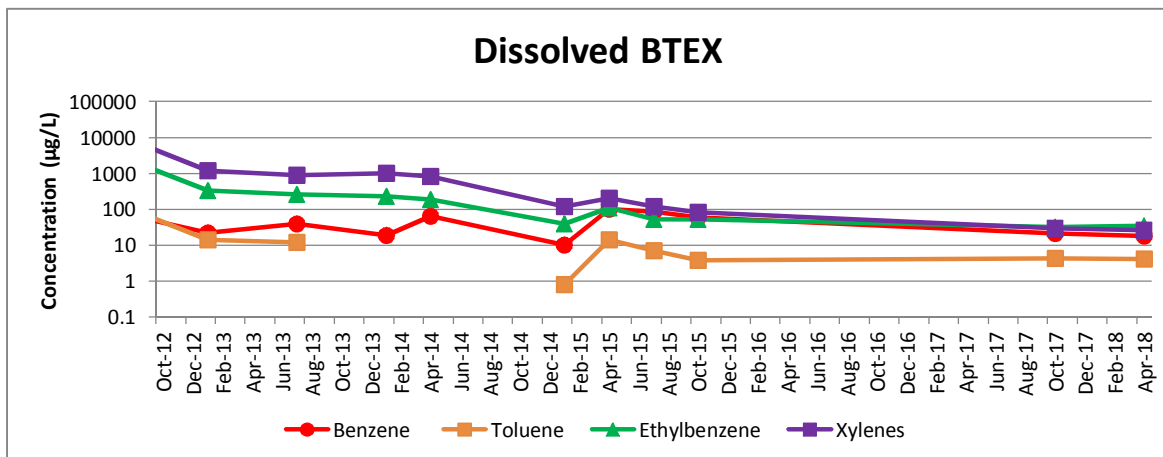
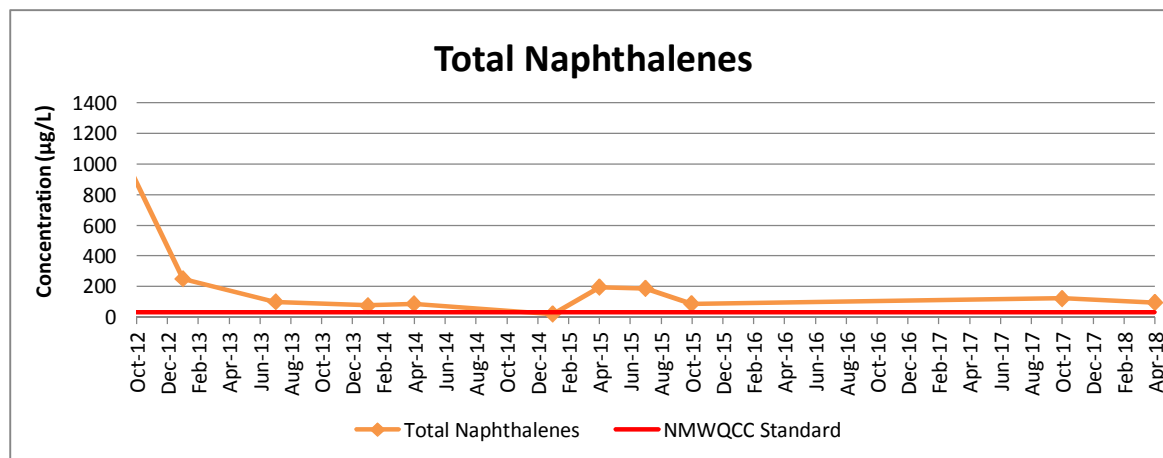
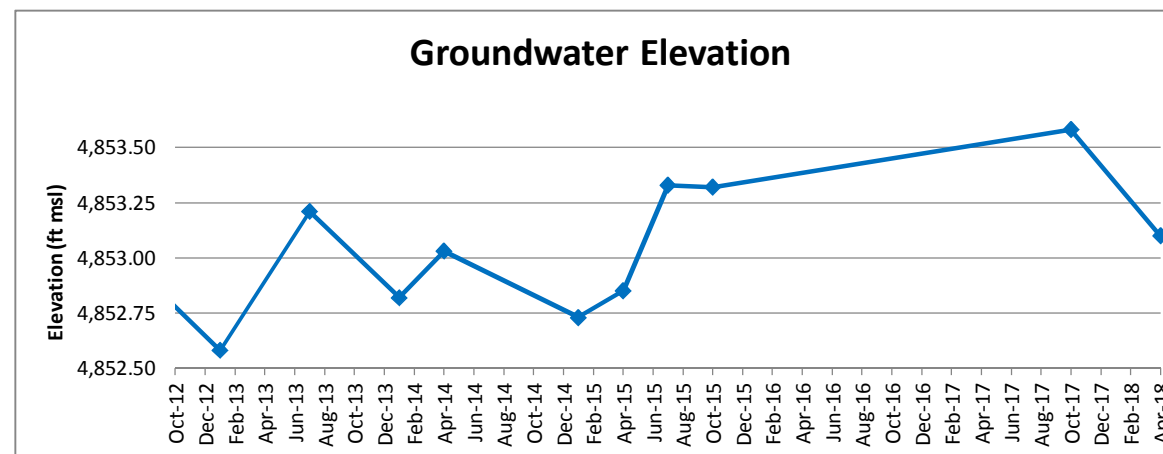
MW-8A— From August 2012 to October 2017, dissolved benzene and total naphthalenes have exceeded NMWQCC standards at MW-8A with concentrations ranging from 10 to 100 µg/L and 21 to 1,300 µg/L, respectively. Toluene, ethylbenzene and total xylenes have not exceeded their respective NMWQCC standards since at least January 2015, although they are consistently detected.

Between the October 2017 and April 2018 sampling events, the dissolved benzene concentration decreased from 21 to 18 µg/L. During the same period, the total naphthalenes concentration decreased from 122 to 93 µg/L. Both contaminants of concern at MW-8A have exhibited a generally decreasing trend over time with intermittent periods of seasonal rebound (Graph 1).

Graph 1
MW-8/MW-8R/MW-8A Dissolved BTEX and Naphthalenes Concentrations Vs Time
Chevron Isleta Site, Albuquerque, New Mexico

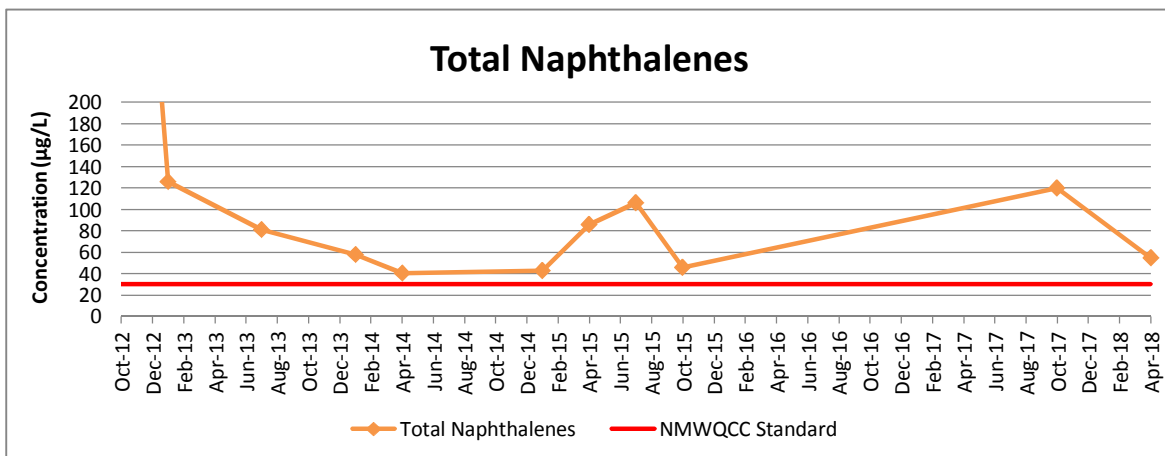
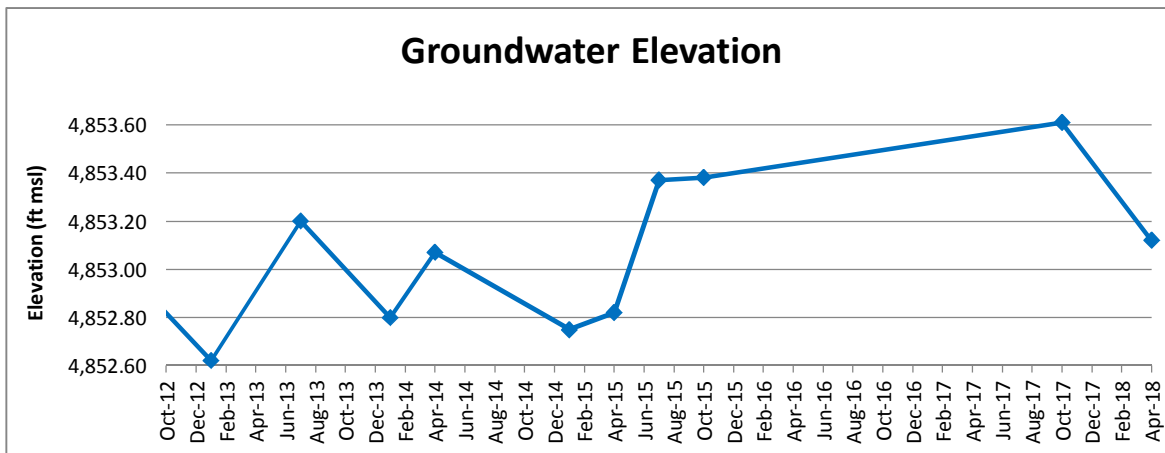
MW-11A— Since August 2012, dissolved benzene concentrations have exceeded the NMWQCC standard three times, and dissolved naphthalenes have consistently exceeded the NMWQCC standard ranging from 40.5 to 1,060 µg/L. Between the October 2017 and April 2018 sampling events, dissolved benzene at MW-11A was not detected. The total naphthalenes concentration (54.7 µg/L) decreased from the October 2017 concentration (120 µg/L) but continues to exceed the NMWQCC standard of 30 µg/L (Graph 2). Both contaminants of concern at MW-11A have exhibited a generally decreasing trend over time with intermittent periods of seasonal rebound.

Graph 2
MW-11/MW-11R/MW-11A Total Naphthalenes Concentrations Vs Time
Chevron Isleta Site, Albuquerque, New Mexico
