ABANDONED OR INACTIVE URANIUM  
MINES IN NEW MEXICO

A report of investigation carried out  
between August 1979 and May 1980 under  
contract with the New Mexico Energy and  
Minerals Department.

New Mexico Bureau of Mines and  
Mineral Resources  
Open-File Report 148

Mine name(s) Silver Spur 1 & Silver Spur 5 County McKinley

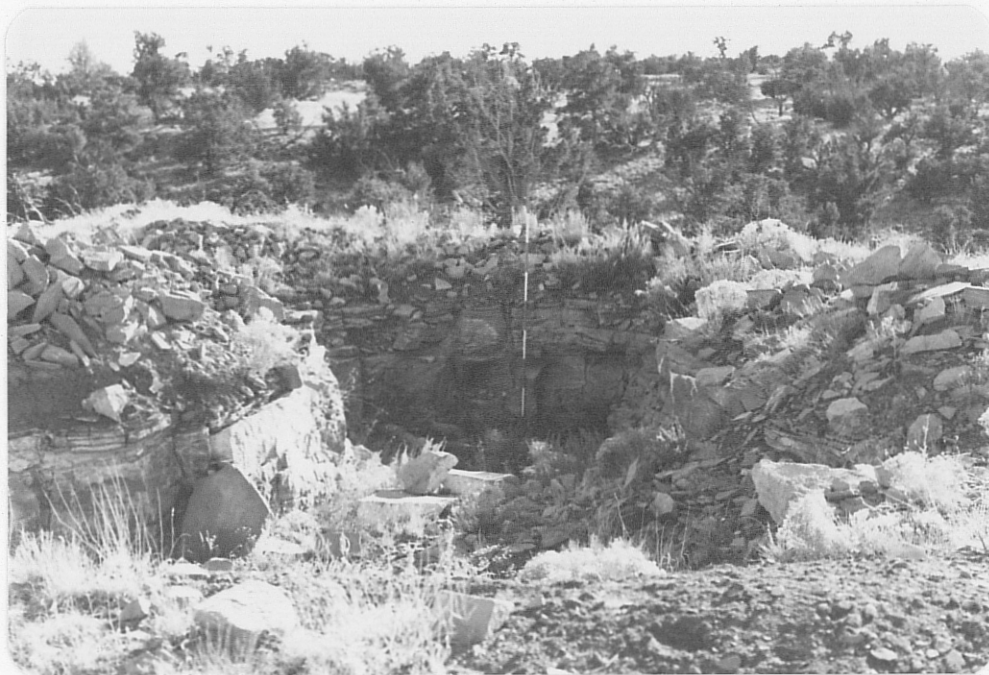
Photo (a) Looking south into 8' x 35' trench at southern edge of Silver Spur workings; note range pole for scale.

The southern area open cuts range from 35'-60' long, 8'-25' wide, and up to 5' deep, see photos (a) and (b). The north end cut is 15' wide, 110' long, and 9' deep at the face where the adit is driven, see photo (c). The adit portal is 5' high, 6' wide, with one set of timbers just inside, see photo (d). Scintillometer response at the southern pits was 750 cps to 1,800 cps, at the larger one on the north 2,000 cps.

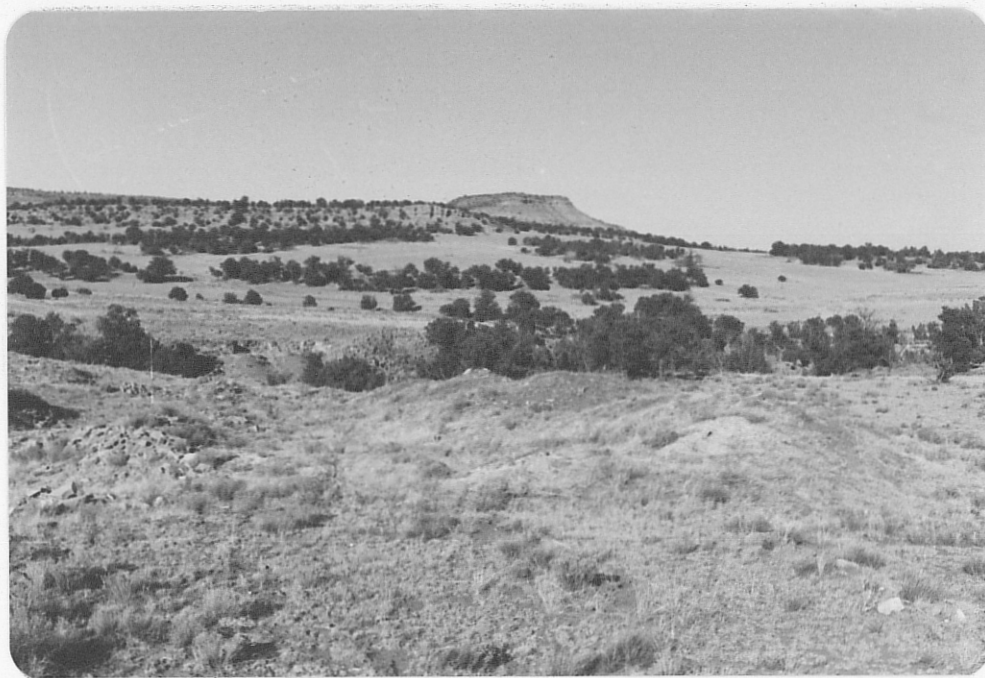
Photo (b) Looking northward near middle of workings, 200' north of photo (a); poorly defined cut is about 25' x 60'.

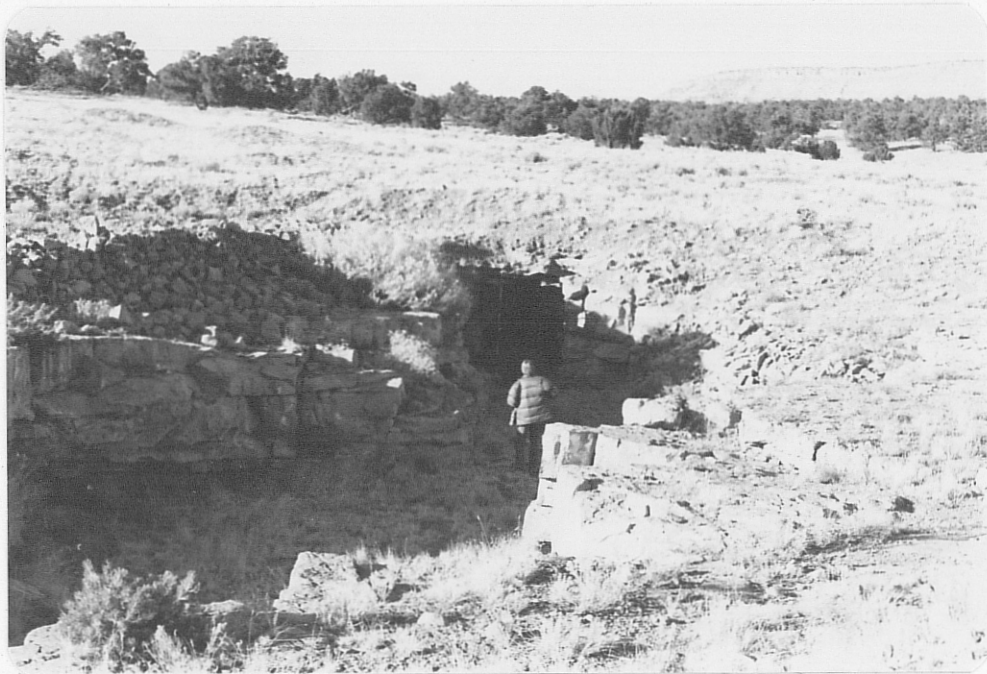
Photo (c) Looking northward at northernmost cut; trench is 110' long with adit at far end.

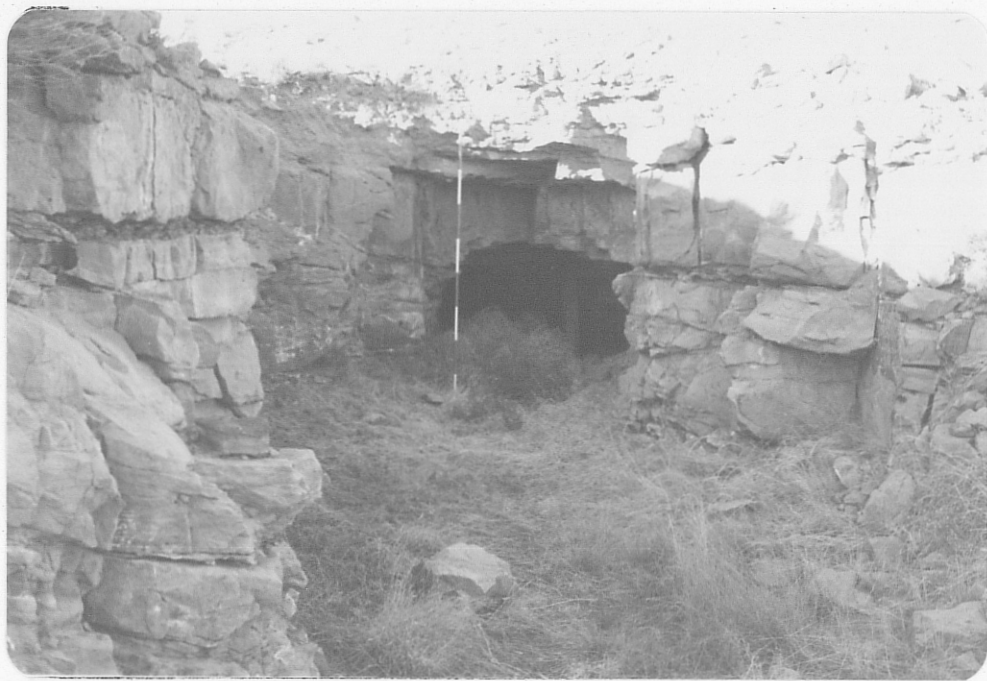
Photo (d) Close-up of adit shown at end of trench in photo (c). Portal is 5' x 6', workings go in about 22'. Note range pole for scale.

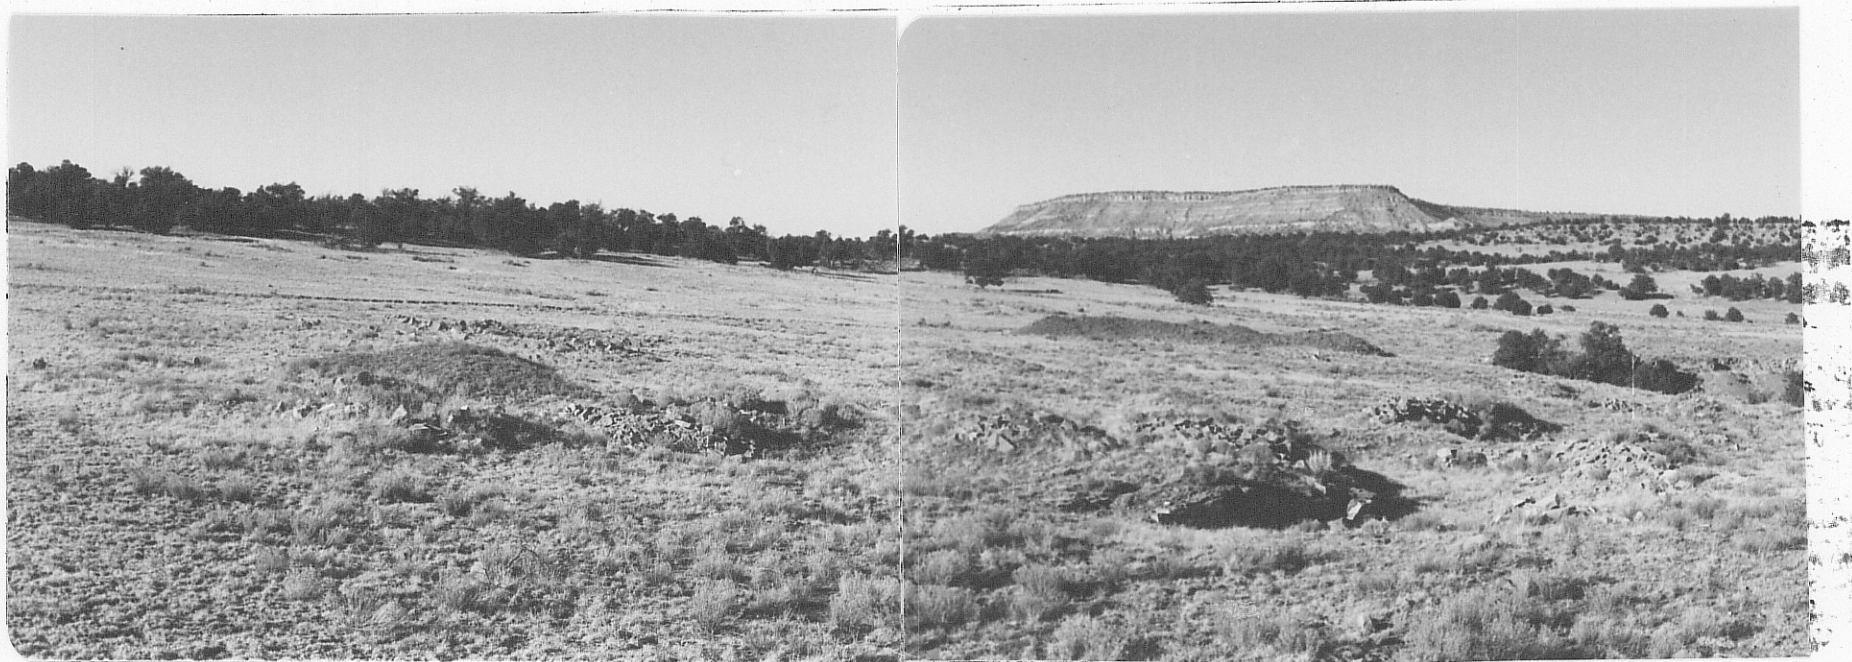
Photo (e) Panorama looking northwestward from near middle of Silver Spur workings, showing numerous small overburden and tailings piles from the small open pits described in text. Note range pole at far right for scale.

Photo (e) shows several small scattered tailings piles along the west side of the workings; they are generally not over 3' high and less than 10' in diameter. Photo (f) is a view of the tailings dump from the north cut and adit. Readings of up to 900 cps were recorded on the dump, which measures about 200' by 20' and 5' in height.

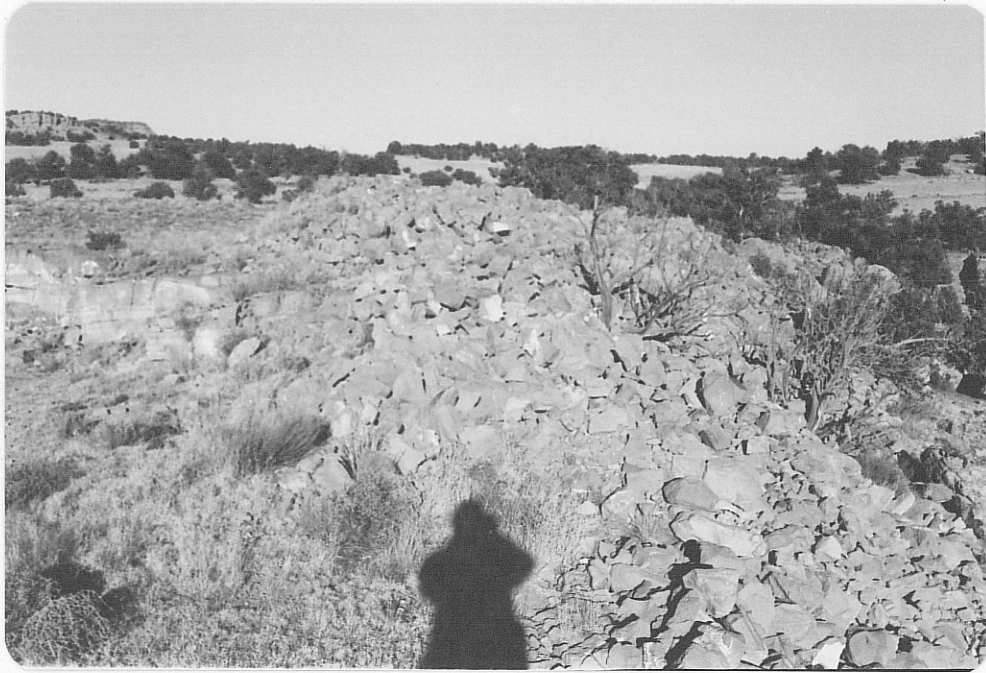
Photo (f) Looking eastward at tailings dump from long cut with adit.
