NEW MEXICO
ENVIRONMENT DEPARTMENT

Memorandum

Subject: Pre-CERCLIS Screening Assessment of the Hogan mine
(Grants Mining District), McKinley County, New Mexico: Further
action under CERCLA recommended

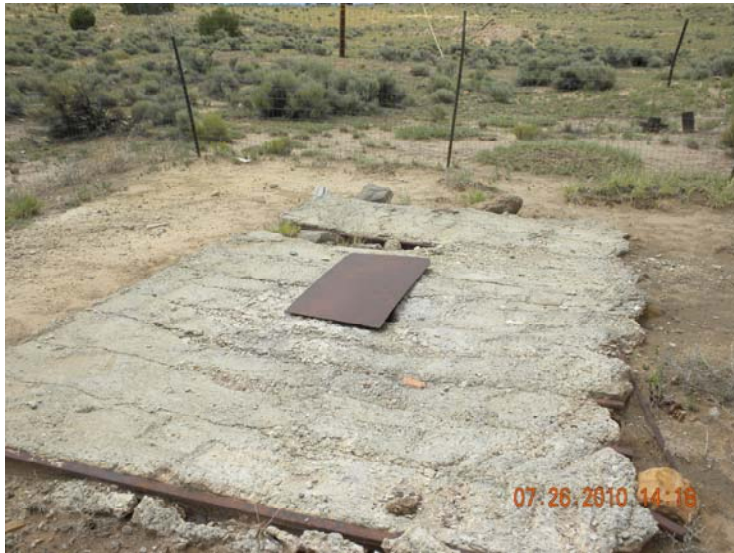
P1: Hogan mine shaft

A reconnaissance performed by personnel from the New Mexico Environment Department ("NMED") and NMENNRD on July 26, 2010 identified the same features. The shaft is fenced and covered by crumbling concrete that has been poured over railroad track sections placed over the opening (see P1). Numerous small piles of waste or bulldozed materials are scattered around the Site. Additionally, several sections of rusted iron pipe were observed close to the shaft location (see P2).

The Site should be assessed for potential physical hazards, especially the compromised cover of the open shaft, should be assessed and mitigated as soon as possible.

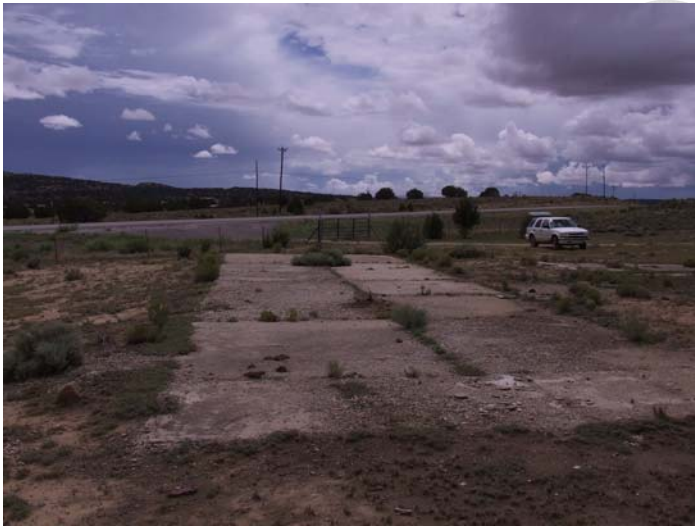
P3: Concrete pad adjacent to shaft

The Hogan minesite ("Site") is located approximately 200 feet ("ft") north of State highway 605, approximately 1.5 miles east of Ambrosia Lake junction (Ref. 1, p. 69). A 2007 survey performed by a contractor to the New Mexico Energy, Minerals, and Natural Resources Department ("NMEMNRD") identified an open shaft, several areas of concrete (see P3) and 2 supports for the headframe.
