ABANDONED OR INACTIVE URANIUM
MINES IN NEW MEXICO

A report of investigation carried out
between August 1979 and May 1980 under
contract with the New Mexico Energy and
Minerals Department.

New Mexico Bureau of Mines and
Mineral Resources
Open-File Report 148

Mine name(s) Moe No. 4 (Sec. 32) County McKinley

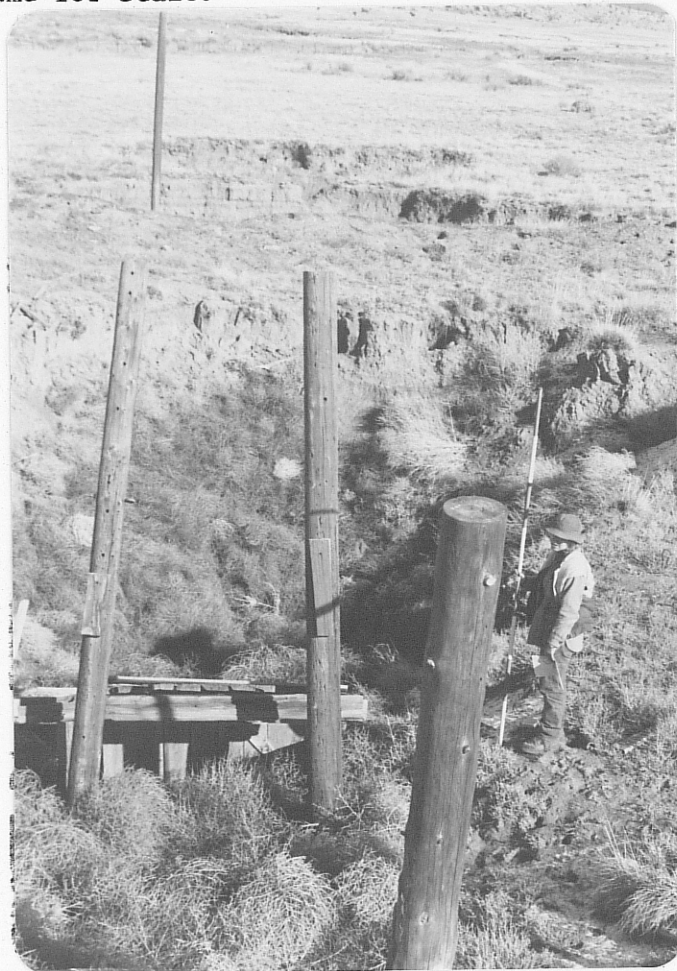
The decline has collapsed in 3 segments along the first 175' of workings (photo b). The first one is at the site of the portal and is 35' long, 75' wide, and 15' deep. The second one is about 60' x 30', and the third is 40' x 20', each being about 10' deep. No evidence of recent collapse or movement was noted and all three are filling with tumbleweed and blow sand. None of the 3 collapse features were centered.

Photo (b) Looking northward from atop headframe down the collapsed decline. Note 3 separate collapse features, the first one being at the portal.
