SAN MATEO - EXHIBIT Y

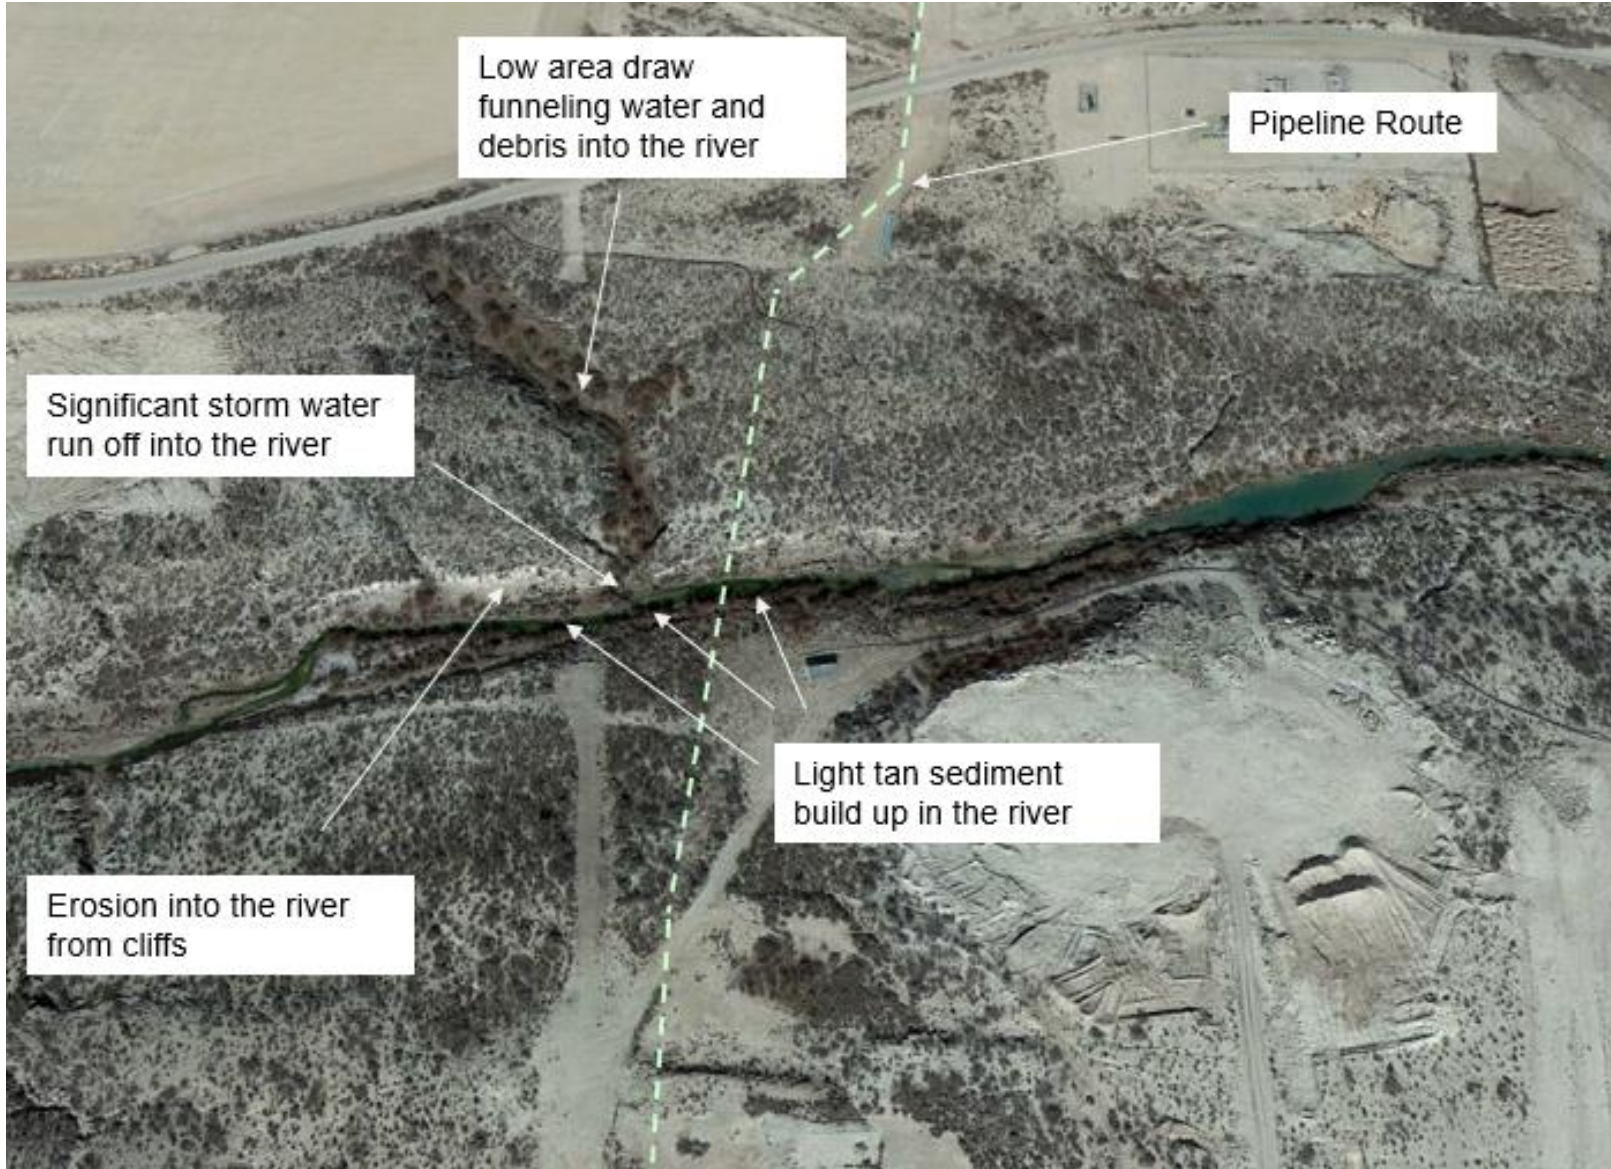
May 27, 2020 :
Streambed
sedimentation, located
approximately 25-75
yards upstream of
Boring Operations Site,
matching the color and
characteristics of
observed and
documented runoff.

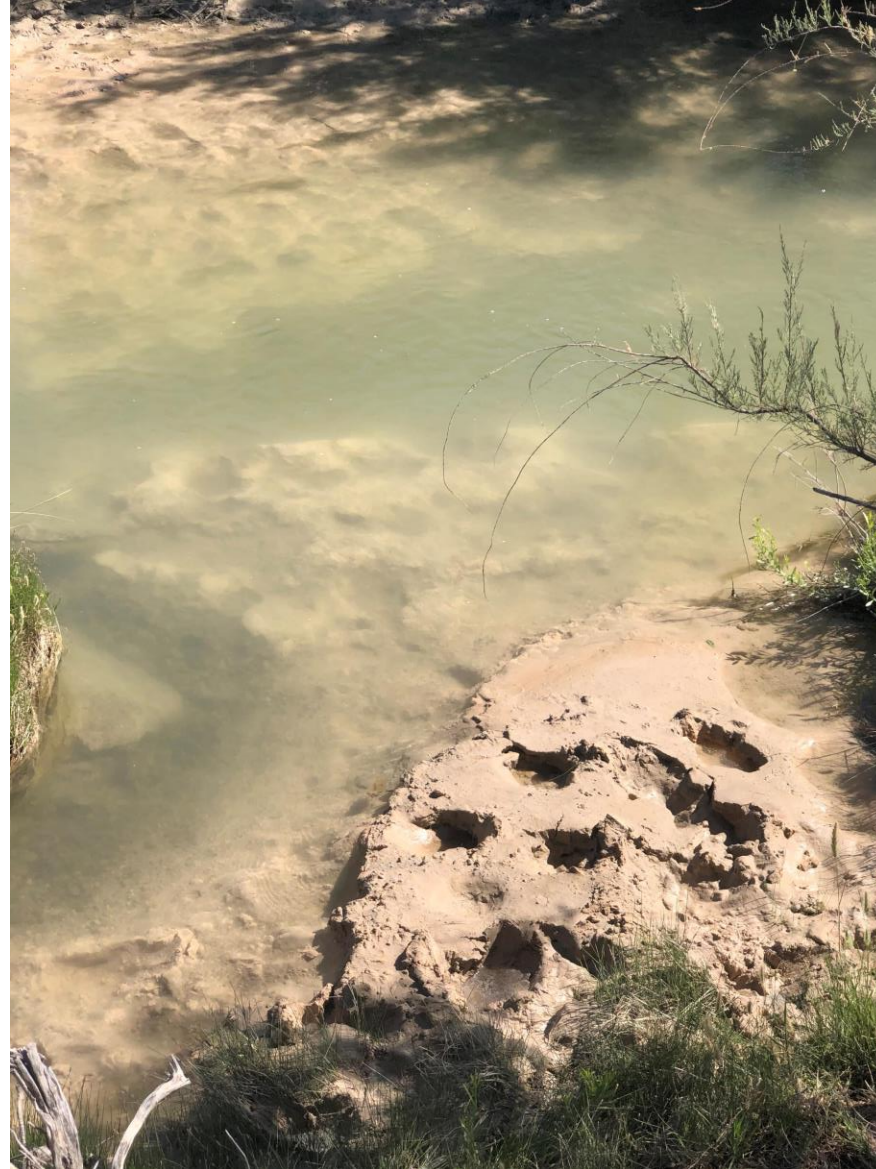
May 27, 2020: Left, dried riparian sedimentation, located approximately 25-75 yards upstream of Boring Operations Site, matching the color and characteristics of observed and documented runoff.

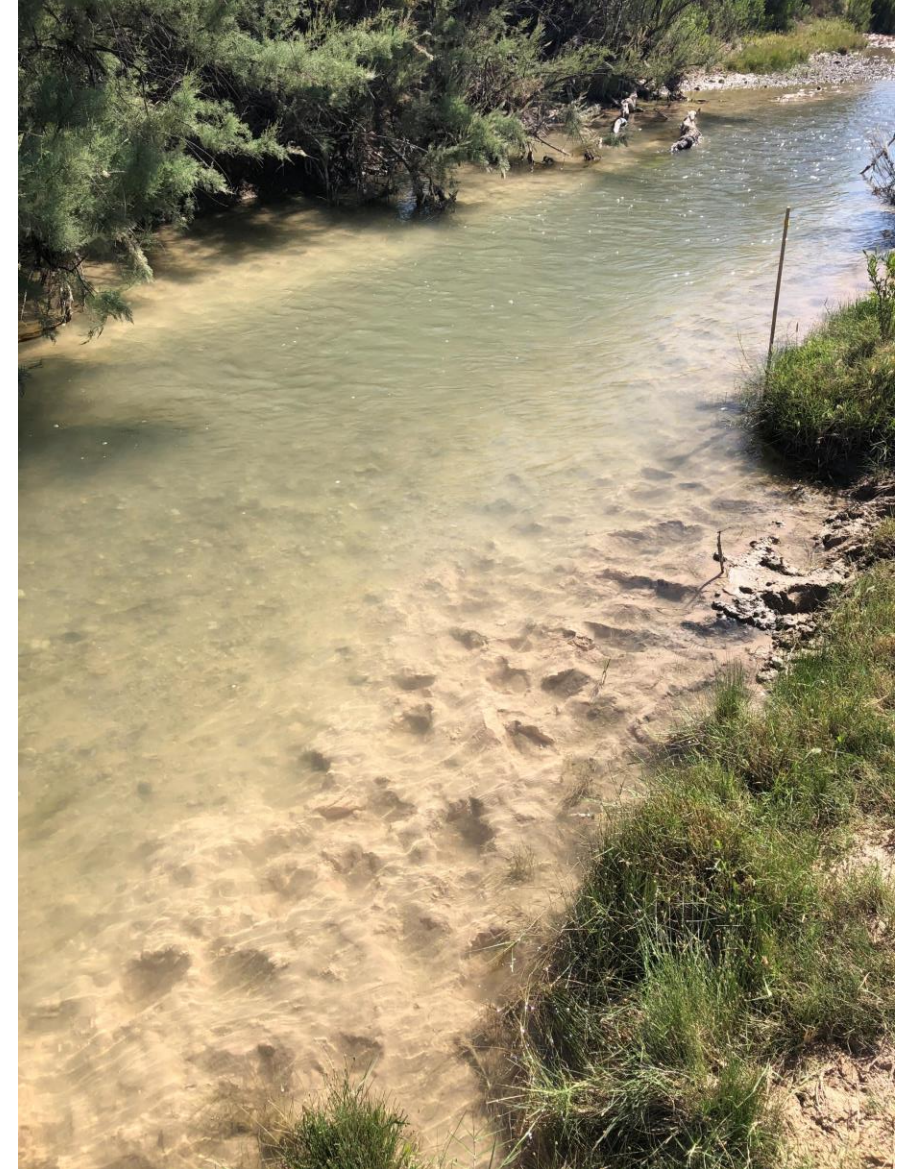
Right, upper riparian stream bank, approximately 25-75 yards upstream of Boring Operations Site, evidencing erosion and loss of soil matching the color and characteristics of documented runoff and downstream streambed sedimentation.
