ABANDONED OR INACTIVE URANIUM
MINES IN NEW MEXICO

A report of investigation carried out
between August 1979 and May 1980 under
contract with the New Mexico Energy and
Minerals Department.

New Mexico Bureau of Mines and
Mineral Resources
Open-File Report 148

Mine name(s) Hogback Claim

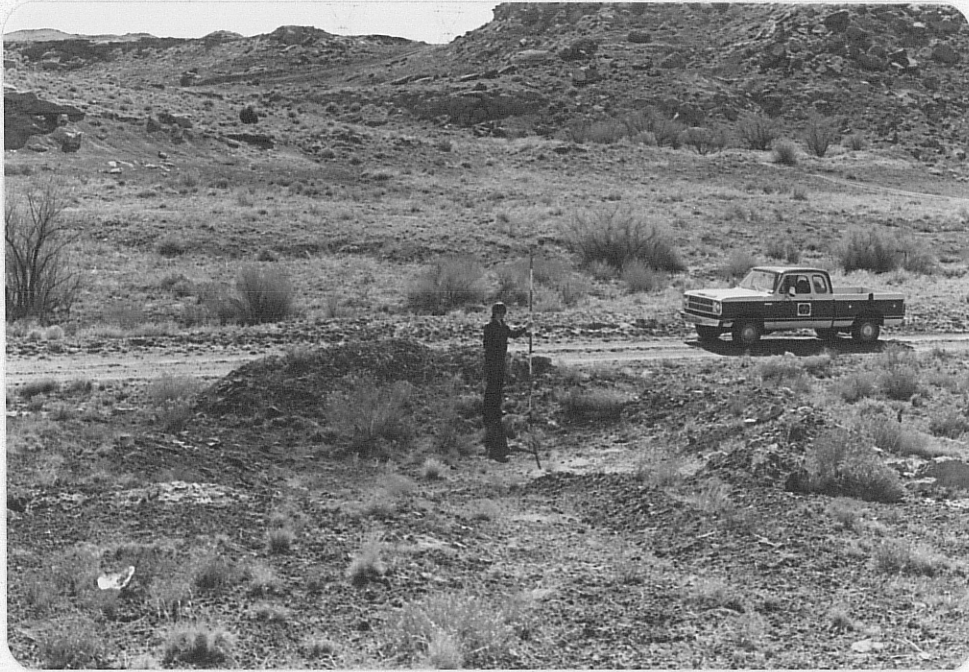
Workings on the claim consist of 3 very small bulldozer cuts. The main one, shown in photo (2), is closest to the road and measures about 20' x 25', up to 2½' deep, with a 4' high waste pile at the east end (photo b). Scintillometer readings here ranged up to 2,000 cps with the highest counts being recorded at the northeast corner of the pit on a bedrock face.

Photo (a) Hogback claim, main pit, looking east

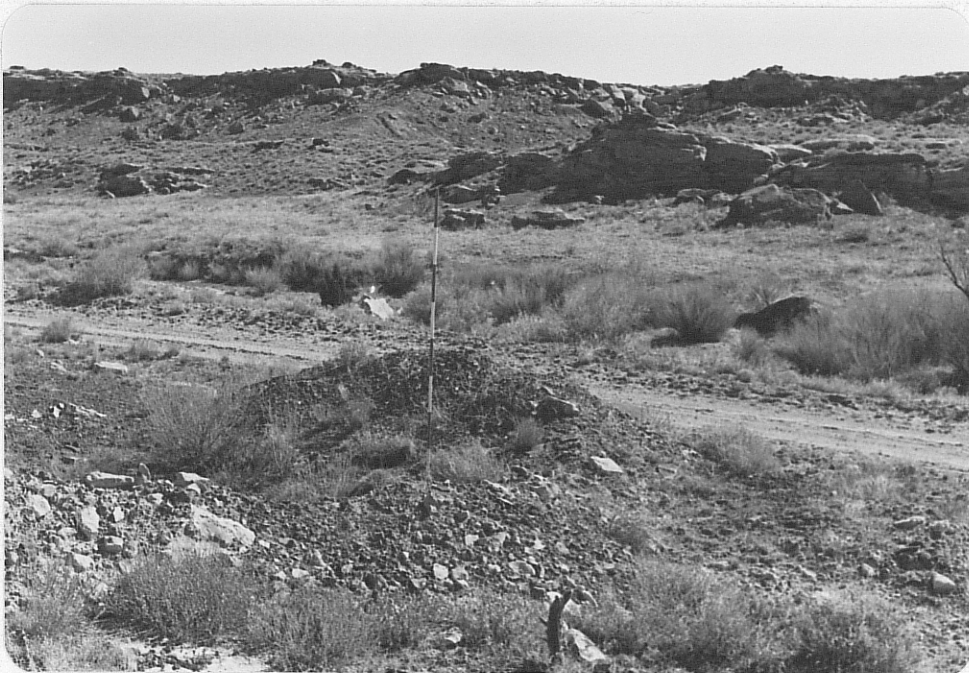
Photo (b) Hogback claim, east end of main pit and waste pile; looking northeast.

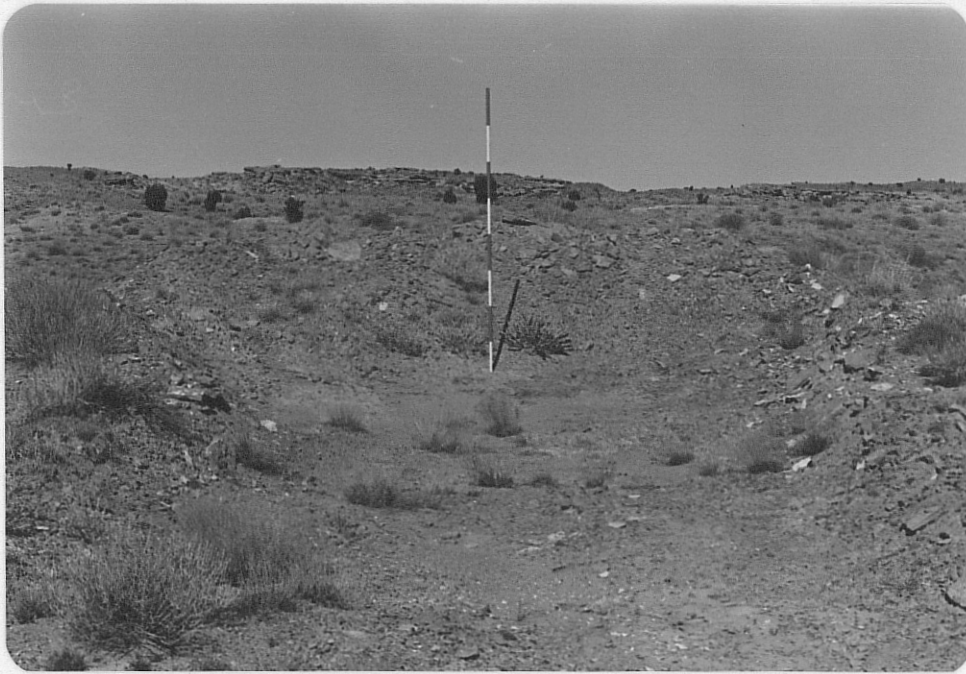
The other two pits lie about 100' to the west of the main one, are much smaller, and have much lower radioactivity values--about 300 cps maximum. They are shown in photos (c) and (d).

Photo (c) Looking west at one of smaller dozer cuts about 10' wide.

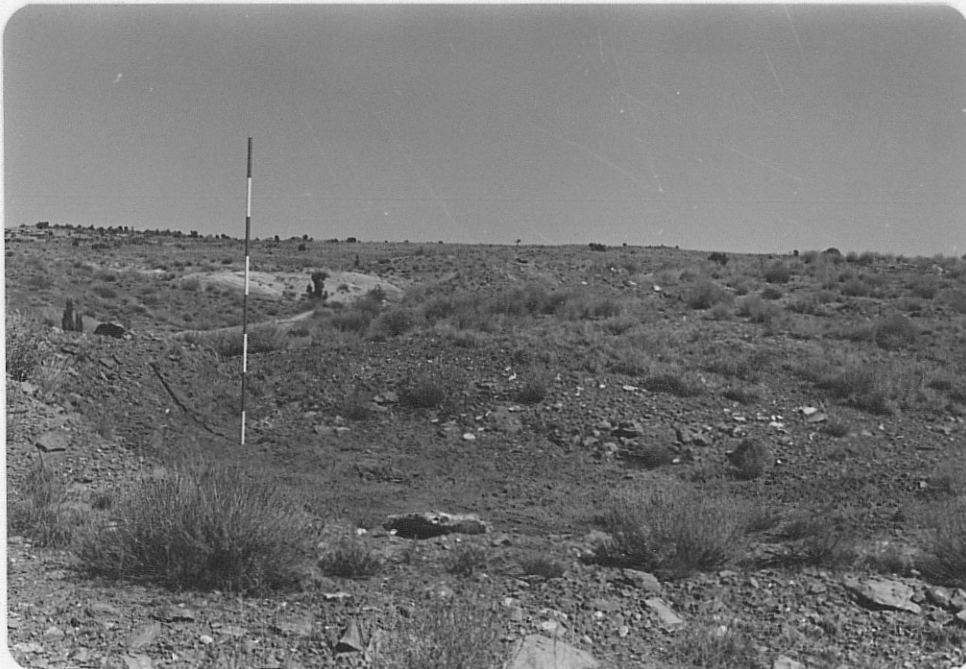
Photo (d) Looking north at small dozer cut with dump from cut in photo (c) visible in background.
