**Memorandum**

**Subject:** Pre-CERCLIS Screening Assessment of Red Bluff #1 Mine,  
McKinley County, New Mexico: Further action under CERCLA  
recommended

<b>Site name</b>	Red Bluff #1 Mine				
<b>City</b>	not applicable	<b>State</b>	New Mexico	<b>Zip code</b>	not applicable
<b>County</b>	McKinley				
<b>Latitude</b>	35° 18' 59.97"	<b>Longitude</b>	107° 50' 26.61"

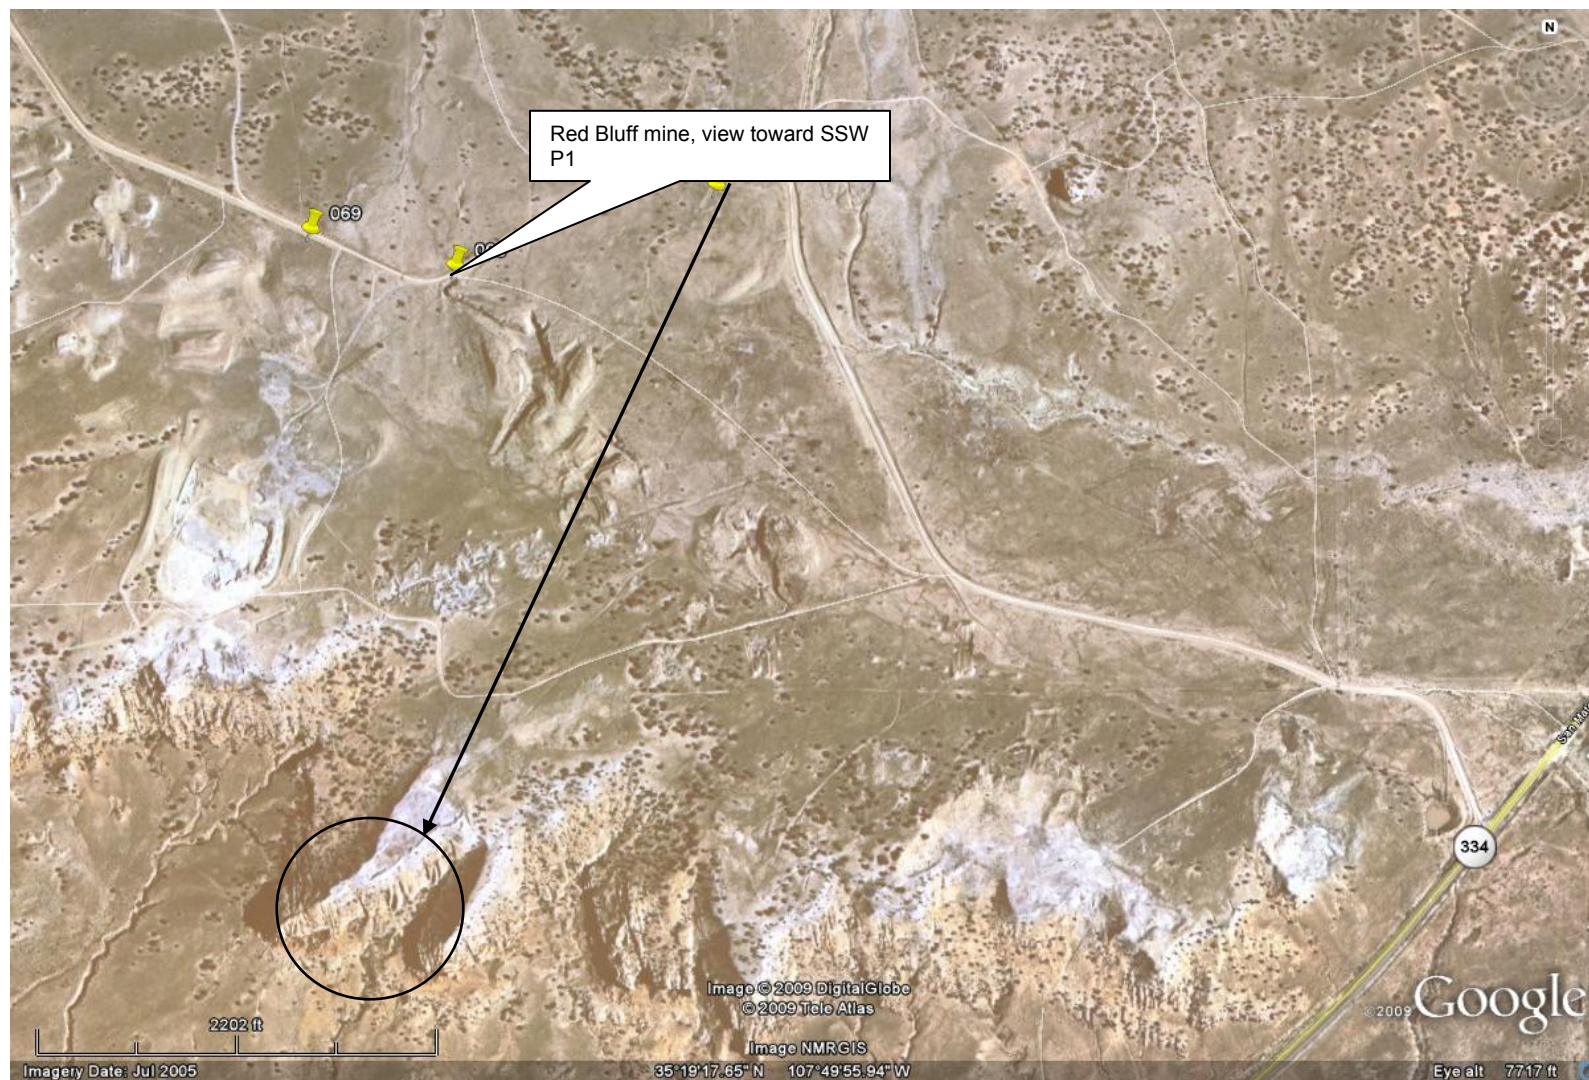
**Figure 1: Red Bluff mine**

"Px" reference the location of photographs on pages following.

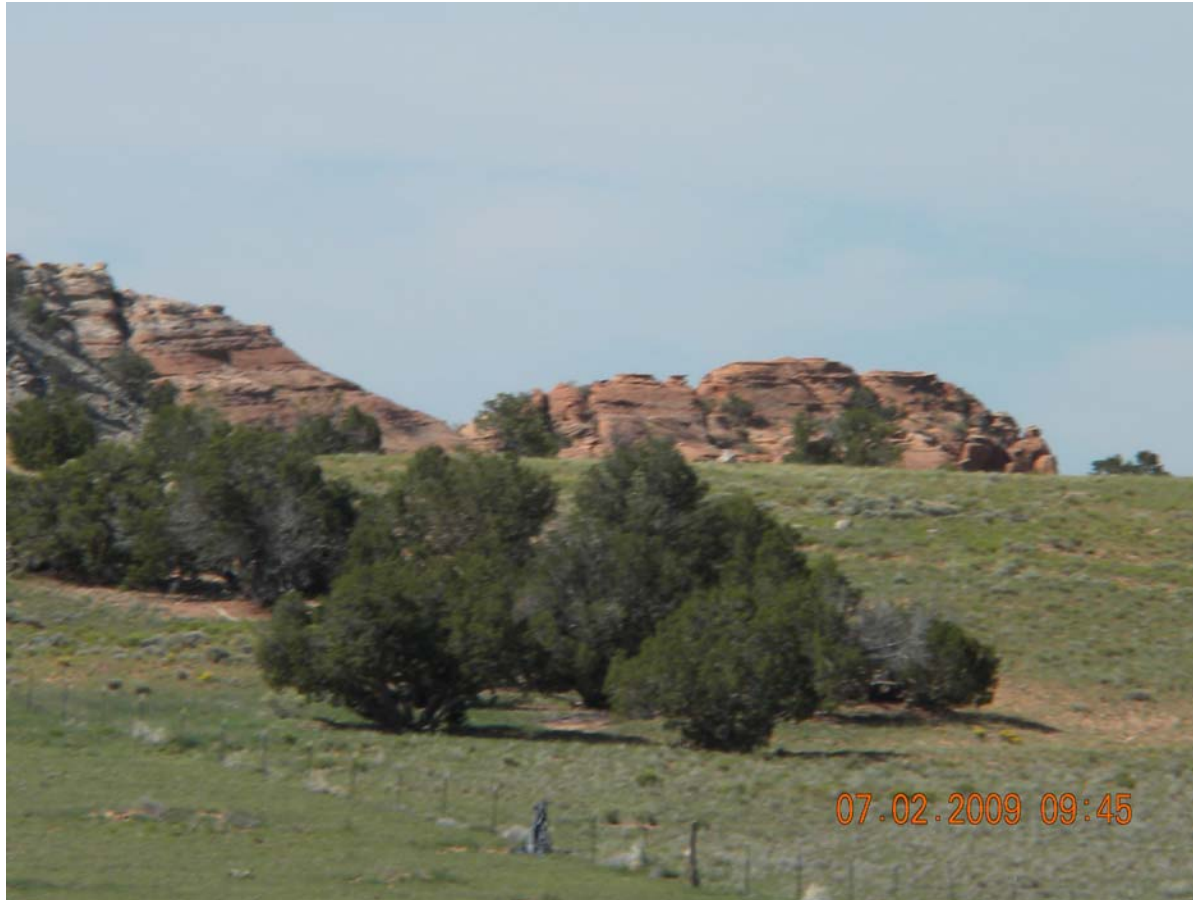
**Site summary:** Observations made during NMED's Site reconnaissance are shown on the accompanying figures. As indicated, no disturbance was visible from Haystack Road.

P1: Red Bluff Mine; view toward SSW
