SAN MATEO - EXHIBIT U

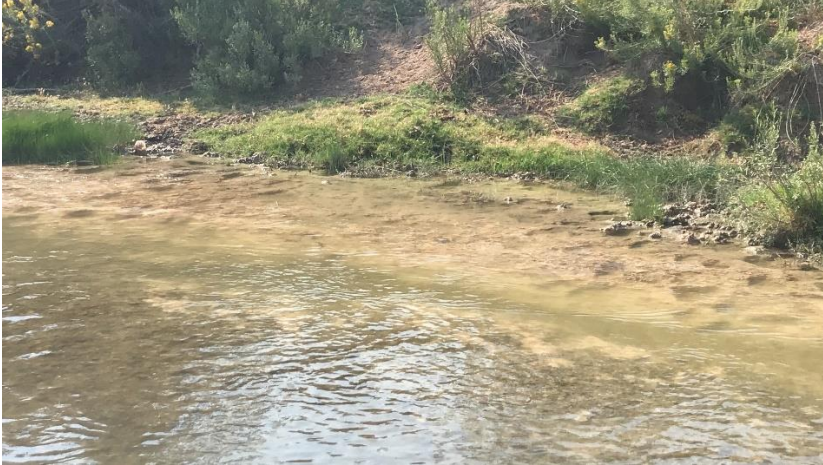
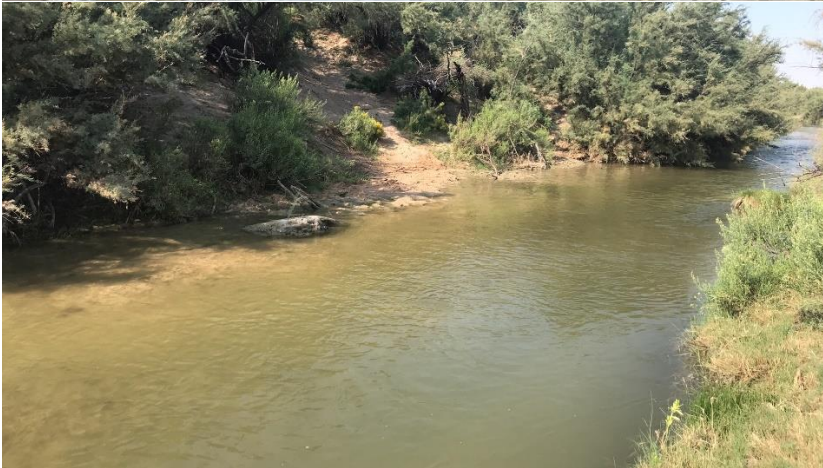
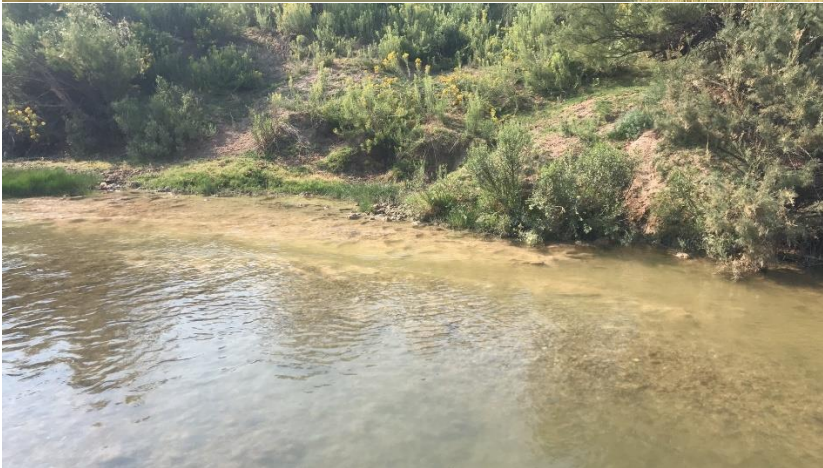
The images to the left correspond in sequence to the preceding data-tagged images, which were reproduced in lower resolution. These photos depict the area just downstream from the alleged release location approximately where core samples C2 and C3 were collected and where NMED alleges in the ACO that the riverbed was covered in light-tan, pudding-like mud. XRD/XRF analysis confirmed the absence of bentonite in these sediments, and indicated that they instead match the chemistry and composition of limestone caliche.
