**PROJECT**  
 DOÑA ANA DAIRIES  
 MESQUITE, NEW MEXICO

**FILE**  
 GROUNDWATER ANALYTICAL RESULTS  
 NOVEMBER/DECEMBER 2023  
 NORTHERN PORTION, REGIONAL AQUIFER

**FIGURE 6**

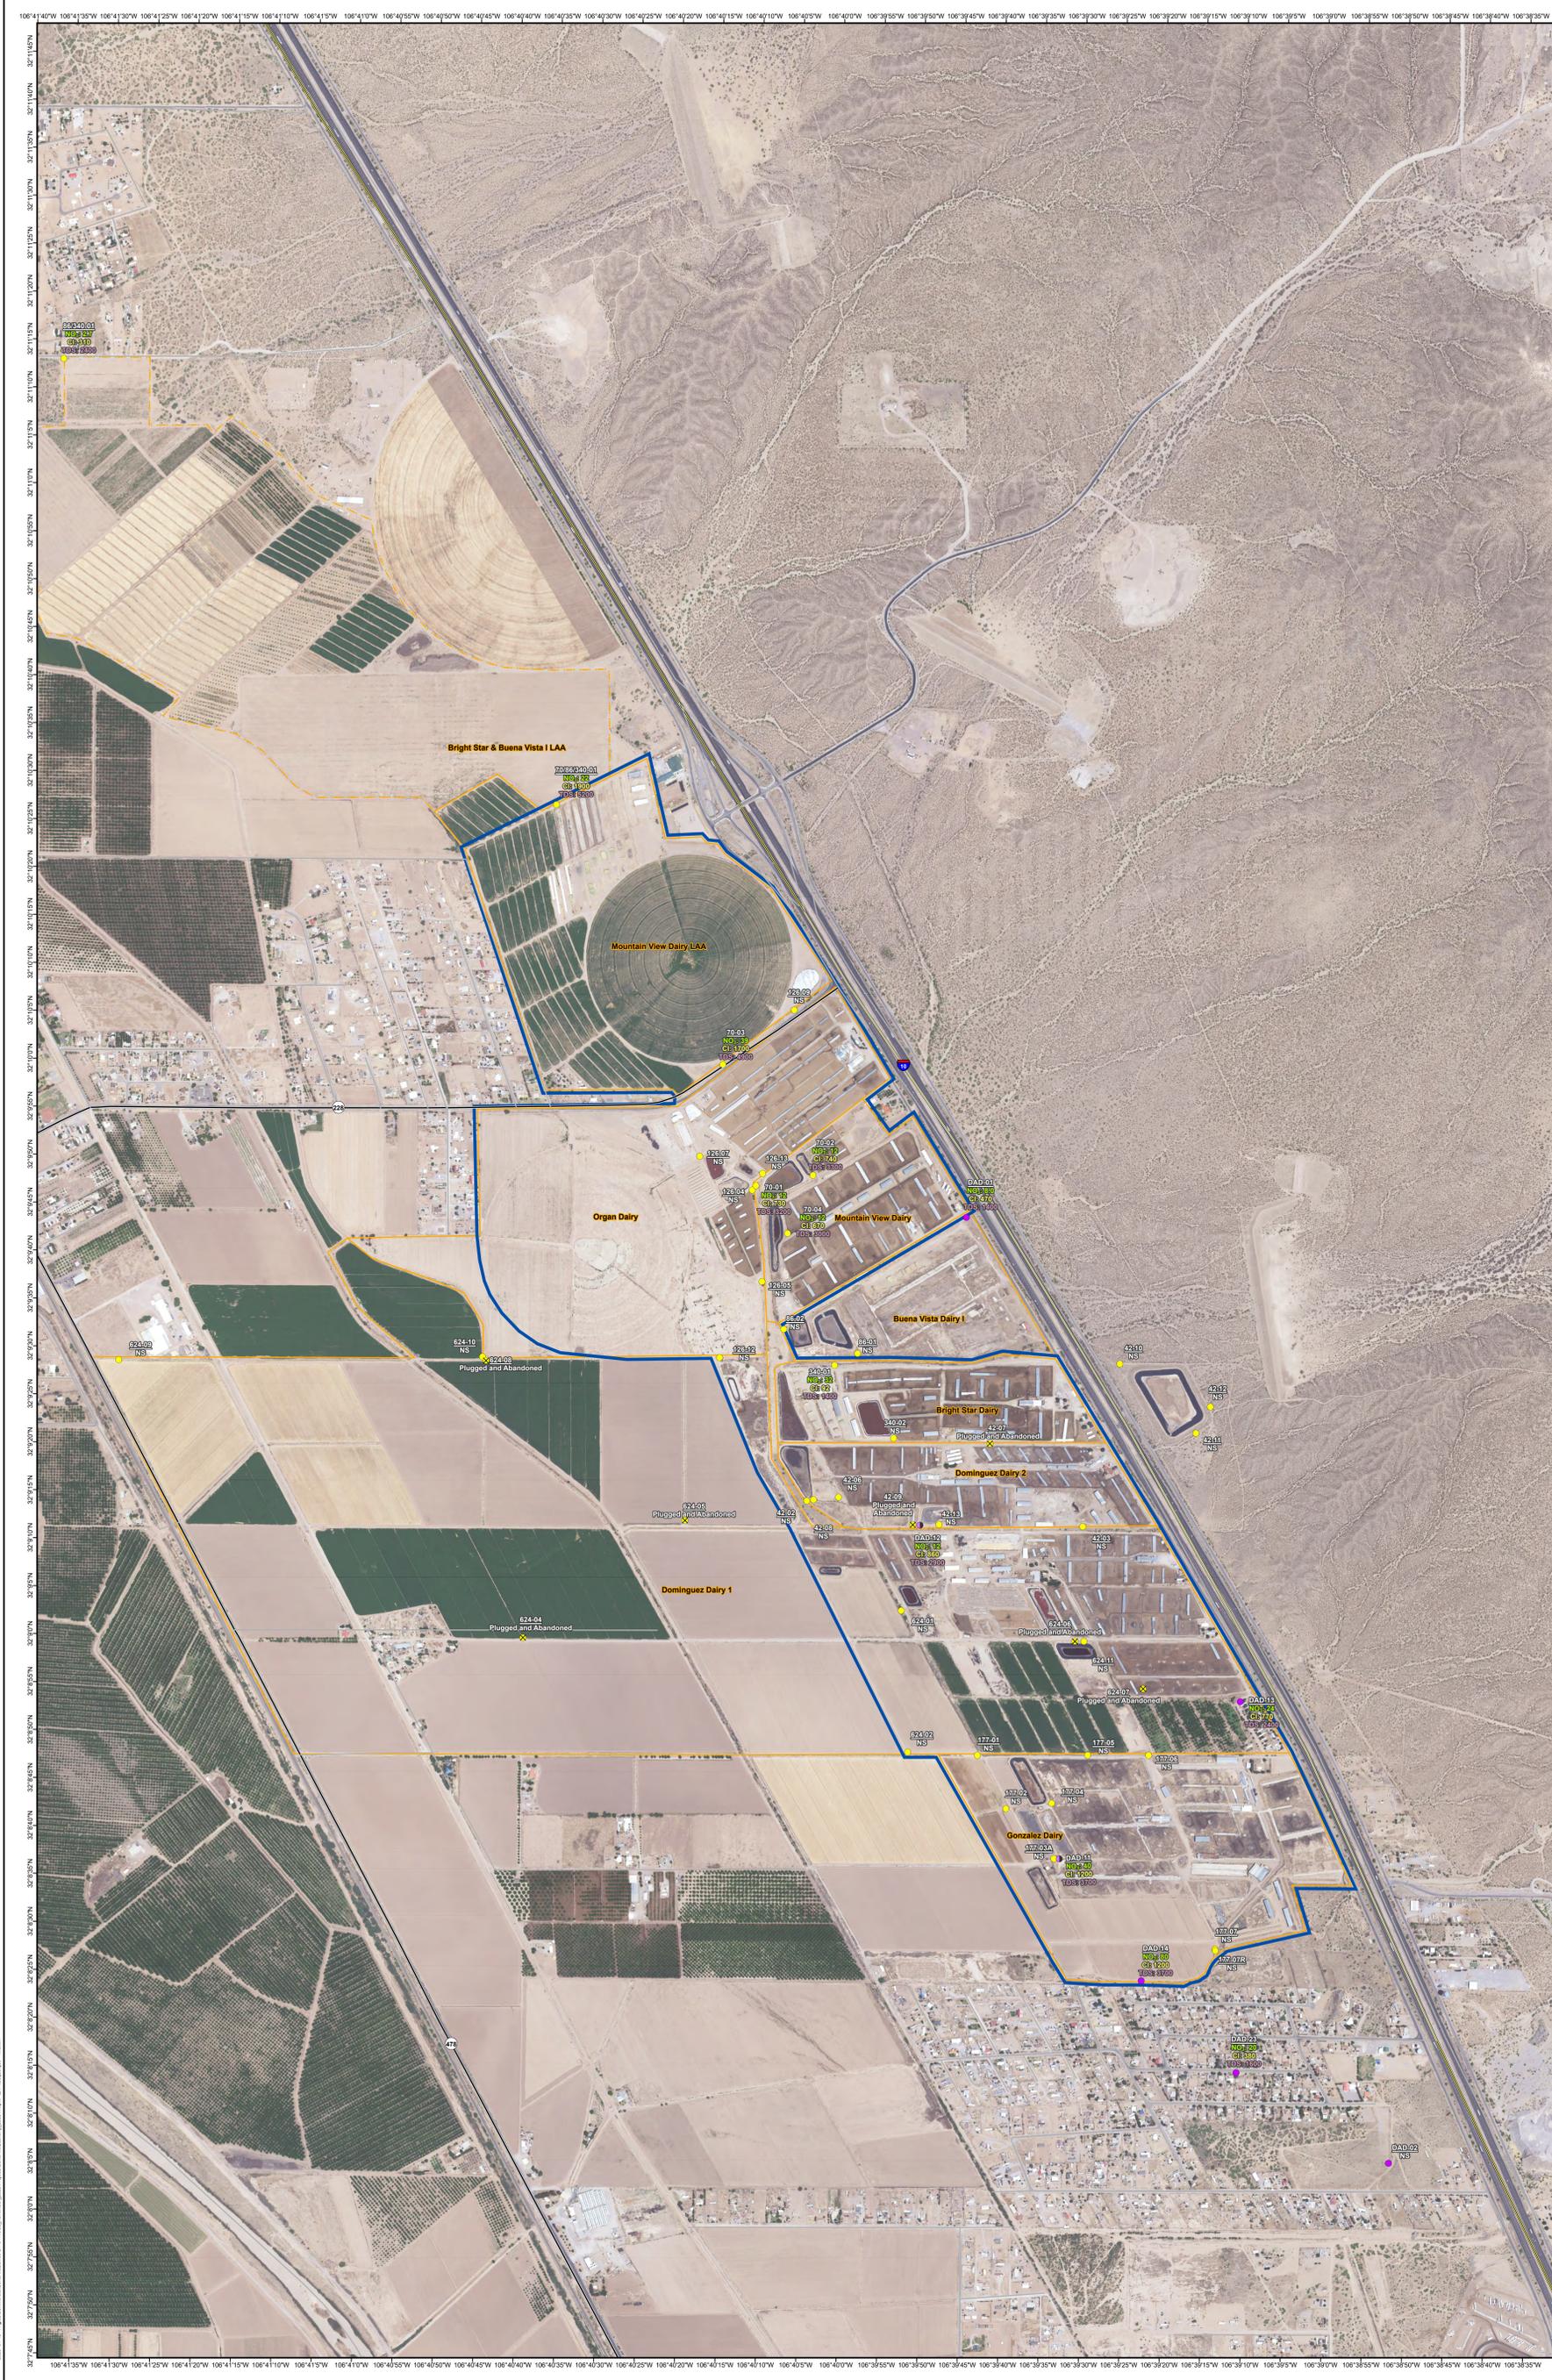
**Notes:**  
 Units are in milligrams per liter.  
 Cl = Chloride  
 NO<sub>3</sub> = Nitrate as N  
 NS = Not Sampled  
 TDS = Total Dissolved Solids
