ABANDONED OR INACTIVE URANIUM

MINES IN NEW MEXICO

A report of investigation carried out between August 1979 and May 1980 under contract with the New Mexico Energy and Minerals Department.

New Mexico Bureau of Mines and  
Mineral Resources  
Open-File Report 148

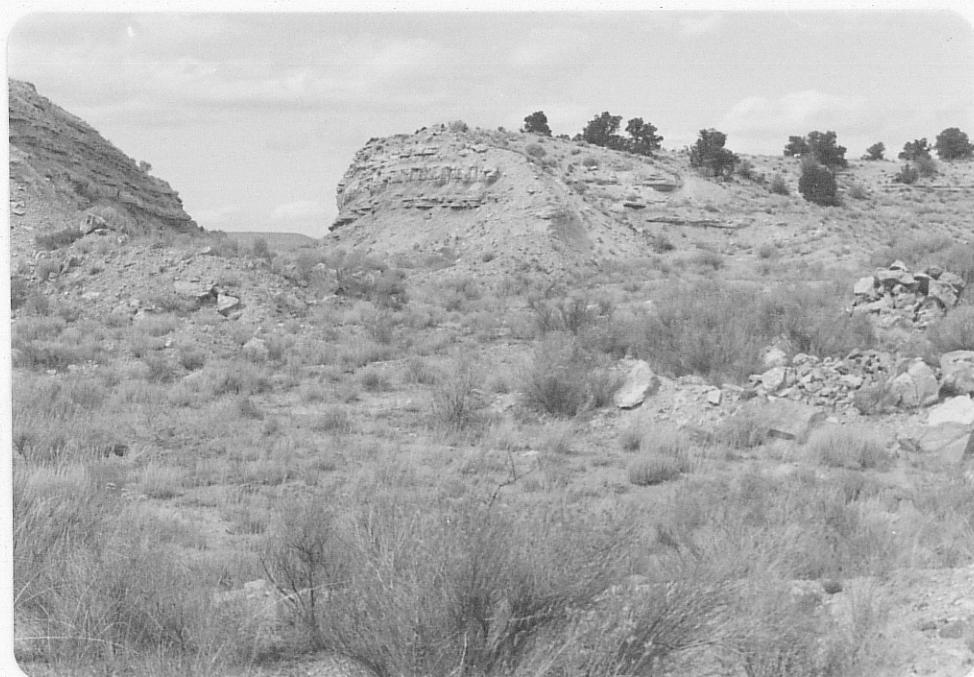
The mine itself is a rectangular open pit or trench 260' long, up to 50' wide, and up to 30' deep, oriented N 60° W. It is a notch in the sense that it goes completely across the spur (see photo a), with an abrupt drop off into adjacent canyons at either end of the cut. The east end of the cut is the widest.

Photo (a) Looking northwest into Box Canyon Mine; cut is generally 35' wide (wider at east end), and 260' long. Small waste piles in foreground produced scintillometer readings up to 1,200 cps.

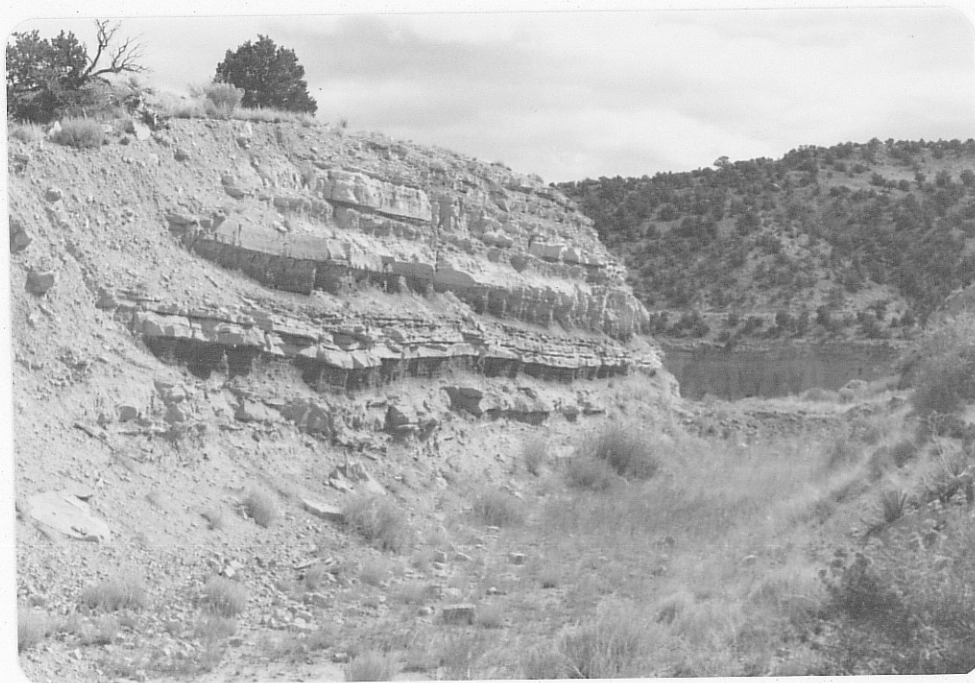
The face of the cut exposes a lower Morrison fm. sequence of sandstone, mudstone, and claystone (see photo b), with the host rock Todilto limestone presently exposed only along the base of the south wall in a low amplitude fold (see photo c). Scintillometer readings at this limestone outcrop ranged up to 1,700 cps. The only other significant readings registered in the mine area were found at the waste piles shown in the foreground in photo (a)-up to 1,200 cps. The major portion of the waste was bulldozed into the canyons on either side of the cut.

Photo (b) Looking E-SE from inside cut at Morrison fm. exposed on north face; note hammer (circled) for scale. Access road (arrow) is visible across canyon at east side of cut.

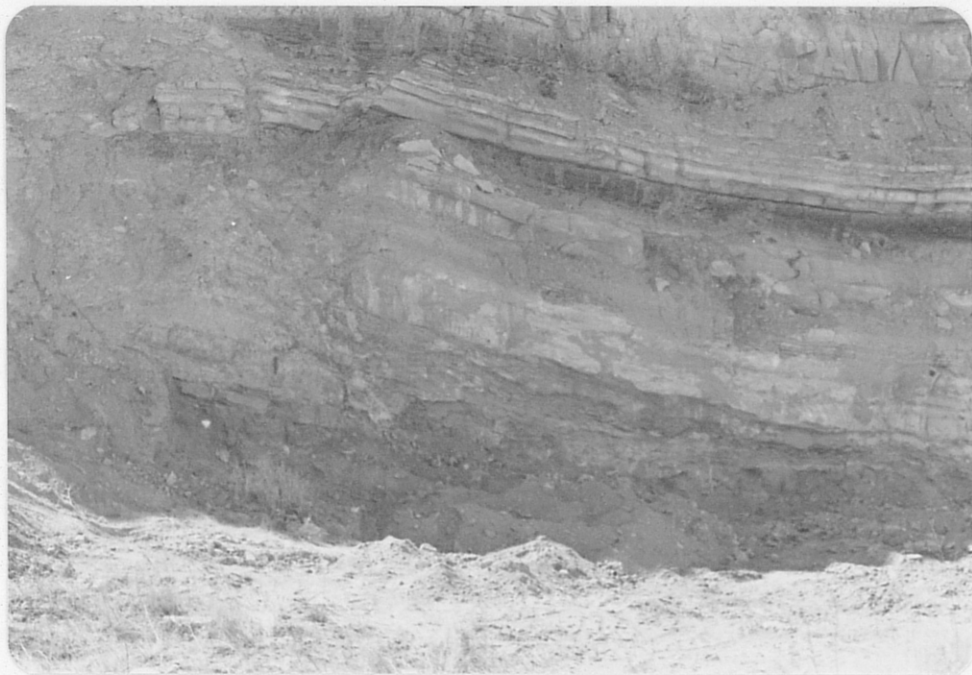
Photo (c) Looking south at south face of cut; showing fold and small fault near top; note hammer (circled) for scale.

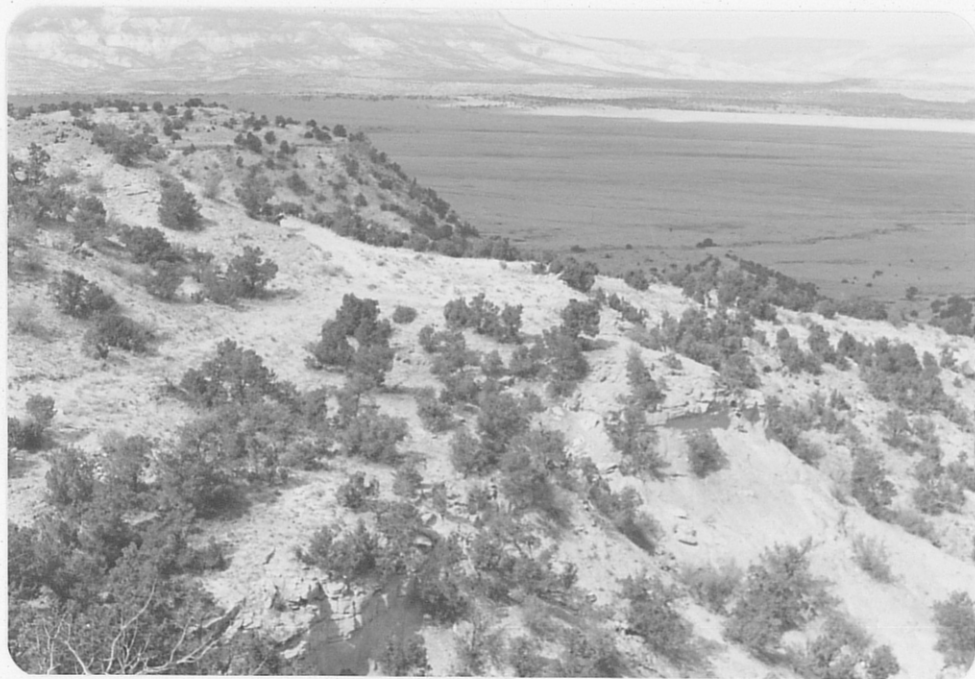
A portion of the mine access road and the local topography are shown in photo (d).

Photo (d) View northwestward just east of mine site, showing mine road (center and upper left) and the La Joya del Pedregal plain 400' below in the distance.
