ABANDONED OR INACTIVE URANIUM
MINES IN NEW MEXICO

A report of investigation carried out
between August 1979 and May 1980 under
contract with the New Mexico Energy and
Minerals Department.

New Mexico Bureau of Mines and
Mineral Resources
Open-File Report 148

Mine name(s) United Western (J. and M) County McKinley

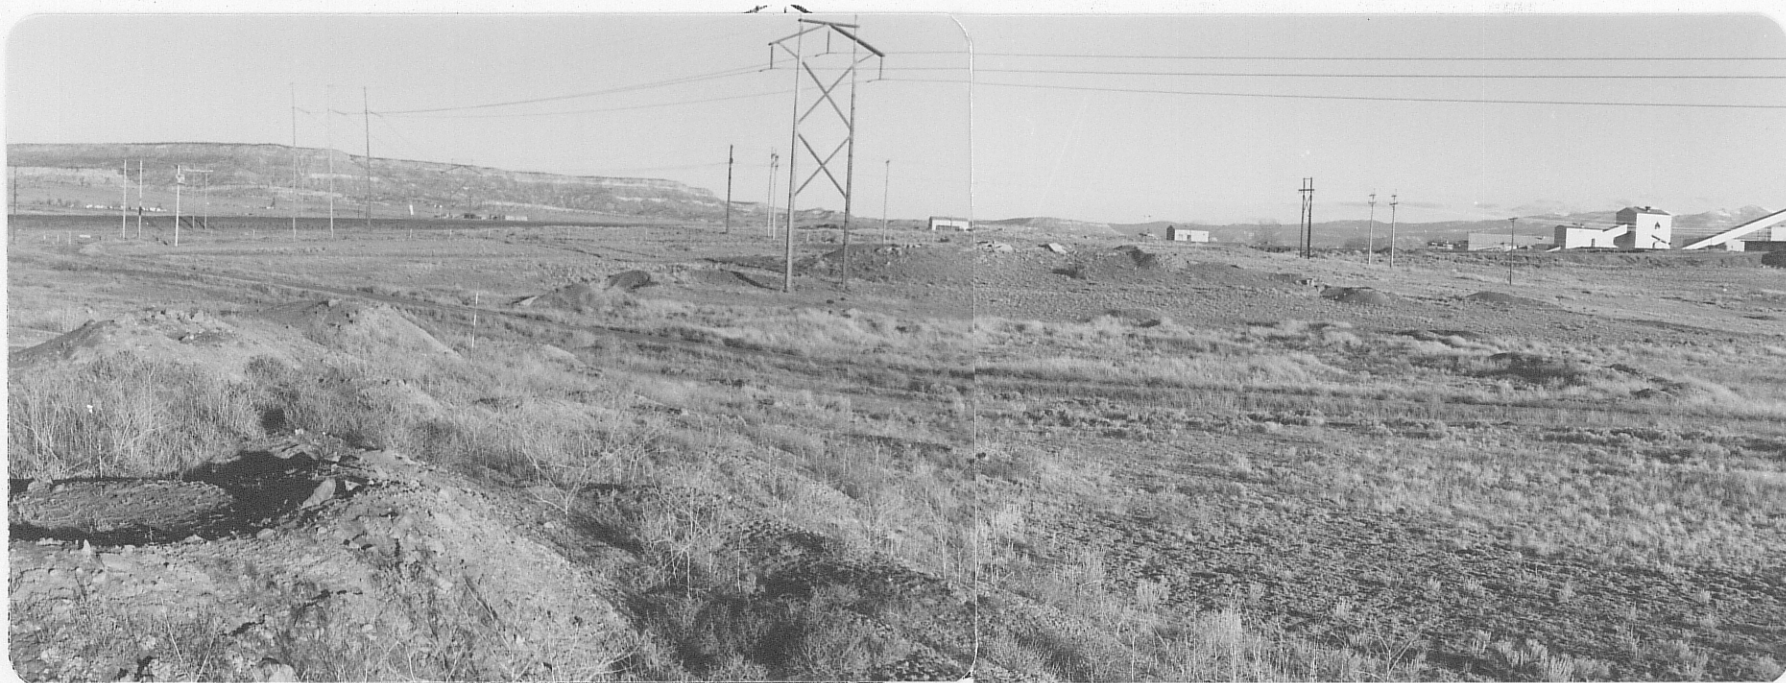
The mine shaft has apparently been backfilled, the buildings removed, and most equipment salvaged; the most prominent features remaining are the mine dump and powder magazine (see photo a). The mound of waste at the shaft site is cratered at top showing some evidence of a recent collapse and the earth is very soft, (see photo b). The remains of a small timber headframe lie 50' to the southeast of the shaft site, (see photo c). The powder magazine is a 5' high dugout in a gentle slope 400' southeast of the mine; entrance is timbered, (see photo d).

The mine dump lies across the access road directly west of the mine shaft. Maximum dimension is 250' in a generally E-W direction, and height varies between 3' to 6'. It consists of a cluster of conical piles in a fairly compact area on a gentle slope; scintillometer readings ranged up to 900 cps, but were generally less than 700 cps (see again photo a).

Photo (a) Looking eastward at mine site; dump area in foreground, shaft site indicated by arrow, powder magazine (circled), and Kerr McGee uranium mill at far right. Note range pole between dump and road for scale. The mound extending northward from the powder magazine to the double utility pole is a natural topographic feature formed on a thin sandstone unit in the lower Mancos Shale.

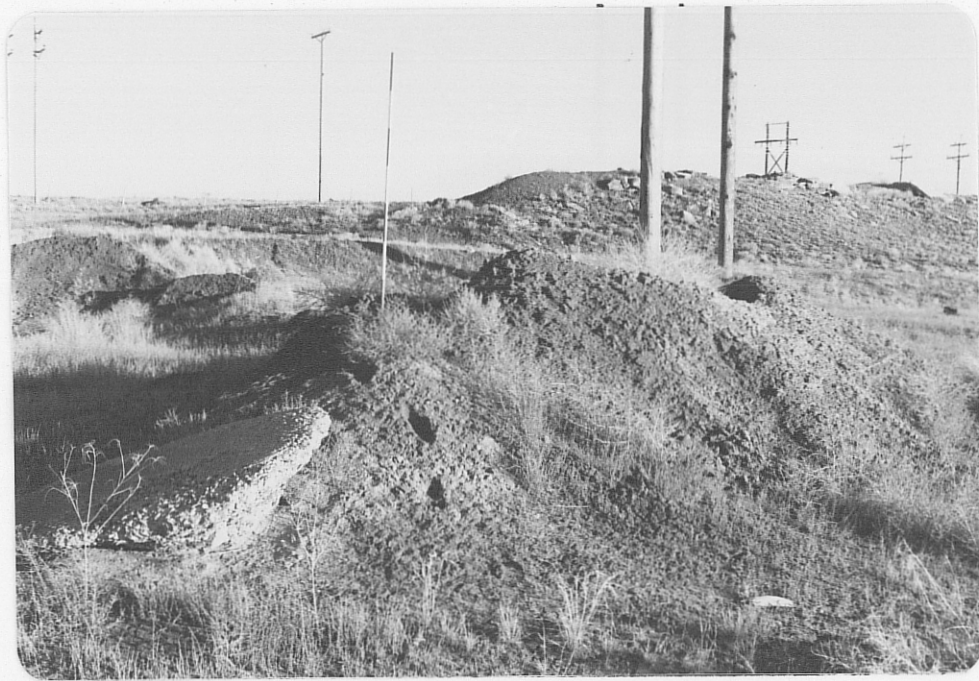
Photo (b) Looking southeast at mine shaft site which shows collapse features; note range pole for scale.

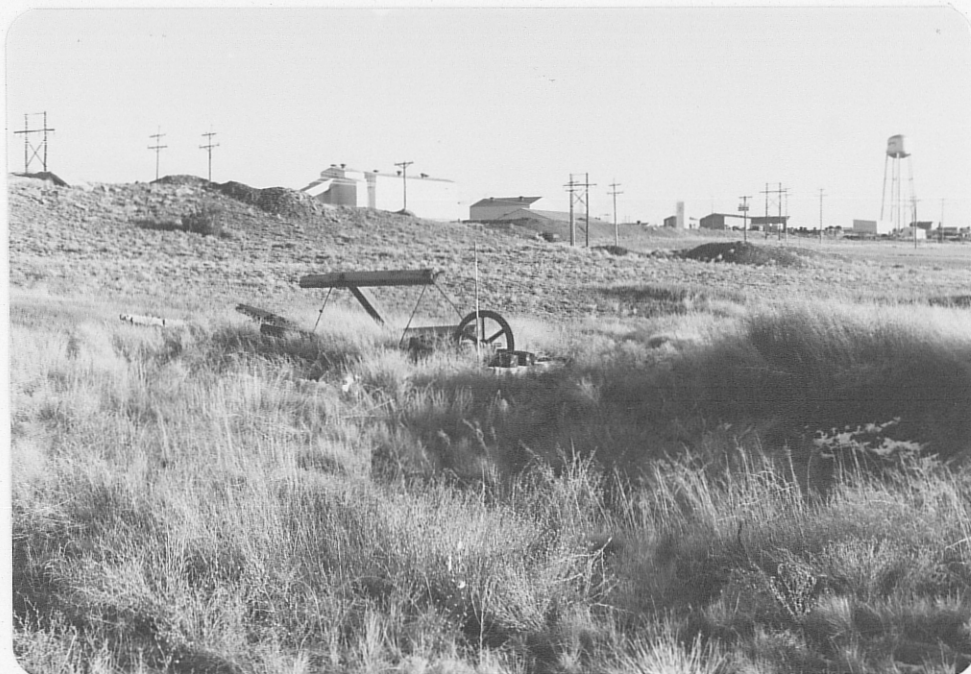
Photo (c) Looking southeastward at remains of headframe which lie 50' southeast of the mine shaft; note range pole for scale. Kerr McGee uranium mill is in background.

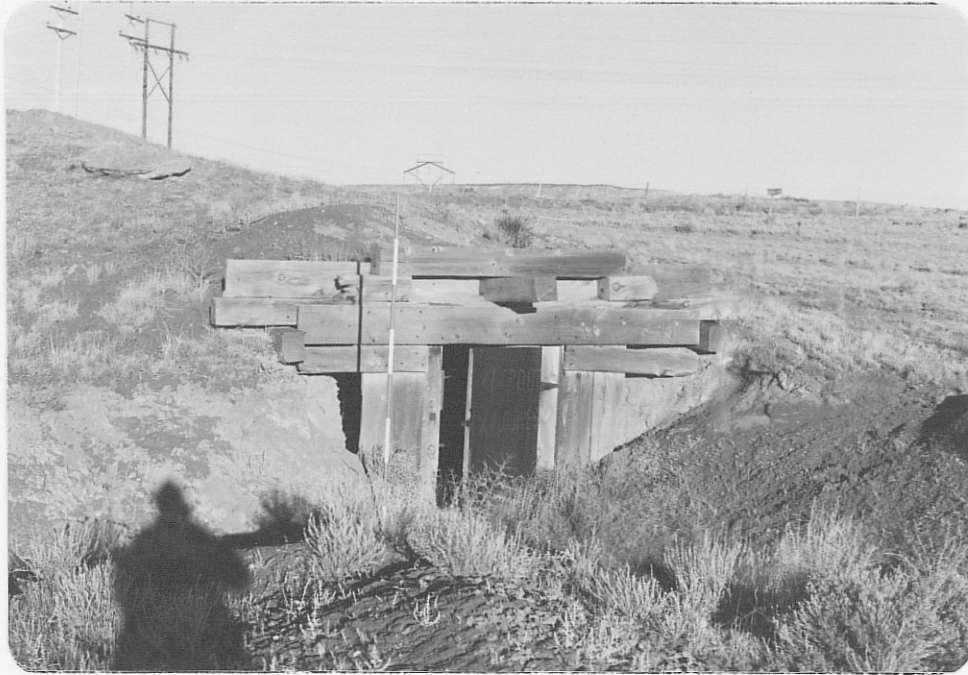
Photo (d) Looking northeast at powder magazine which is located 400' southeast of the mine shaft; note range pole for scale.
