WETLANDS ACTION PLAN for the GALISTEO WATERSHED

**U.S. EPA Cooperative Agreement CD# 976733-01-0(FY2004)
“Planning for Wetlands in the Galisteo Watershed”
And Addendum “Galisteo Pilot Project”**

Galisteo Watershed Wetlands Action Plan

New Mexico Environment Department
Surface Water Quality Bureau
Wetlands Program

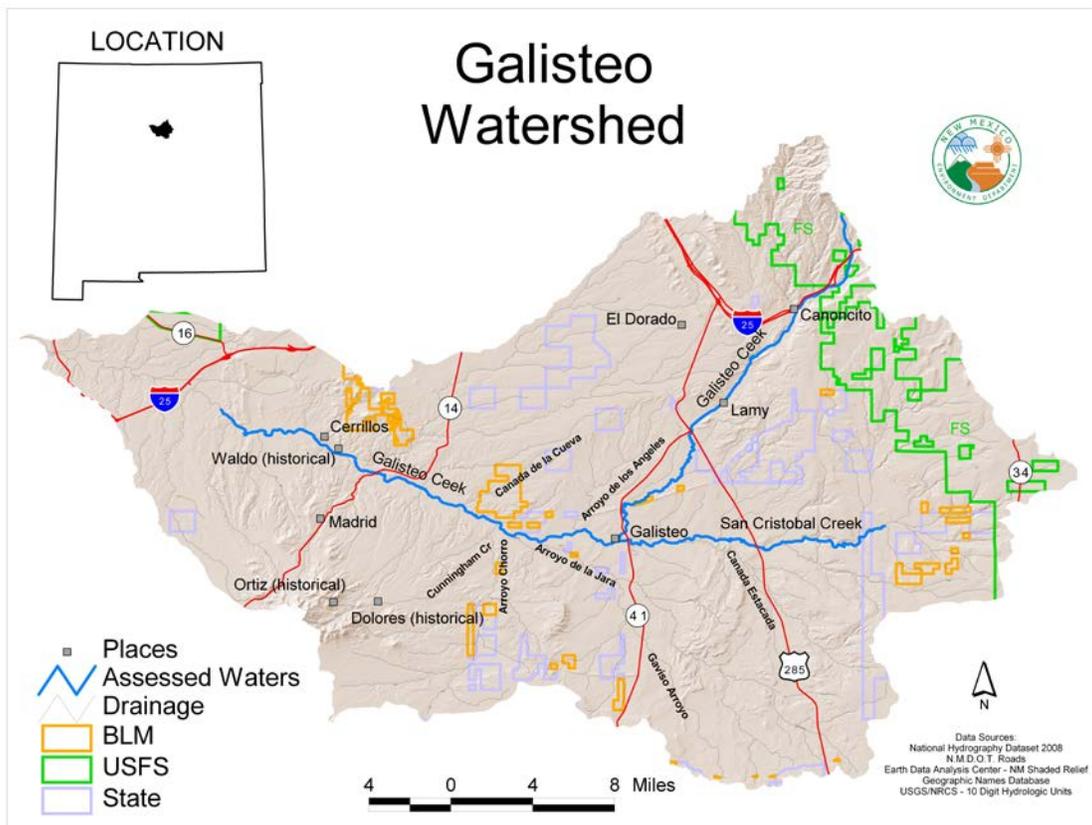
Figure 2. Galisteo Watershed with major perennial drainages, Galisteo Creek water quality assessment reaches, land ownership and geographical features shown.

The Galisteo Watershed is a 730-square mile sedimentary basin, located just south of Santa Fe, New Mexico (Figure 2). The Galisteo Watershed is named after the Galisteo Creek, which begins its course on the flanks of Thompson Peak and Glorieta Baldy. These peaks form the southernmost reach of the Sangre de Cristo Mountains, officially the southernmost mountain range of the Rocky Mountains. Other headwater creeks include Grasshopper Canyon, Deer and Apache Canyon Creeks. Each mountain creek valley is about eight miles long, and elevation differences between headwaters at Thompson Peak (10,533 ft) and Glorieta Baldy (10,199 ft) and their confluence at Canoncito (6,937 ft) are significant.

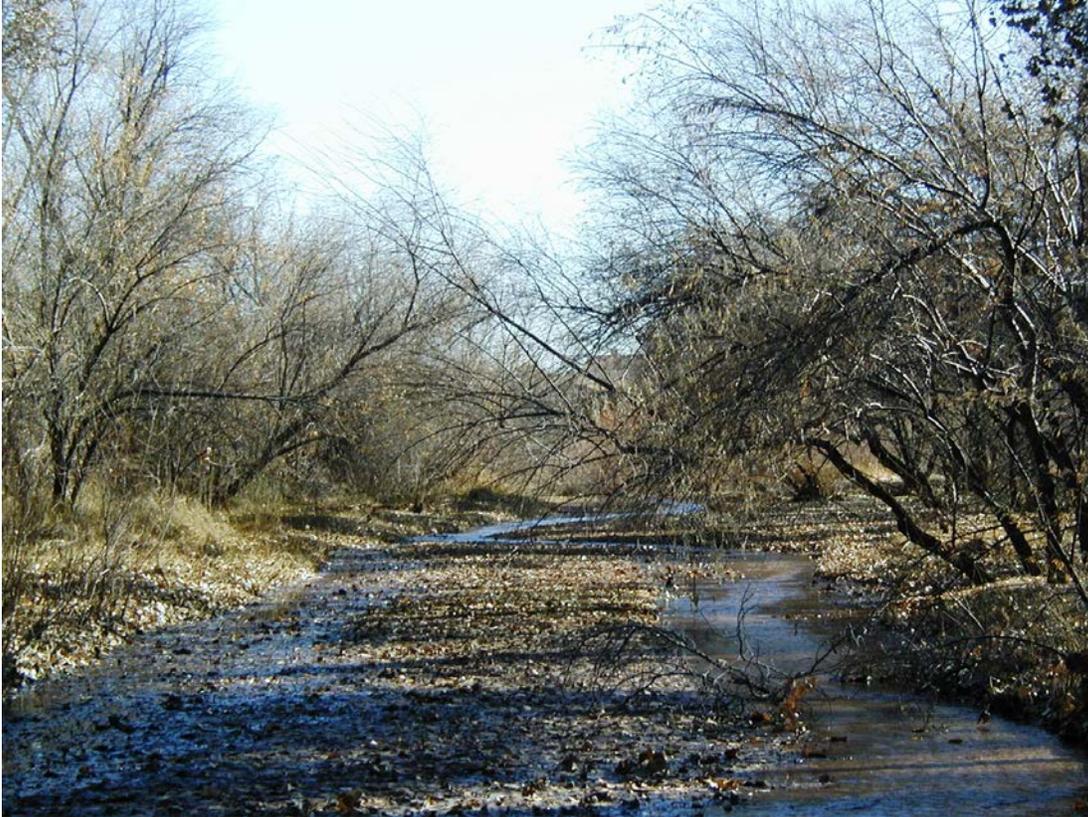
Figure 3. Galisteo Creek wetland in the Village of Galisteo (2004). Overhanging vegetation is primarily exotic Russian olive trees. Project activities have led to the removal of this exotic vegetation and the natural regrowth of willows.

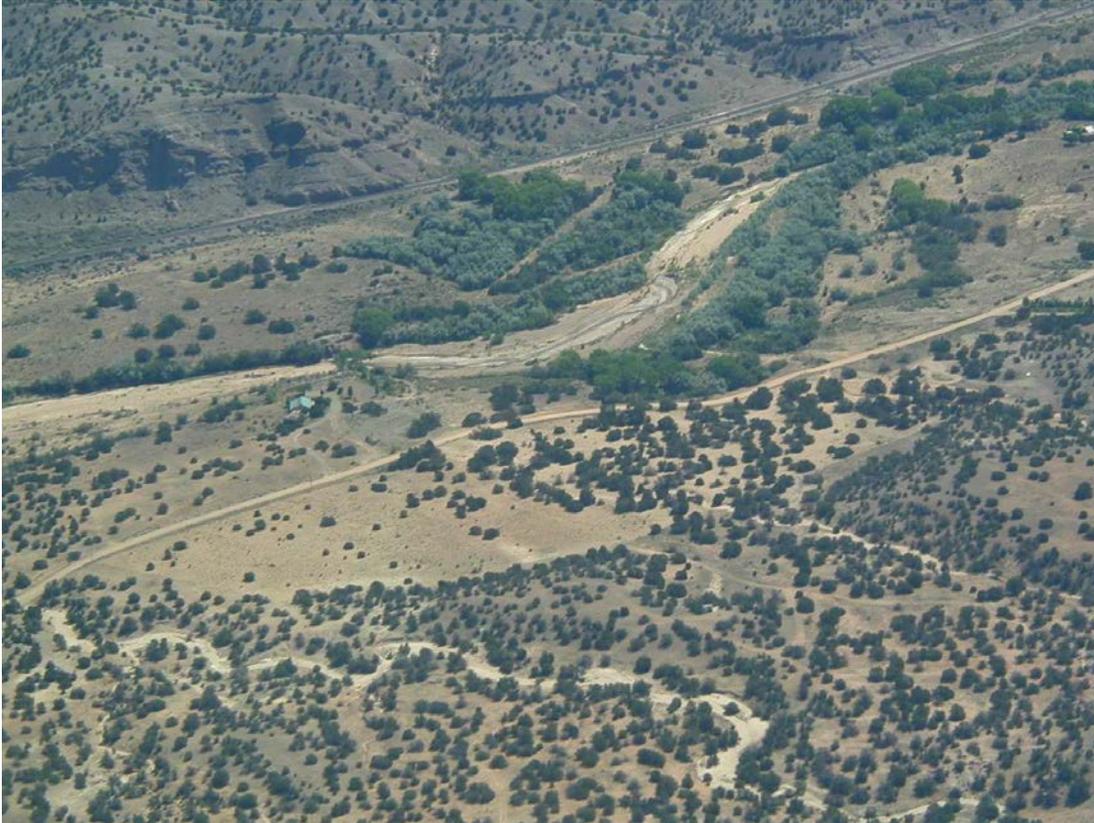
Figure 4. Aerial photograph of Galisteo Creek in the central part of the Galisteo Watershed. The photo shows riparian vegetation patterns that originate from levees constructed by the US Army Corps of Engineers between the 1930s and the 1950s to divert the Galisteo Creek away from the railroad tracks (top of photo). Induced meandering restoration techniques were used to recover stream hydrology, and restore overbank flooding and floodplain function within the confines created by locating railroad tracks adjacent to Galisteo Creek. All land shown in the picture is privately owned.

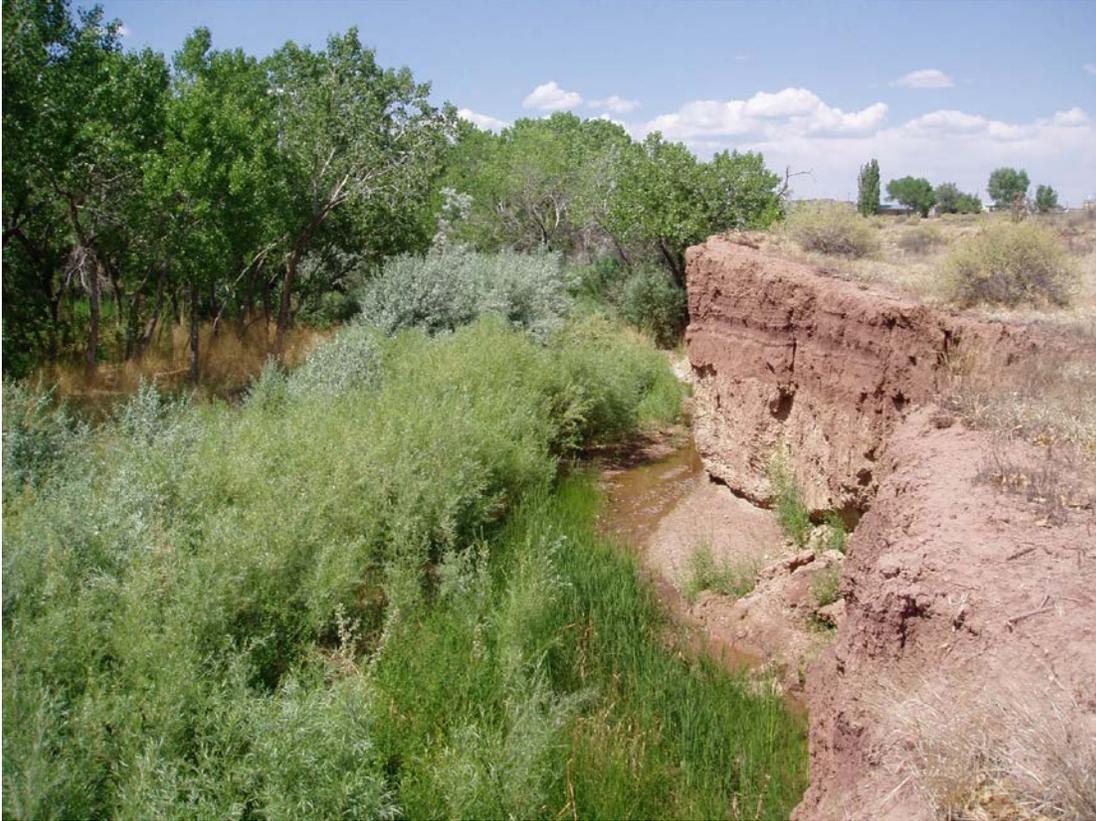
Figure 5. Typical riverine wetland habitat of the Galisteo Creek mainstem. Note the main channel has been incised and steep erodible banks are exposed.

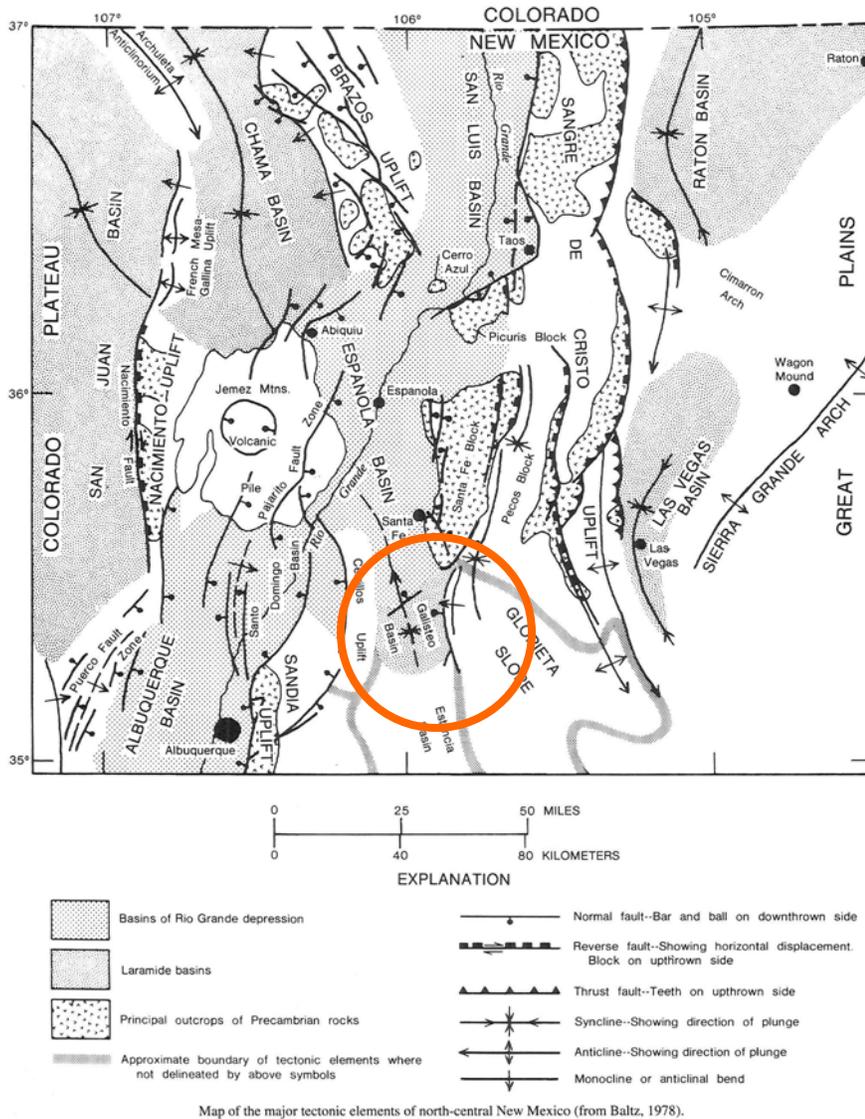
Figure 7. North-Central New Mexico tectonic schematic showing the position of the Galisteo Basin among major tectonic elements (Bauer et al. 1995).

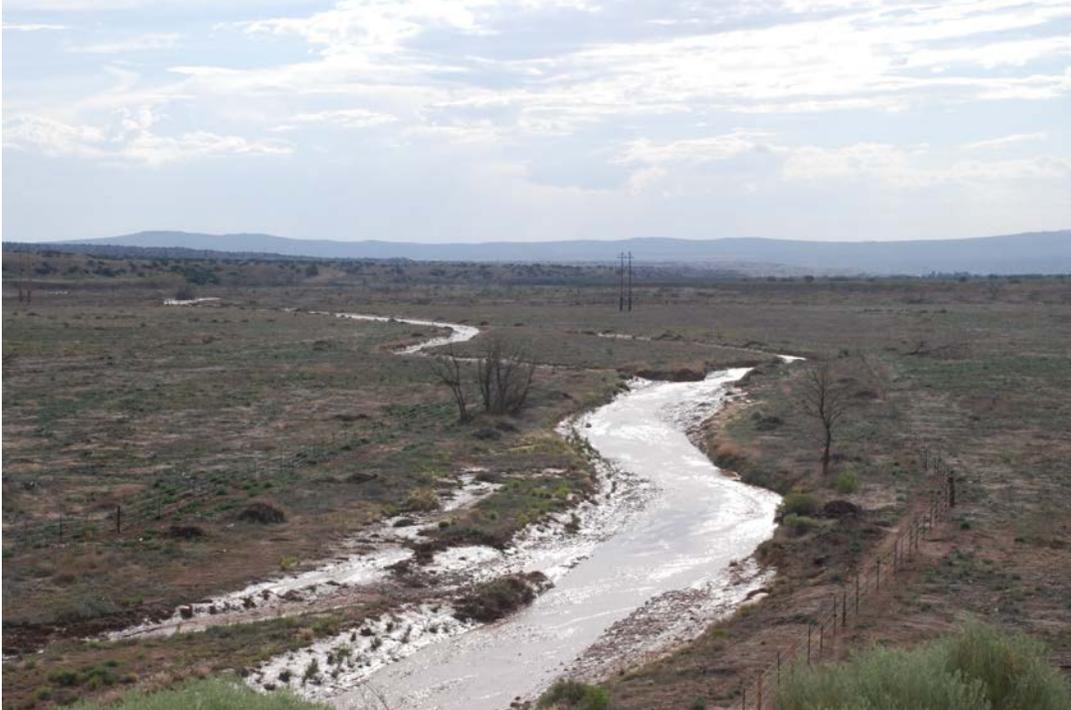
Figure 10. The lower end of Galisteo Creek flows through Santo Domingo Pueblo. This ephemeral portion of Galisteo Creek is shown flowing here after a summer rainfall event in the upper watershed. This area was previously cleared of exotic Russian olive and is now fenced from grazing as a measure to restore wetlands and the riparian area.

peaks and relatively small volumes (USACE 2006). Thunderstorm activity, most prevalent during July and August, produces about 70 percent of the annual runoff (Figure 10). Runoff from snowmelt is less significant but important for the Galisteo Watershed. Although measurements have not been taken, observations show that in some years, snowmelt runoff from February through June help saturate the alluvium in the upper and middle portion of the watershed and in some years the Galisteo flows all the way to the Rio Grande for short periods. The period from April through June is generally dry and produces less than 10 percent of the annual runoff from precipitation events (USACE 2006). Additional flow in the Galisteo Creek is contributed by the permanent springs and seeps (except in very dry years) that occur in various locations along the drainage due to the complex geology of the area.

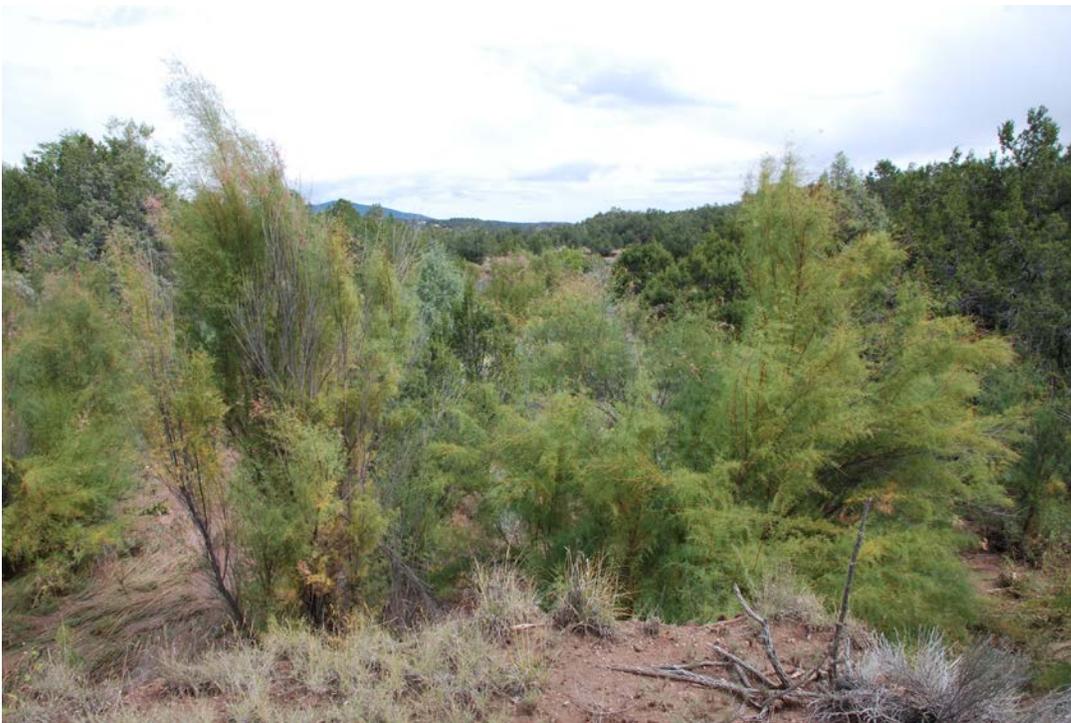
Figure 11. Dense tamarisk shrubland occupies perennial reaches and wetlands of Canoncito Arroyo. Photo taken before restoration activities in 2009.

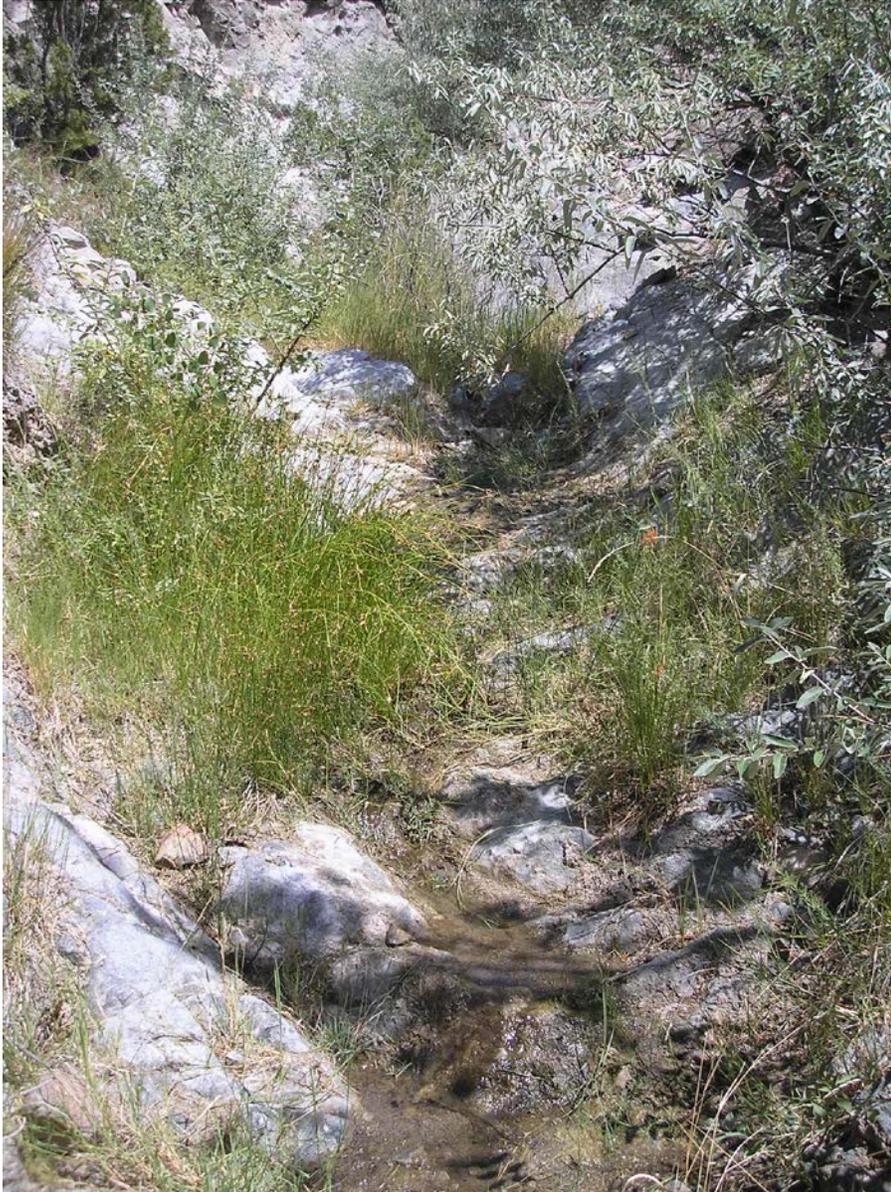
Figure 12. Devel’s Throne Arroyo at Cerrillos Hills Historic Park. Seep supports wetland herbaceous vegetation.

The University of New Mexico, Natural Heritage New Mexico Program conducted an inventory of wetlands/riparian resources and vegetation communities within the Galisteo Watershed in 2009 (Milford et al. 2009) This study primarily used GIS techniques supported by ground-truthing and includes all but the far northeast corner of the study area which is not covered by color-infrared photography. In addition to the location of wetland resources, dominant vegetation was described and high-quality wetland sites were identified. They recognized 7 wetland communities based on vegetation that include Closed Woodland, Open Woodland, Sparse Woodland with Shrubs, Sparse Woodland with Grasses, Shrubland, Herbaceous Wetland, and Herbaceous. These are principally distinguished by percent canopy cover of trees relative to total vegetative cover. Shrublands comprise the greatest amount of area delineated (416 ha); while Herbaceous Wetland had the least (12 ha). Much of the Shrubland community is dominated by salt cedar, with lesser amounts of coyote willow and minor amounts of rubber rabbitbrush (*Ericameria nauseosa*) (Figure 11). Herbaceous Wetlands often occur near impoundments or, in rare cases, as seeps such as within the Cerrillos Hills Historic Park outside of the town of Cerrillos (Figure 12).

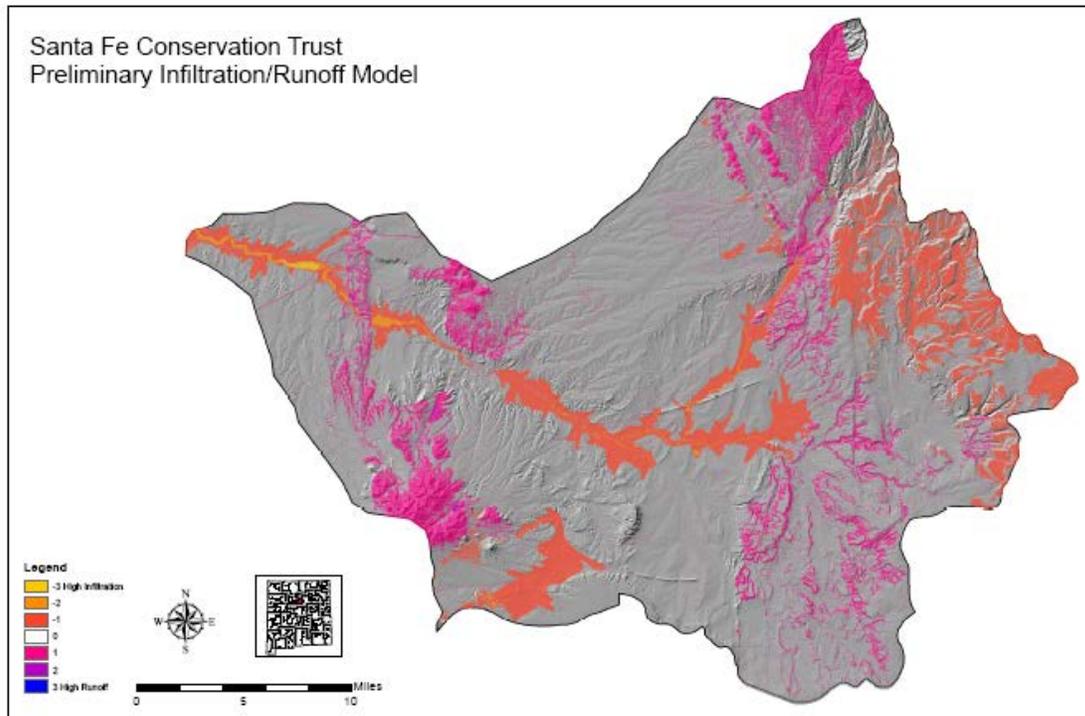
Figure 14. Preliminary Infiltration/Runoff Model. This model was used to produce a Green Infrastructure Plan for the Galisteo Watershed that identified priority areas for conservation, such as wetlands (Earth Works Institute and Santa Fe Conservation Trust 2007).

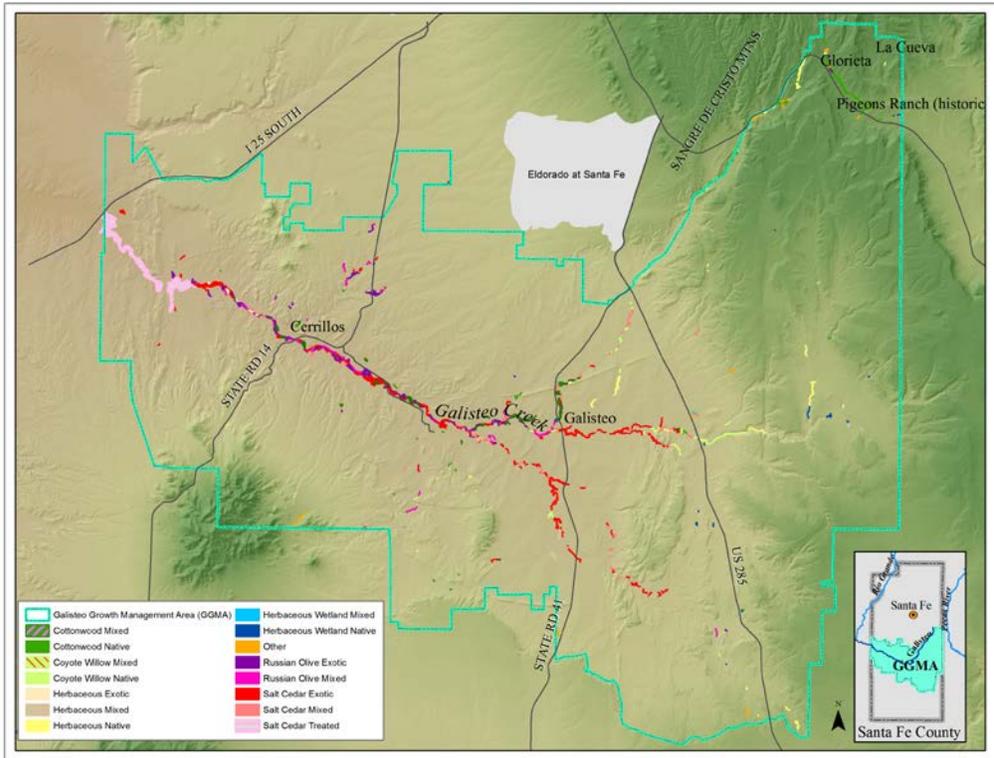
Figure 15. Map of wetland/riparian vegetation communities in the Galisteo Watershed (Milford et al. 2009)

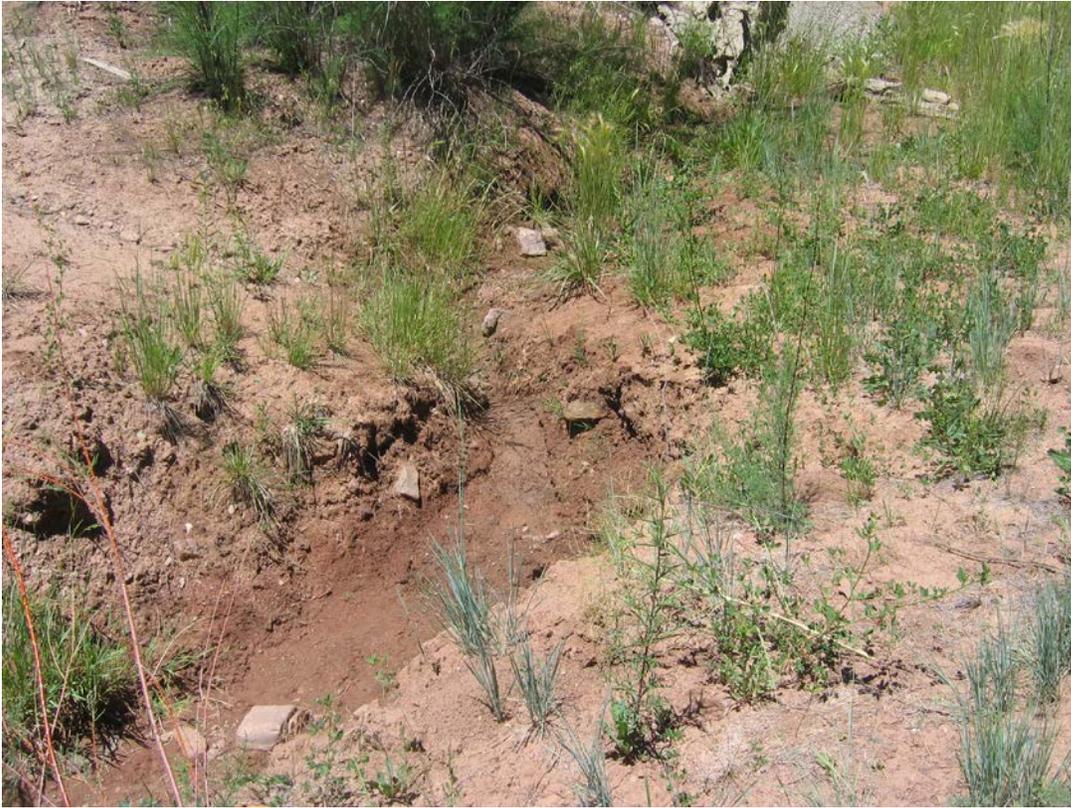
Figure 19. Headcut caused by nearby road culvert dewaterers and dries out local wetland in the Galisteo Watershed.

Railway and highway construction in particular have impacted watershed health. The construction of the railway across the watershed from Glorieta to the Rio Grande in 1880 was in many places installed in or just next to the stream channel of the Galisteo Creek. In many places, the floodplain of the Galisteo creek was cut in half lengthwise, which destroyed the creek morphology and ecosystem. In subsequent flood events the concentrated flood waters caused severe damage to the railway structure, and the Railroad sought to stabilize undercuts and erosion of the railway with concrete bank revetments and large stream modification structures, such as levees and dams. In addition, highway widening, drainage structures, culverts, bridges and other hard infrastructure design have concentrated stormwater runoff throughout the watershed. In many locations, poorly installed culverts have contributed to headcutting and lowering of gully and stream channel levels and contributed to accelerated erosion (Figure 19).

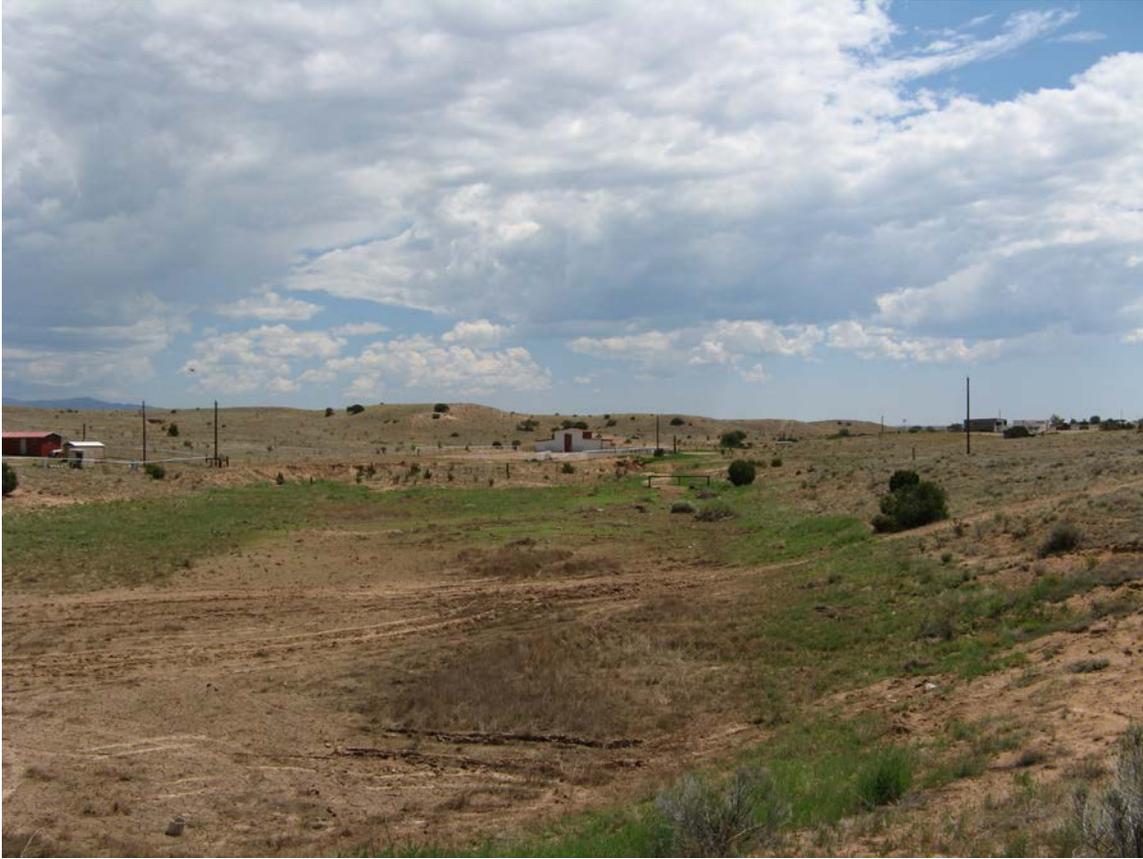
Figure 20 The Upper San Marcos Arroyo has been severely degraded as a result of uncontrolled development, poor grazing practices, off road vehicle use, stream modification, and groundwater extraction by individual wells.

Potentially degrading activities in the watershed also include off-road vehicle use, trails and pedestrian access, mowing, landscaping, solid waste dumping, domesticated animal access and resultant wildlife decimation, herbivory, vegetation trampling, soil compaction, and other local activities (Figure 20).

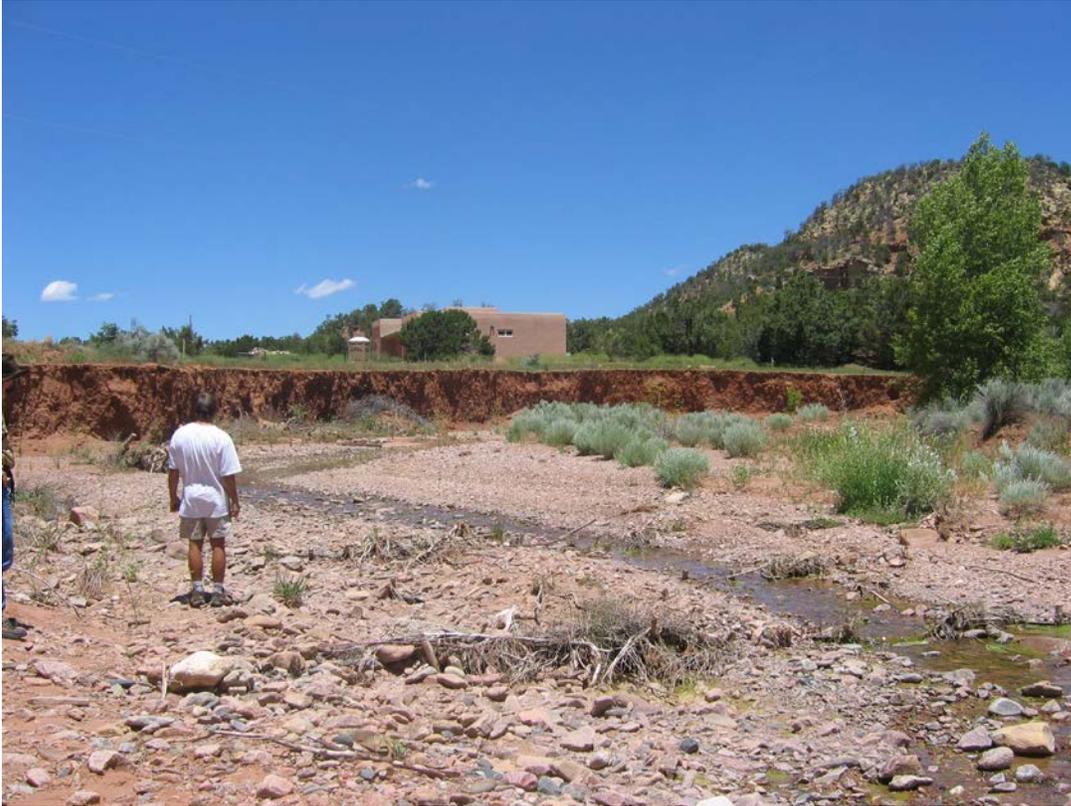
Figure 21. Loss of wetlands and their flood control functions allows for severe bank erosion in this section of the Galisteo Creek. Bank erosion threatens nearby homes and property value.

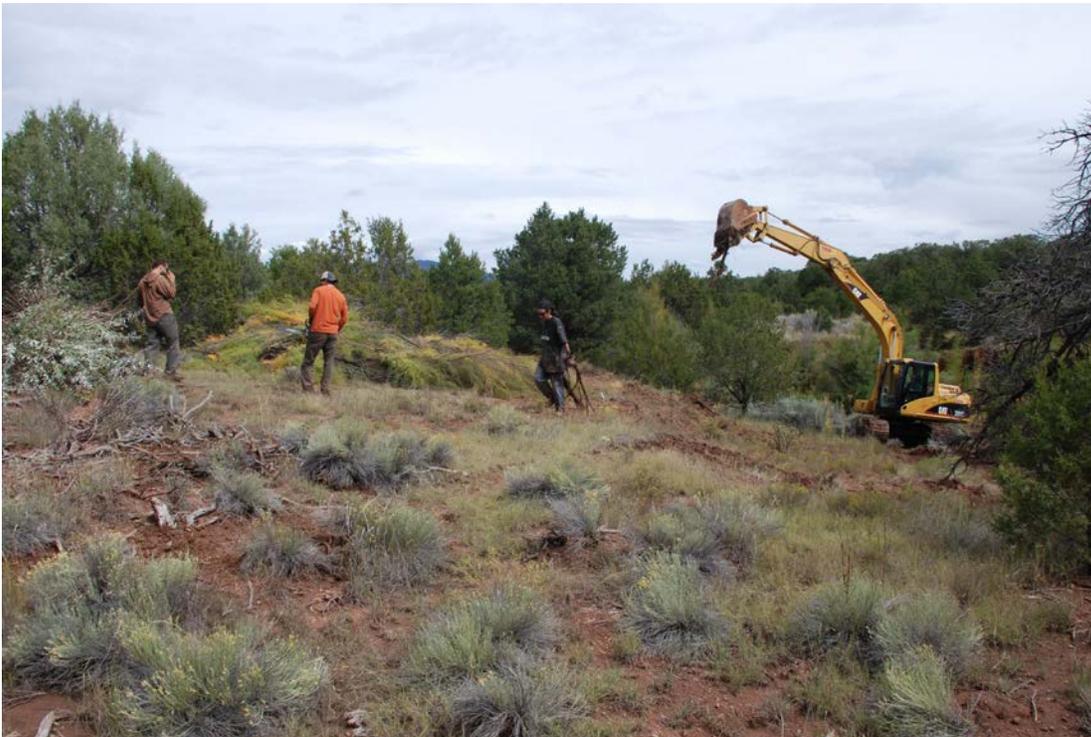
Figure 22. Tamarisk removal at Canoncito Arroyo. Tamarisk is pulled with heavy equipment and then stacked and hauled out of the open-space area by hand.

of floodplains at a world market value is about \$8,000 per acre, which translates into more than \$11,000 per acre per year at present values in 2010. This would mean that the 1,000 acres of present wetlands and streams in the Galisteo Watershed represent an annual value of at least \$11 million to society, while about 4,000 acres of historical wetlands and floodplain in the watershed have disappeared, at an annual value of \$44 million (based on 2010 values). In contrast, the average cost of a wetlands restoration project funded by EPA to restore approximately 30 acres of New Mexico wetlands (SWQB Wetlands Action Plan Program) is about \$500,000 using low-tech restoration practices, and including the value of in-kind match donations to complete the work and associated planning and outreach activities. This would value restoration of “restorable” wetlands at approximately \$16,700 per acre. Restoring highly degraded wetlands, using high-tech practices, and including future monitoring, maintenance and management would cost considerably more (Figure 22).

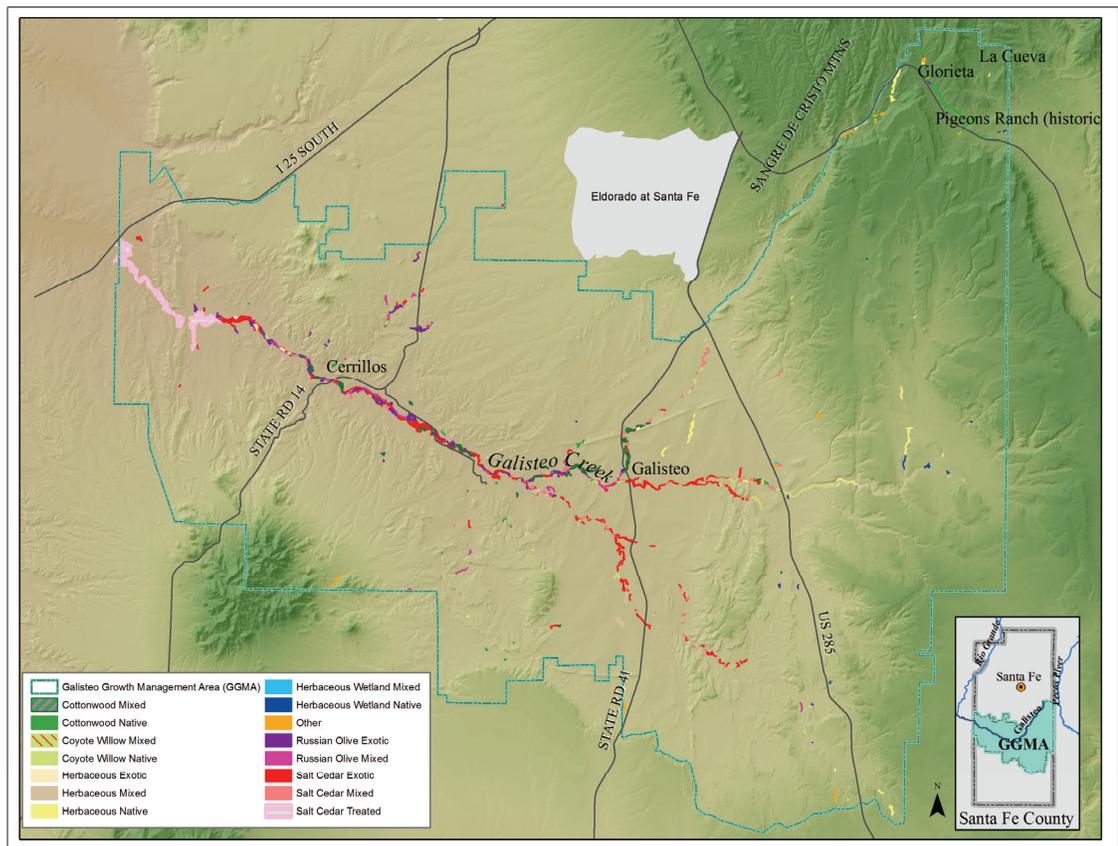
Figure 3. Final Riparian/Wetland vegetation map for the GGMA.

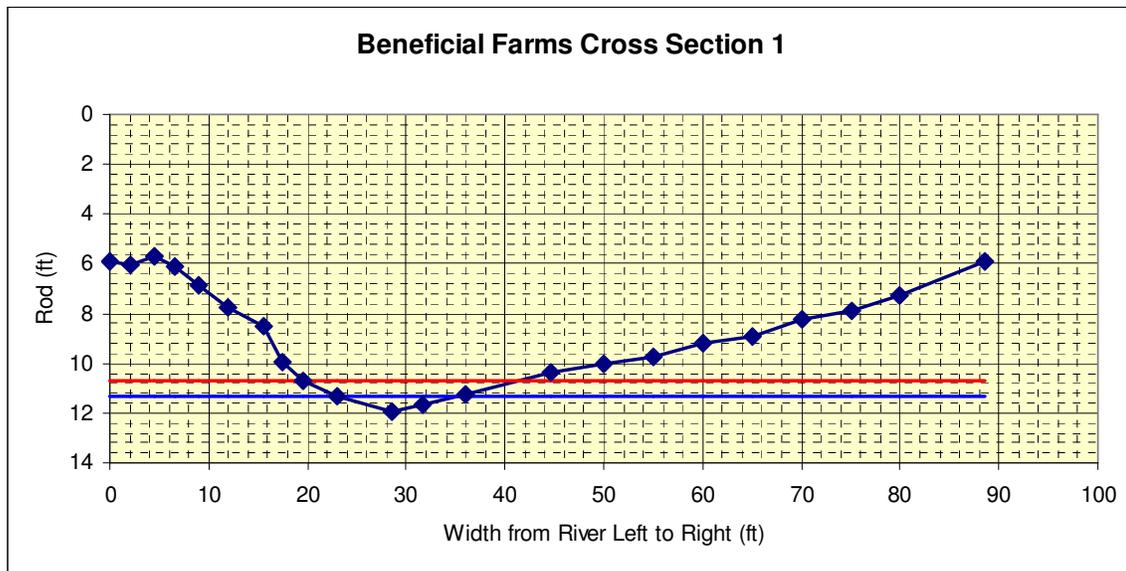
Cross Section 1, Beneficial Farm

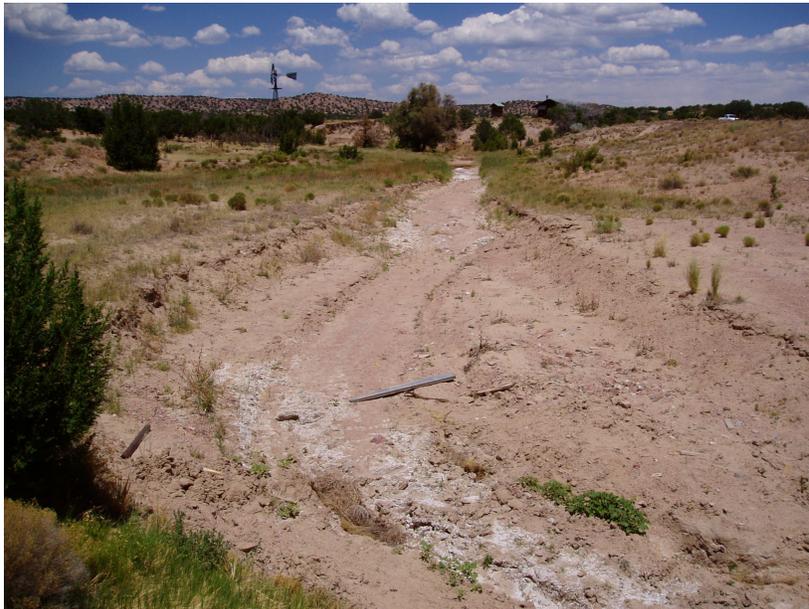
Looking Upstream at Cowboy Shack Wetland, Headcut begins at bottom of Picture.

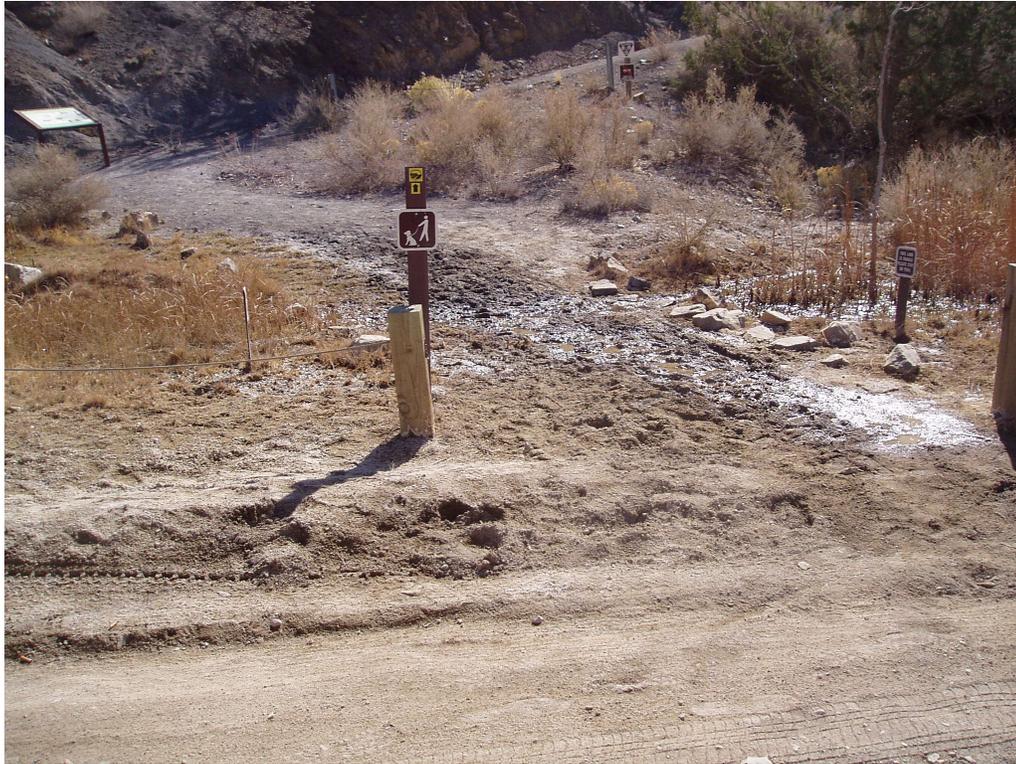
Mineral Spring Trail Crossing: needs protection from trampling.

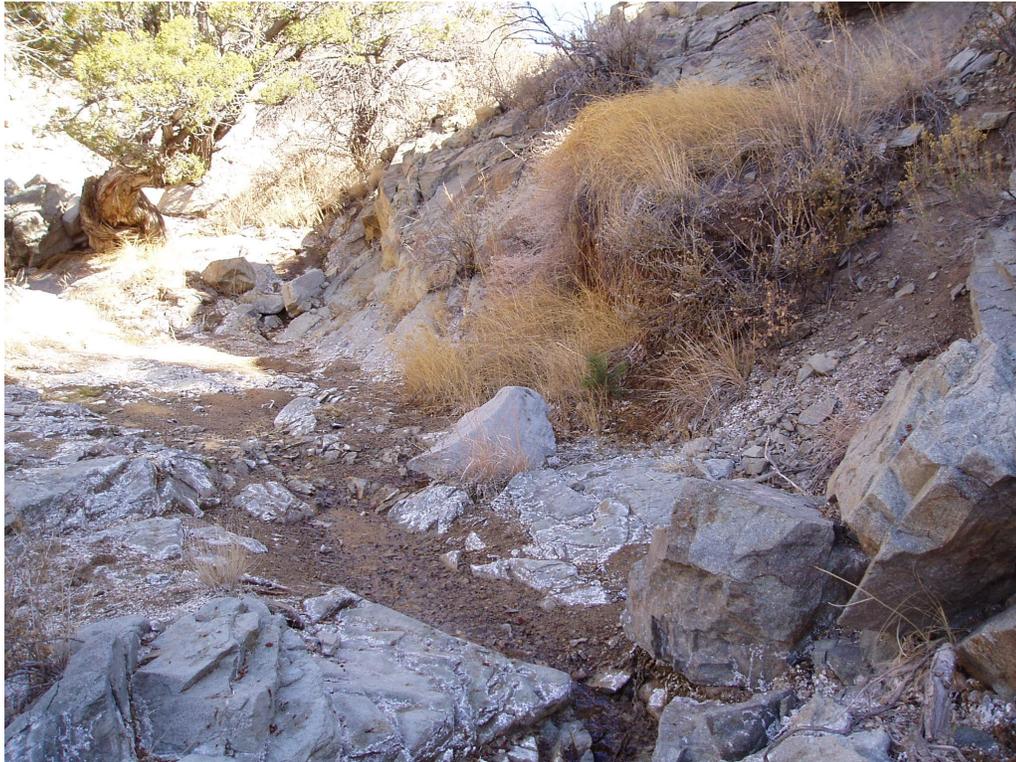
Miner's Spring, Elevation of *Juncus Balticus* Clump was Old Channel Elevation.

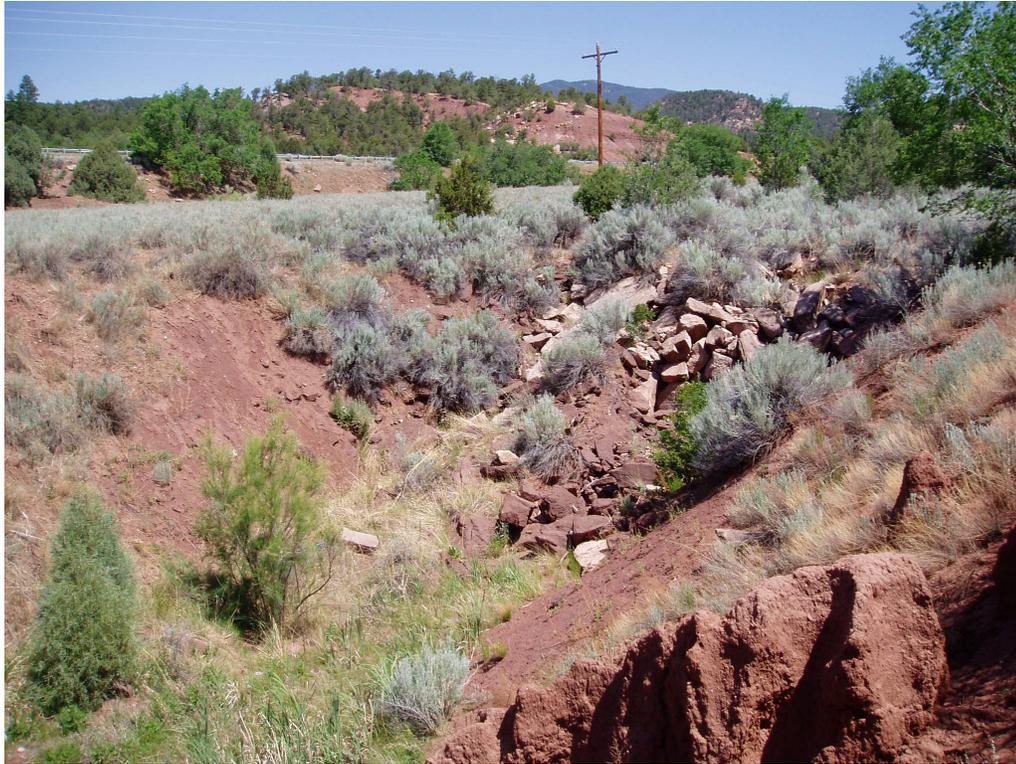
Headcut at Upper Galisteo Creek above Valencia.

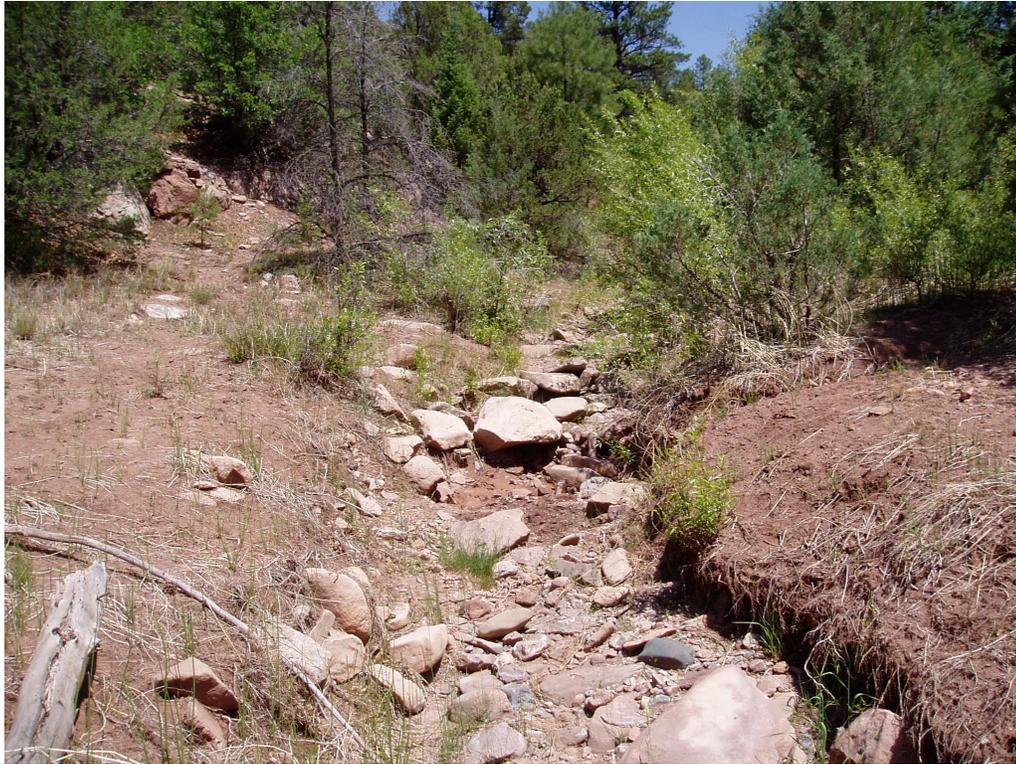
Headcut on Deer Creek: Creek incised for 100 yards downstream.
