Cieneguilla Creek Riparian Ecosystem Restoration Project

2012 Final Report

Date: June 2012

**Prepared by:
Implementation Task Manager: William "Hoot" Gibson
and Monitoring Coordinator: Alán Huerta**

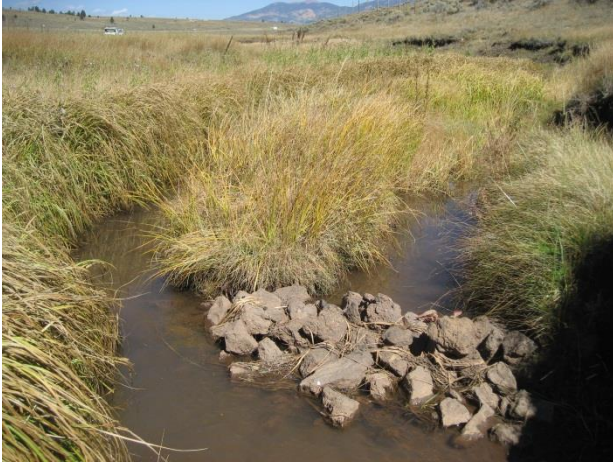
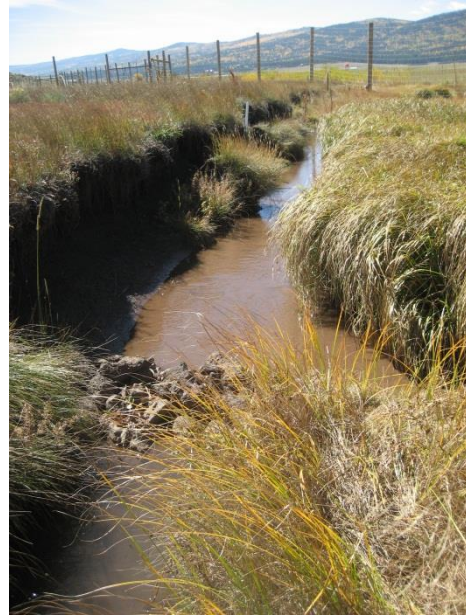
One rock pass through dam

The one rock pass through dam provides a perfect nursery for small fish, shelter from predators in the loose rocks and still get fresh water passing through the rocks. I conducted a count by walking down the entire length of the creek of the project area with a tally counter, pencil and field book. I counted 1 ~ dead 6" trout, over 157 ~ 1' – 3' small fish and 28 fish over 4" in length.

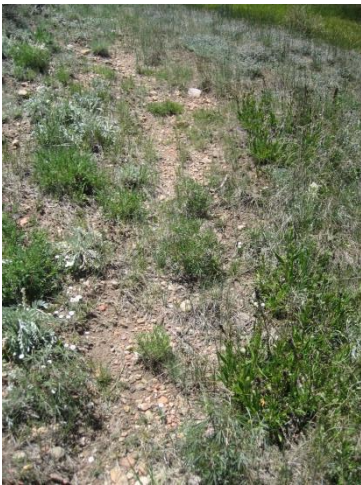
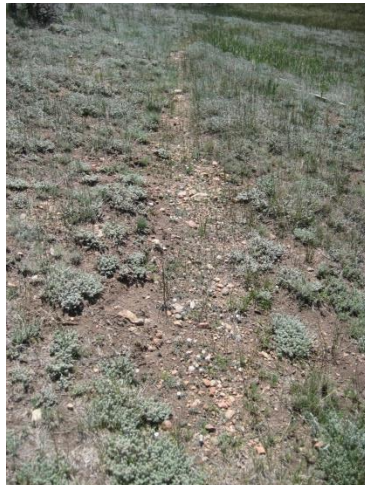
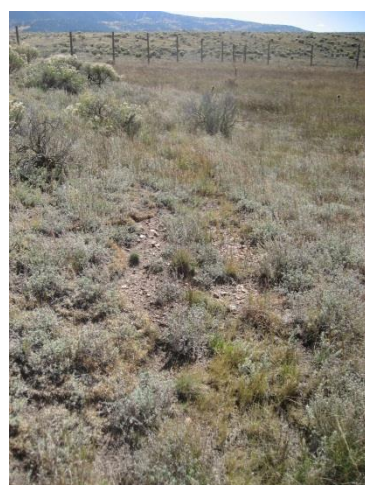
The disappearing large game trails are evident. Shrubs and Grasses are populating once bare trails.

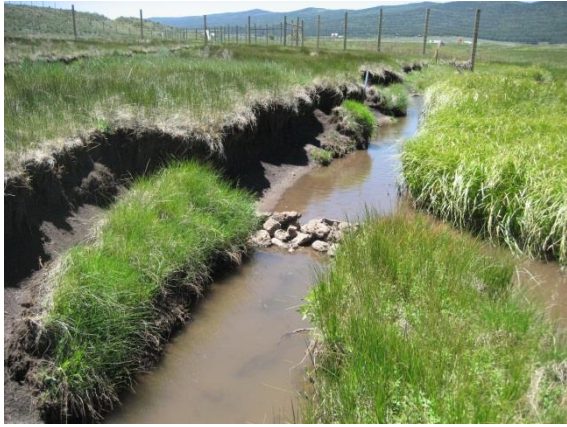
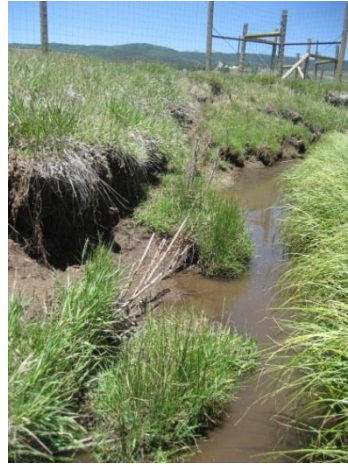
Natural calving of stream banks are closing and re-vegetating once bare vertical stream banks.

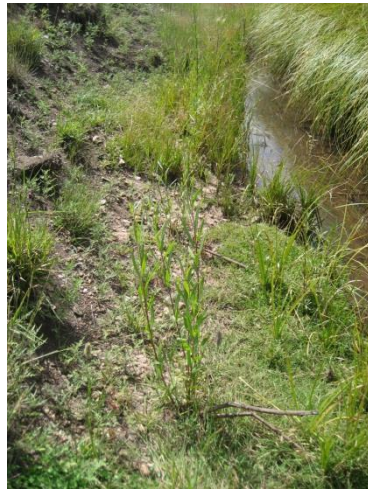
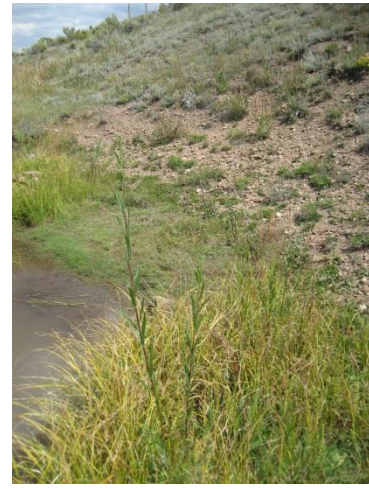
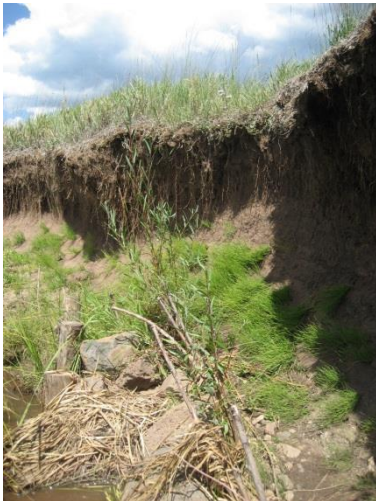
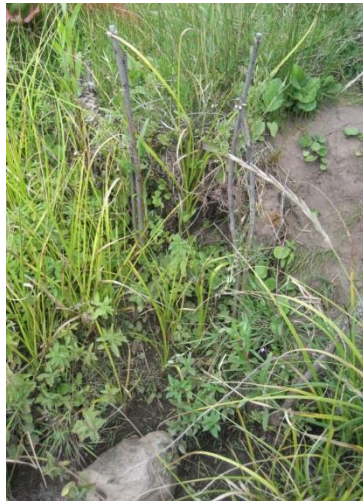
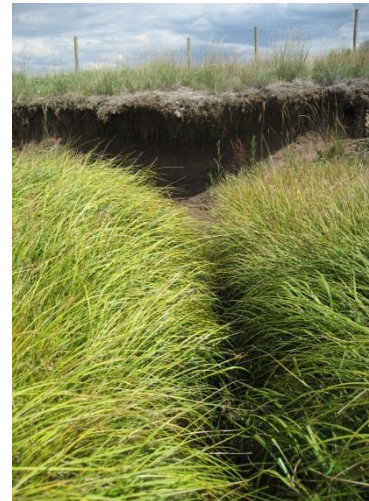
Obligate plants such as grasses and planted red willow are taking hold.

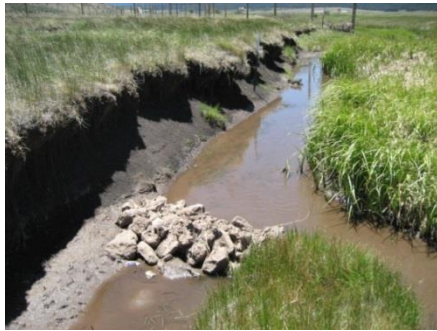
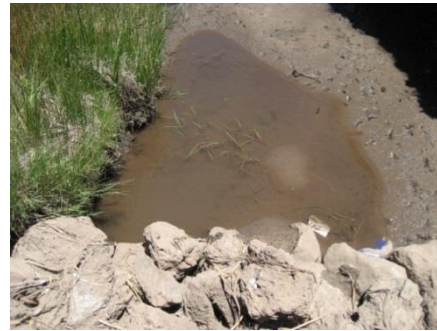
Observations: A marked increase in fish fingerling population from ½ “ to 1 ½”, and in deeper holes fish larger from 4” to 8”, species undetermined.

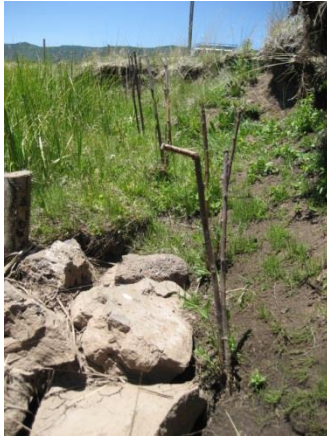
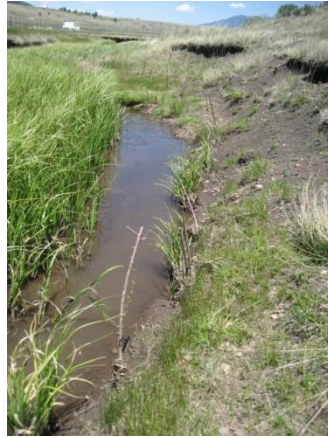
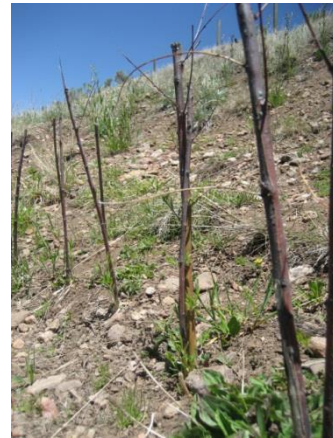
Planted willow stems taking hold with new sprouts shooting up from the roots.

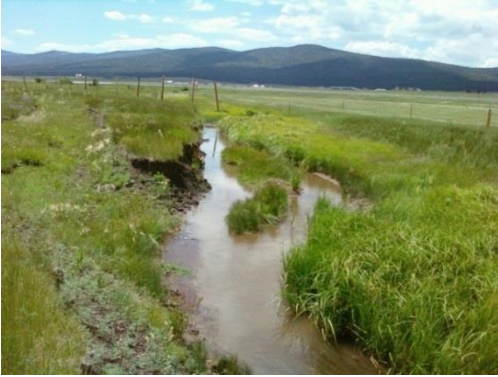
8.08.09

One rock pass through dam. Position: N 36.43328 W 105.28838

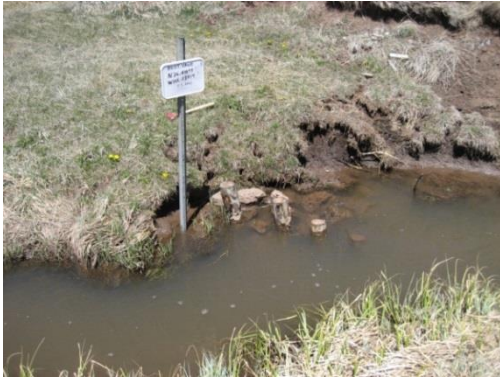
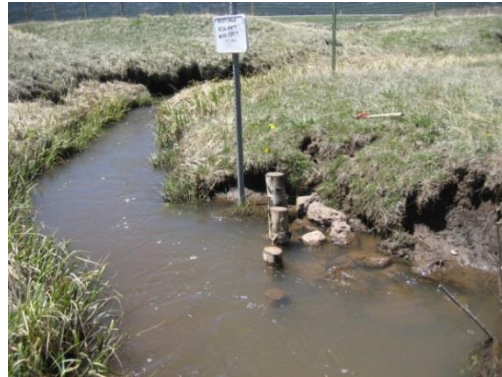
03.05.2011

Post Vane #5. Position N 36.43453 W 105.28819

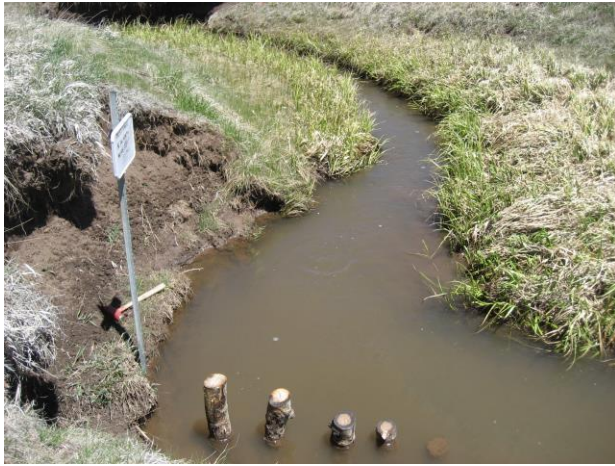
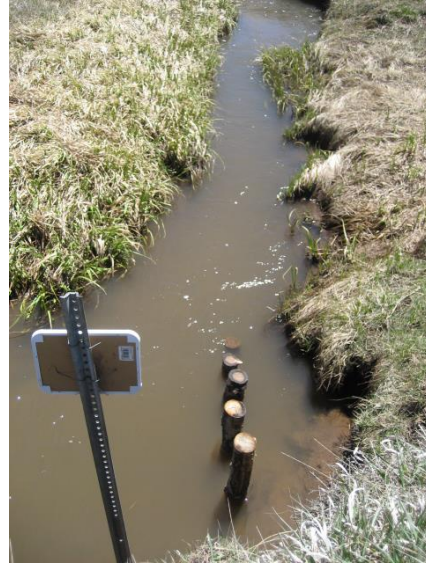
03.05.2011

Post Vane #6. Position. N 36.43456 W105.28835

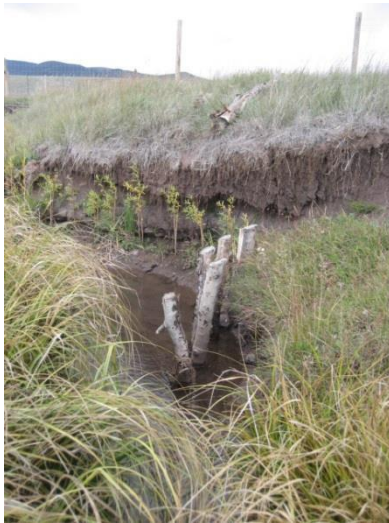
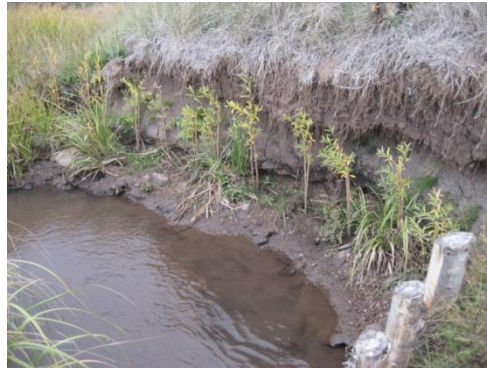
09.27.2011

Post Vane # 7. Position
